**Re: Defect Information Report – supplemental information  
(FL-451), NHTSA no. 05V-285, ConMet TruTurn Drum Tapered Mounting Flange**

**Section 573.6 Defect Information Report**  
**FL-451, ConMet TruTurn Drum Tapered Mounting Flange; NHTSA no. 05V-285**  
**Supplement No.: 03**

## Subject: ConMet TruTurn Brake Drums

**Models Affected: Specific Freightliner Business Class M2, Century Class S/T, Classic, Classic XL, Columbia, Coronado, and FLD vehicles; Sterling A/L-Line and Acterra vehicles; and Western Star 4900 vehicles built between August 26, 2004, and March 31, 2005, with ConMet TruTurn Brake Drums.**

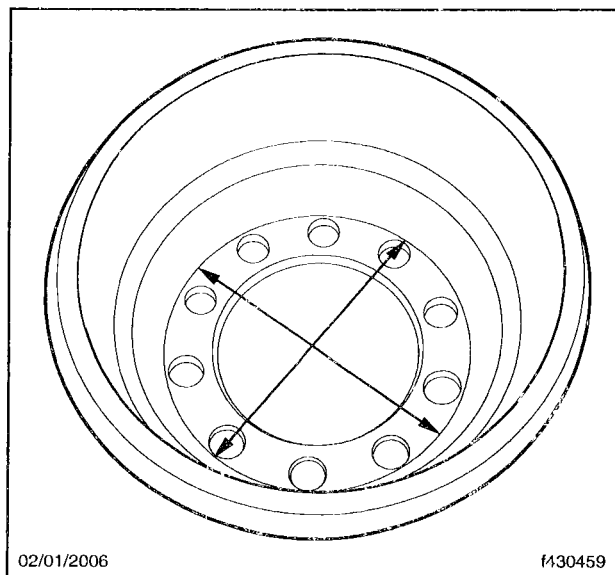
**Fig. 1, Measuring the Brake Drum Flange at Two Places**

If the gap at either measurement is greater than 0.010 inch (0.25 mm), the brake drum and the hub need to be replaced. Mark the drum as right or left side and defective, and set it aside.

8. Measure the removed brake drum for flatness. See **Fig. 1**.
  - 8.1 Make sure the surface of the flange where you will measure is free of all paint, grease, and dirt. If necessary, scrape the surface down to bare metal.
  - 8.2 Lay a 12-inch (30 cm) straightedge across the diameter of the drum, on the inside flange. See **Fig. 2**.
  - 8.3 Slide the straightedge so one end of it is all the way outboard on the machined surface of the brake drum.
  - 8.4 Using a feeler gauge, check and record the gap (if present) between the machined face of the drum flange (outboard of the bolt holes) and the outboard end of straightedge. See **Fig. 2**.
  - 8.5 Repeat the above measurement, at a 90-degree angle to the first measurement.
