SUBJECT: RECALL CAMPAIGN #50615
2004 & 2005 Prowler, Wilderness and Terry
365 FLTS Fifth Wheel Trailer
Missing Chassis Cross-Member Welds

RECALL BULLETIN:
50615

Installation of
Steel Support
Tubes and an
Inspection and
Correction of
Chassis
Cross-Member
Welds

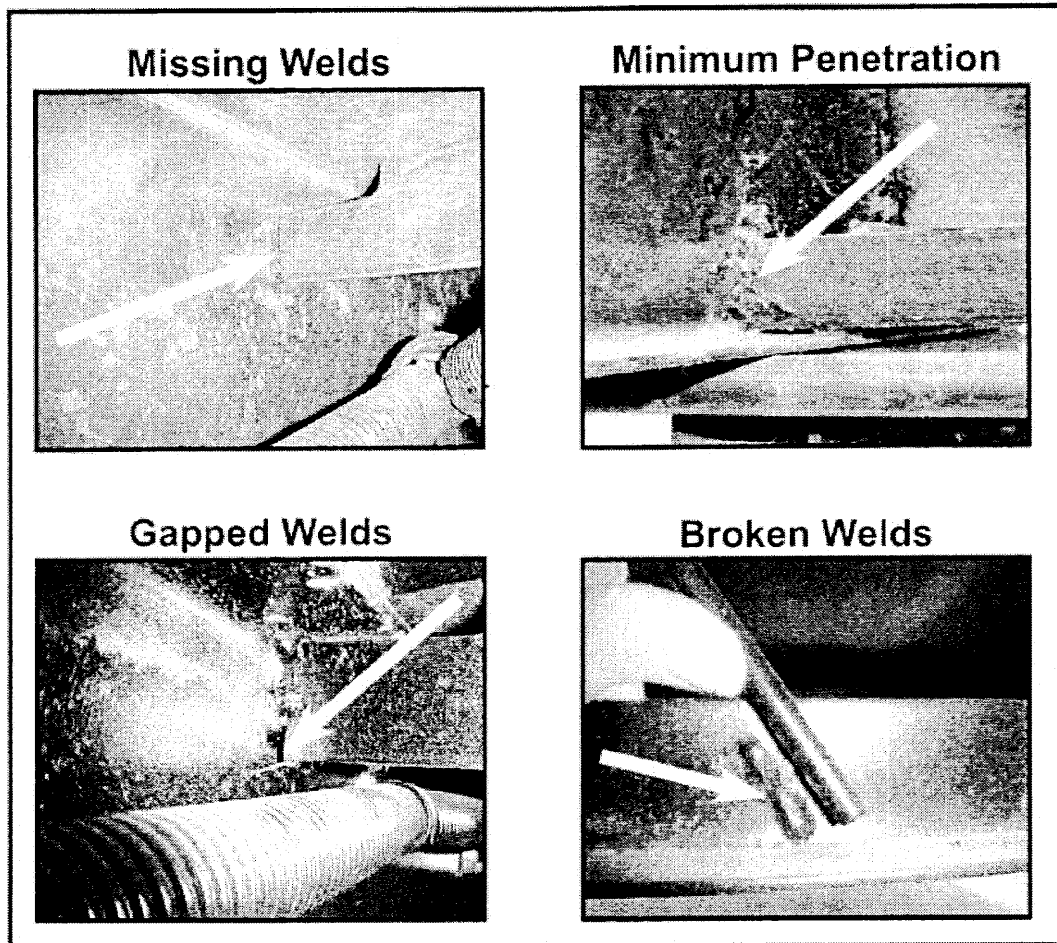
Follow the steps below to inspect the welds on the two (2) Rod and Angle chassis frame cross-members. If any of the welds are missing or improper, corrective action must be taken by following the Weld Repair Procedure section of the Bulletin. Use the photographs in Figure 1 for weld condition reference.

1. Inspect the vertical welds for the top and bottom angle iron attachments to the chassis frame rail, 8 locations.
2. Inspect the horizontal welds for the bottom angle iron attachments to the chassis frame rail, 4 locations.
3. Inspect all rod welds at the angle iron attachment points. Pull and push on the rods at each weld location to inspect weld condition. All loose, damaged, or missing welds will require correction. See Figure 1. Continue with the Weld Repair Procedure section of this Bulletin.

Examples of Welds that Require Correction

1. Grind out original welds on the Rod and Angle cross-member, identified as inadequate during the inspection process, before correcting.
2. For each weld, clamp the rod to the angle iron and correct all inadequate or missing welds on the Rod and Angle cross-member. Weld corrections must include the angle iron attachments to the chassis frame rail.

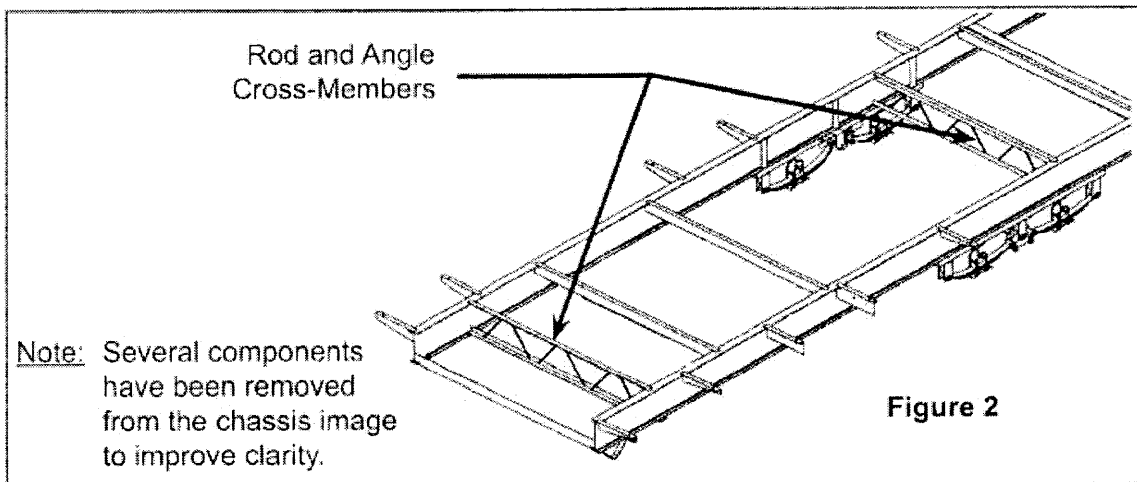
The two (2) Rod and Angle cross-members are installed laterally between the chassis frame rails. One is installed near the rear of the 5th wheel travel trailer and the second located between the axle hangers. See Figure 2.
