**RE: Safety Recall 05V-294/Intellic**

Re: Safety Recall 05V-294/Intellic

Your immediate and prompt attention is required to address a potential concern involving the Intellitec Generator/Shoreline Transfer Switch on certain 2005-6 rear diesel motor homes.

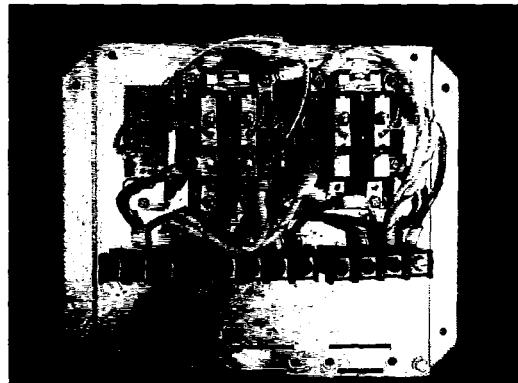
Our supplier, Intellitec, made a change to the transfer switch assembly that may allow the loosening of the relay wire connections resulting in a high resistance condition, which may cause excessive heat, smoldering, and/or fire in the relay wiring.

(Figure 2) Relay showing copper lugs

If any copper wire connector lugs are present, the transfer switch must be replaced and the motorhome must not be sold or leave the dealership until the replacement occurs. In cases where the motorhome is retailed, contact the owner immediately and schedule an appointment for the inspection and, if necessary, subsequent transfer switch replacement.

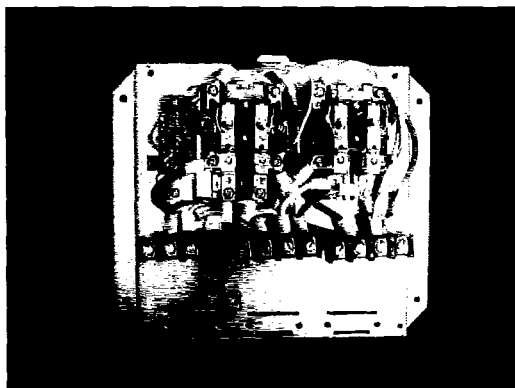
Immediately inspect the listed units attached with this letter for the Intellitec transfer switch and the presence of any copper wire connector lugs on the assembly. All wire connector lugs must be of a silver, tin-plated color. If the transfer is of the ESCO brand, it is not involved in this service advisory.

(Figure 3) Relay with proper lugs
