# TOYOTA CUSTOMER SERVICES

Volume: XII  
Number: TC05-014  
Date: 06/27/2005  
 Action  
 Retain  
 Information

SUBJECT: SPECIAL SERVICE CAMPAIGN (SSC) – 50I  
2005 MY TACOMA REGULAR CAB BENCH SEAT WIRE HARNESS

**SPECIAL SERVICE CAMPAIGN 50I**

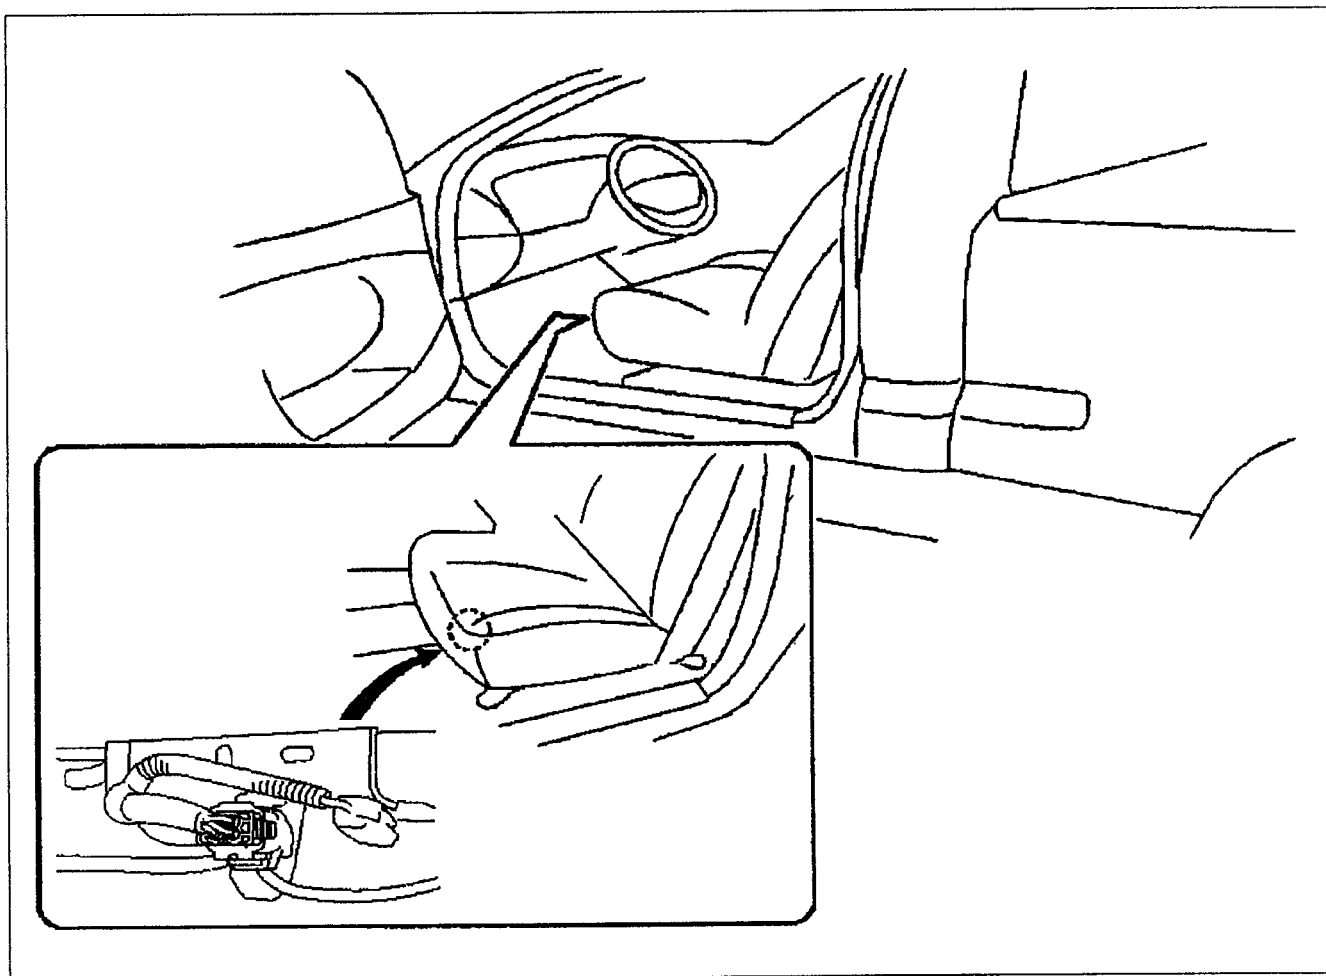
- (a) Slide the bench seat to the rearmost position.
- (b) Locate the floor wire harness and connector under the seat on the driver's side, closest to the front edge of the seat cushion.

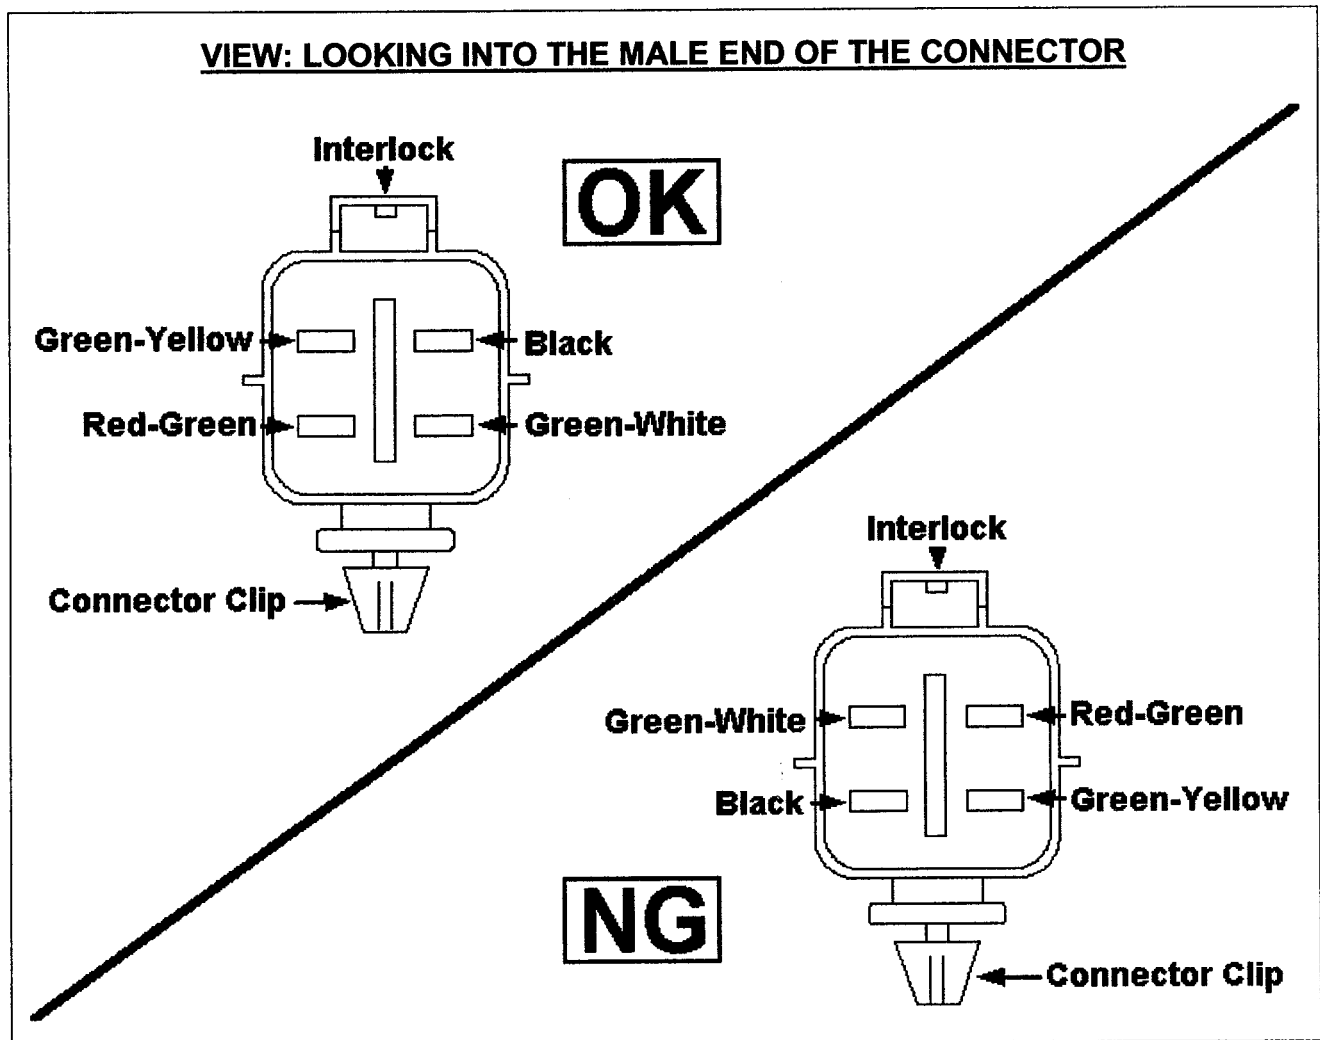
- (a) Check the wires of the floor wire harness connector (male end) to see if they are in the correct position.

**Make sure to view the male end of the connector in the proper orientation as shown in the illustration.**

- (b) If the connector wires are correctly installed, installation of the wire seat jumper is NOT REQUIRED, proceed to section "VI. SSC COMPLETION LABEL INSTALLATION".
- (c) If the connector wires were NOT correctly installed, proceed to step "B. INSTALL THE WIRE SEAT JUMPER".

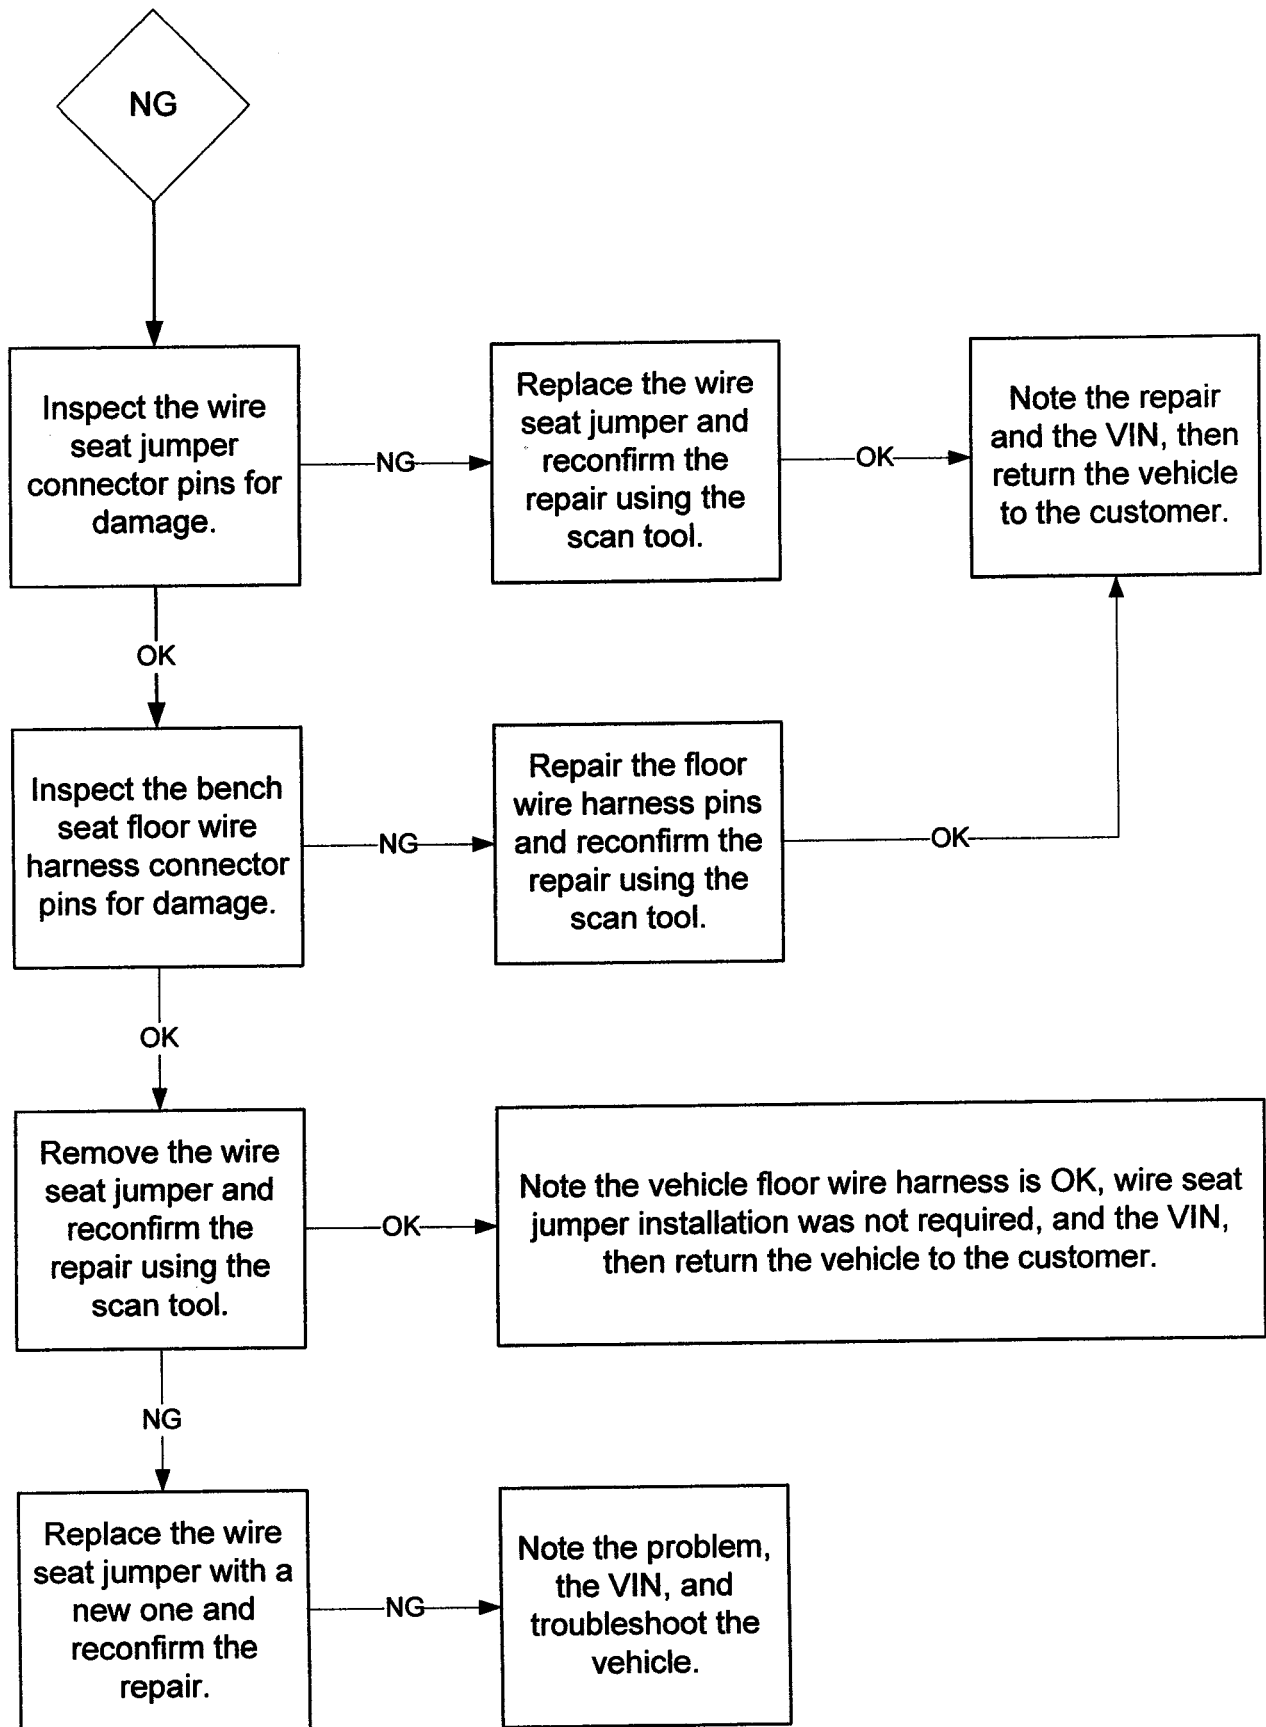
Troubleshooting Flowchart

- (a) If ALL four test results are OK the vehicle has been repaired, proceed to step "4. REMOVE THE SCAN TOOL".
- (b) In the UNLIKELY event that the test results are NG, refer to the troubleshooting flowchart located in section "VII. APPENDIX".
