**Subject: Recall Campaign M1 (05V-305)
2005 Model Year Volkswagen New Jetta Vehicles
Inspect Engine Compartment Fuel Supply Line and Clamp and Replace if
Necessary**

Subject: Safety Recall M1
2005 Model Year Volkswagen New Jetta Vehicles Equipped with a 2.5L Gasoline Engine
Inspect Engine Compartment Fuel Supply Line Clamp and Replace if Necessary

Safety Recall Circular

**Subject: 2005 Model Year Volkswagen New Jetta Vehicles
with a 2.5L Gasoline Engine
Inspect Engine Compartment Fuel Supply Line Clamp
and Replace if Necessary**

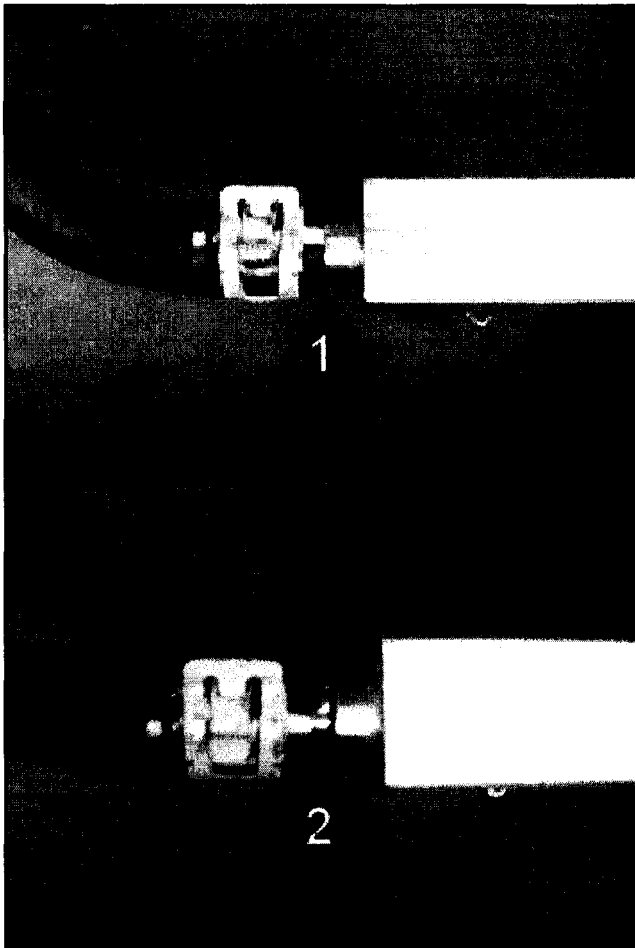
Check 2

- ⇐ Check that fuel feed hose is fully seated on fuel rail -arrow 1-
 - If hose is correctly seated **proceed to Check 3**
 - If hose is incorrectly seated -arrow 2- **proceed to Section B**

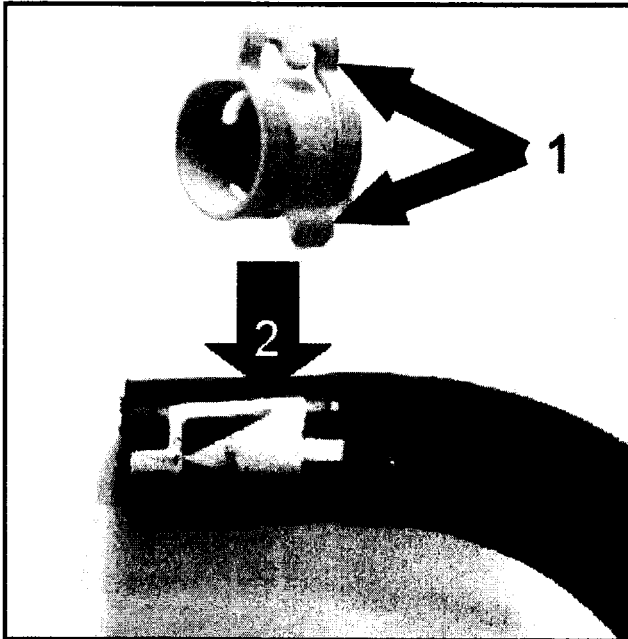
Check 3

⇐ Check spring clip release tabs -arrow 1- to ensure they are centered over box with arrow on hose -arrow 2-

- If spring clip is properly positioned **proceed to Check 4**
- If spring clip not properly positioned **proceed to Section B**

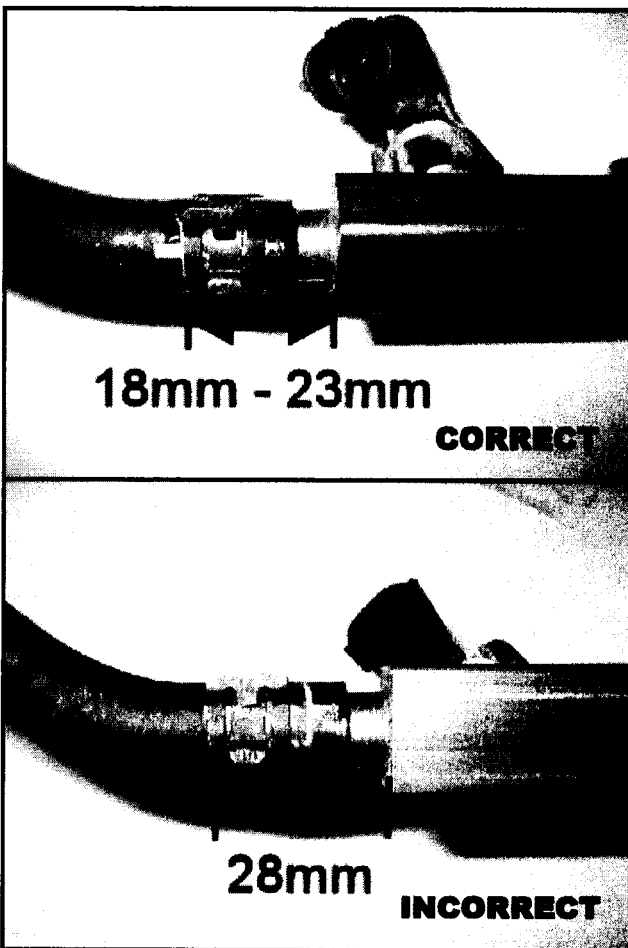
Check 4

⇐ Measure distance from clip on fuel feed hose to the fuel rail base

- If measurement is between 18mm and 23mm no further work required
- Position engine cover correctly in fastening points and push it in by hand
- Close hood

- If measurement is more than 23mm or less than 18mm from fuel rail base, **proceed to Section B**
