SUBJECT: Vehicle Safety Recall - SC0296  
CHN Slack Adjuster, Drag Link Interference

# VEHICLE RECALL

**SC296**

**Subject:** Interference Condition Between Slack Adjuster and Drag Link — CHN Models with FXL12 or FXL14.6 Front Steer Axles and 16.5" x 5" Brakes

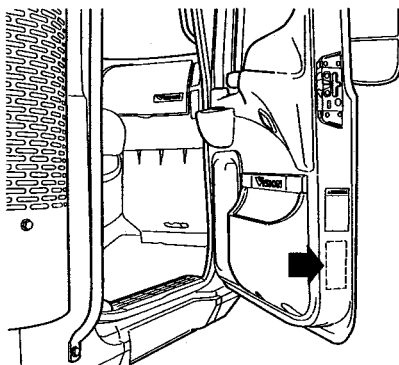
**Figure 1 — Campaign Label Location**

Before proceeding, check the campaign status in the MACKnet system to see if the campaign has already been completed. Campaign status can also be checked by looking at the Campaign Completion Label located on the lower edge of the passenger-side door. If the campaign has been completed, the campaign number (SC296) and the completion date should be written on the label.
