# RECALL CAMPAIGN BULLETIN

NTB05-059

## VOLUNTARY RECALL CAMPAIGN 2003-05 MURANO ALTERNATOR

**CAMPAIGN I.D. # / NHTSA #:** P5215 / 05V-319

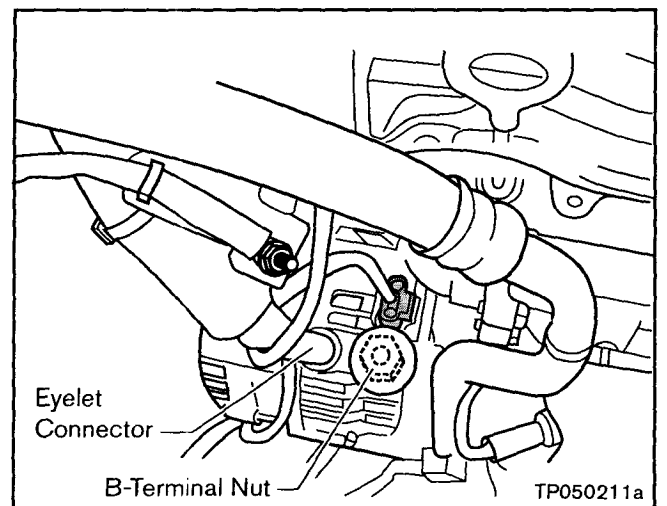
Figure 2

4. Disconnect the B-Terminal Nut and "Eyelet" connector from the Alternator (see Figure 2).

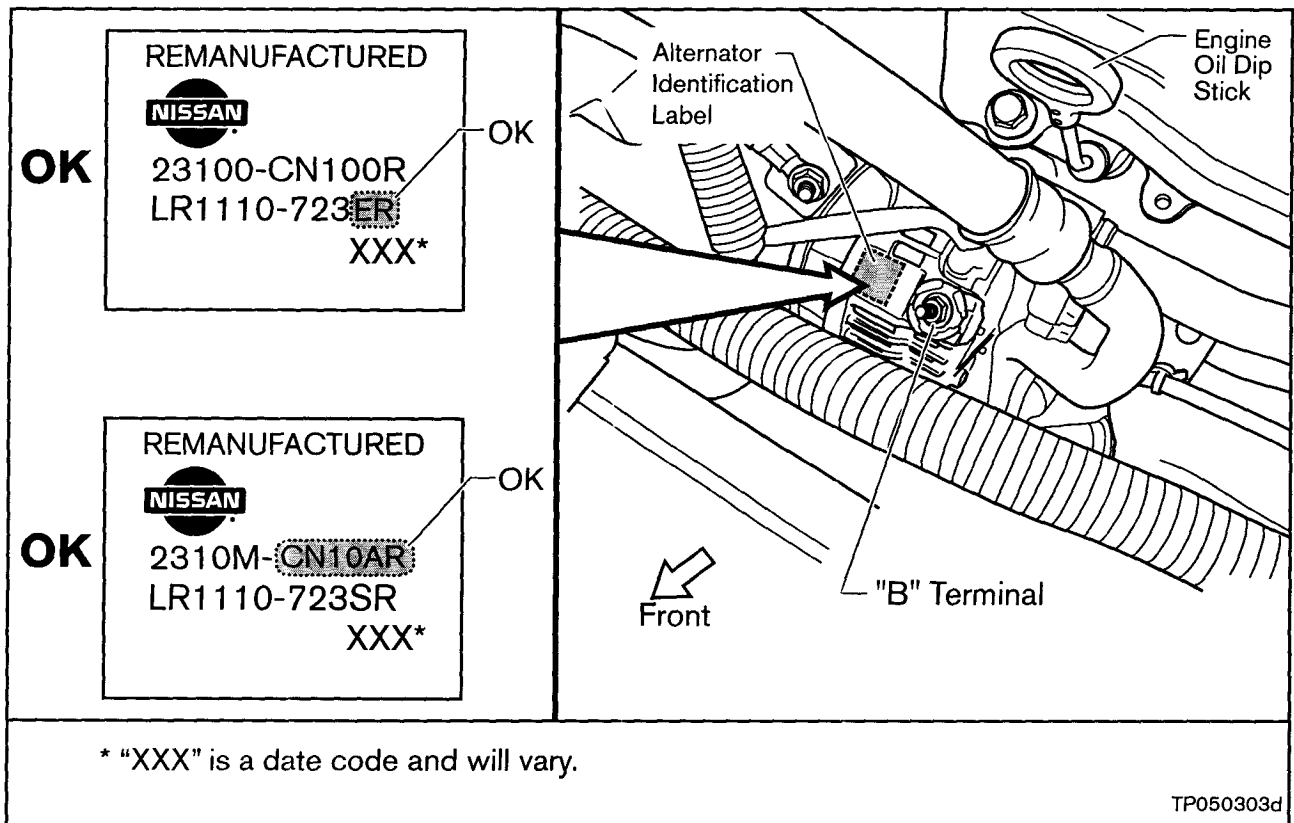
Figure 3

5. Take a look at the Alternator Identification Label (see Figure 3):

- a. If the part numbers on the Label exactly match either one of the highlighted numbers shown in Figure 3, this bulletin does not apply. Do NOT replace the alternator.
  - Re-assemble the vehicle.
  - Re-set all radio station presets.
  - Submit a claim for the inspection and return the vehicle to the customer.
- b. If the part numbers on the Label do NOT exactly match either one of the highlighted numbers shown in Figure 3, replace the Alternator. Refer to the “**Alternator Replacement Procedure**” (next page).

- Alternators with part numbers on the labels that do not match the above examples **EXACTLY** should be replaced under this campaign.
- If the alternator cannot be positively identified (i.e.: missing label or unreadable numbers on the label) the alternator must be replaced.

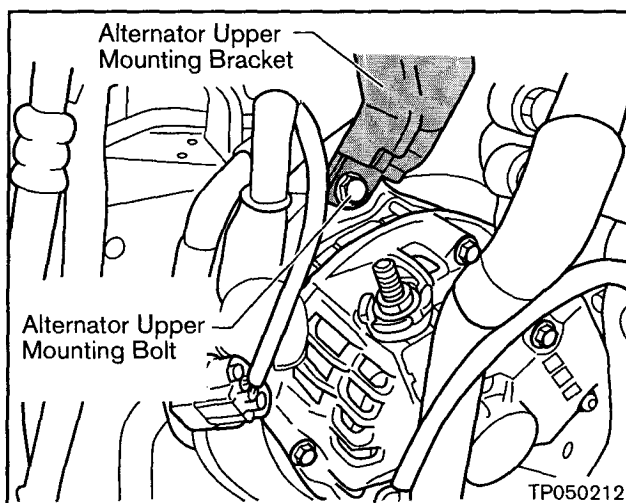
Figure 19a

17. Remove the Alternator Upper Mounting Bolt (see Figure 19a). Then remove the Alternator by carefully moving it between the Exhaust Manifold/Catalyst and Radiator towards the Battery tray (see Figure 19b).

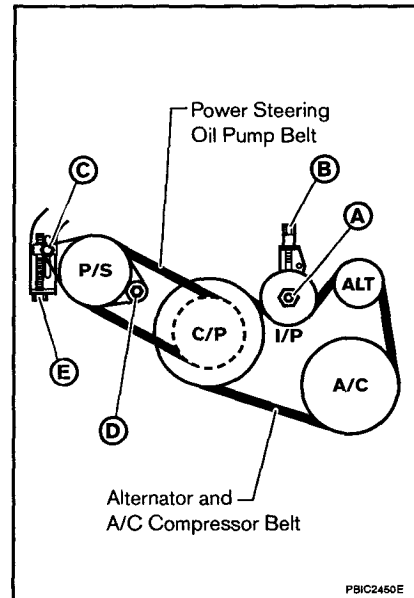
1. Remove splash guard (RH).
2. Loosen idler pulley lock nut (A) and adjust tension by turning adjusting nut (B).
  - For the specified belt tension, refer to EM-12, "Checking Drive Belts".
3. Tighten lock nut (A).
  - 🔧 : 34.8 N·m (3.5 kg-m, 26 ft-lb)
4. Tighten adjusting nut (B).
  - 🔧 : 5.4 N·m (0.55 kg-m, 48 in-lb)
