TOYOTA CUSTOMER SERVICES

Volume: XII
Number: TC05-017
Date: 07/19/2005
 Action
 Retain
 Information

SUBJECT: SPECIAL SERVICE CAMPAIGN (SSC) – 50L
2004 THROUGH MID-2005 MY SIENNA MIDDLE ROW SEATBELT BEZEL

2004 THROUGH 2005 MODEL YEAR SIENNA
MIDDLE ROW SEATBELT BEZEL

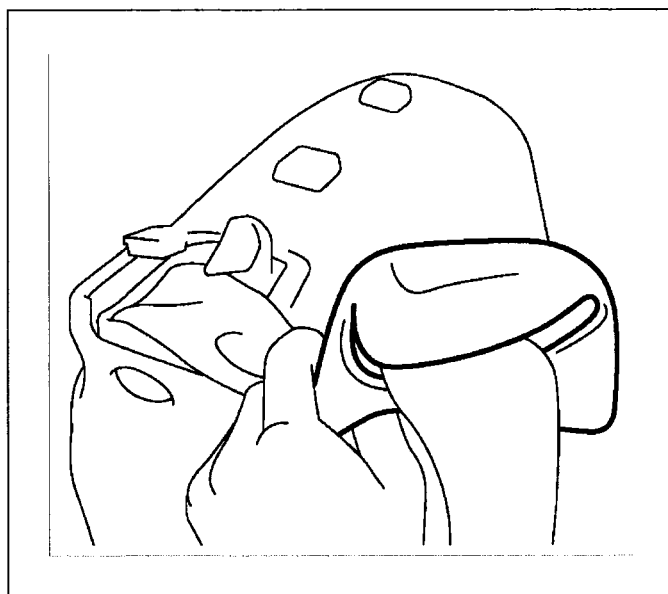
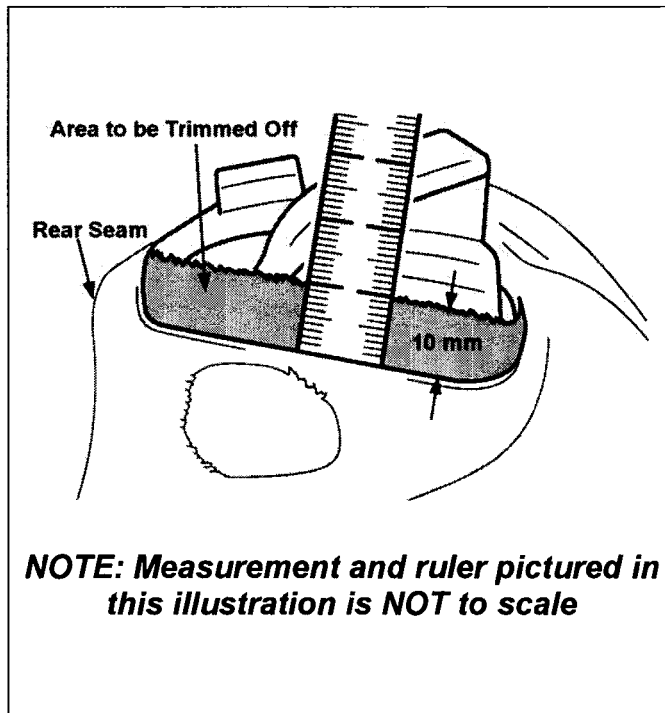
2. TRIM THE SEATBACK COVER

To prevent the edge of the seat material from being visible through the seatbelt slot on the new seatbelt bezel, a small portion of the seat cover must be trimmed.

(a) Measure 10 mm down from the upper edge of the seatback cover (as shown in the illustration), and draw a horizontal line from the front corner to the back edge of the seatback cover, just before the rear seam.
