# TOYOTA CUSTOMER SERVICES

Volume: XII  
Number: TC05-017  
Date: 07/19/2005  
 Action  
 Retain  
 Information

SUBJECT: SPECIAL SERVICE CAMPAIGN (SSC) – 50L  
2004 THROUGH MID-2005 MY SIENNA MIDDLE ROW SEATBELT BEZEL

**SPECIAL SERVICE CAMPAIGN 50L**

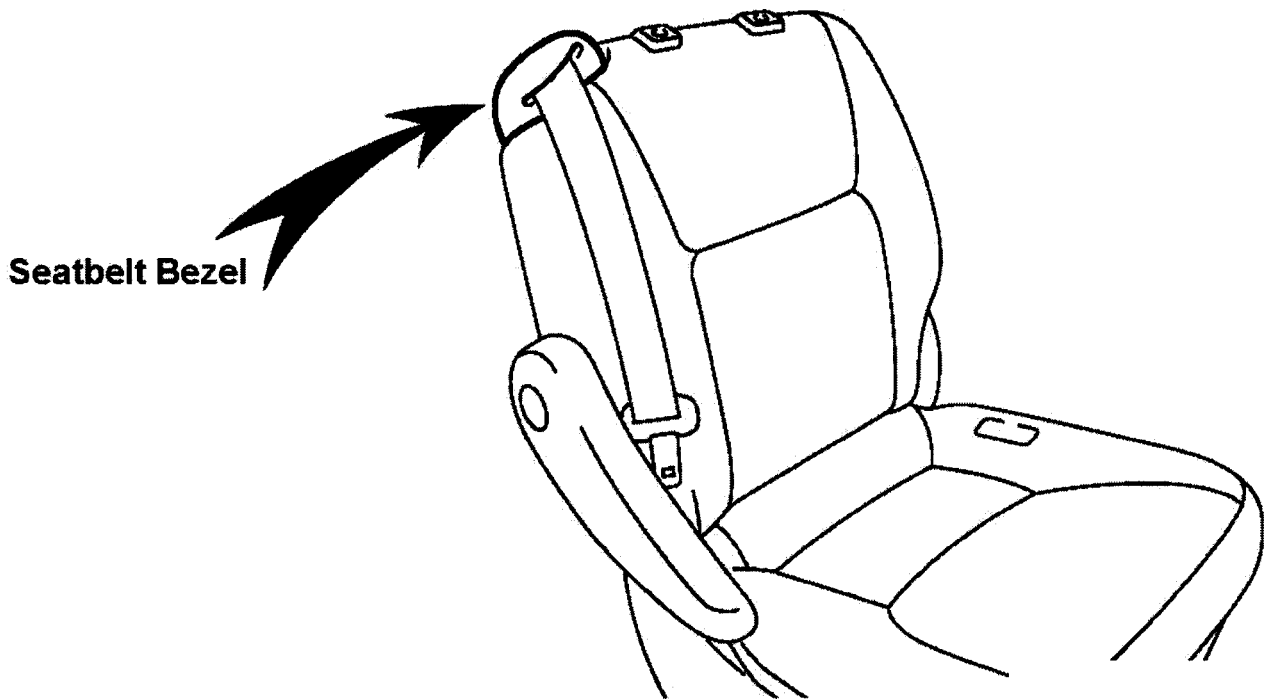
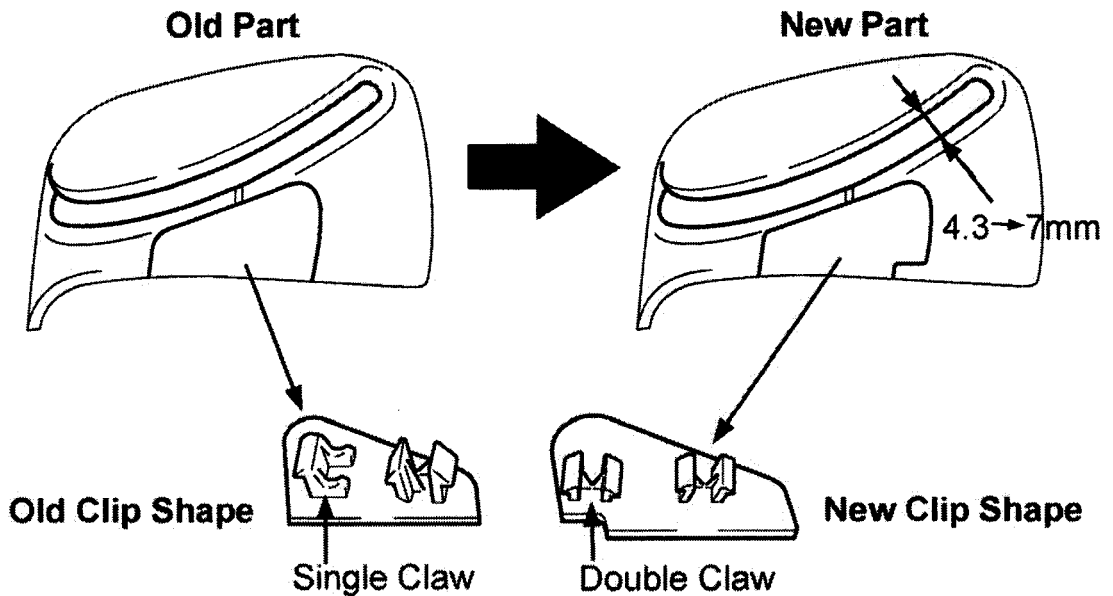
## IV. COMPONENTS

*On 7-passenger models the seatbelt bezel is located on the RIGHT seat assembly  
On 8-passenger models the seatbelt bezel is located on the CENTER seat assembly*

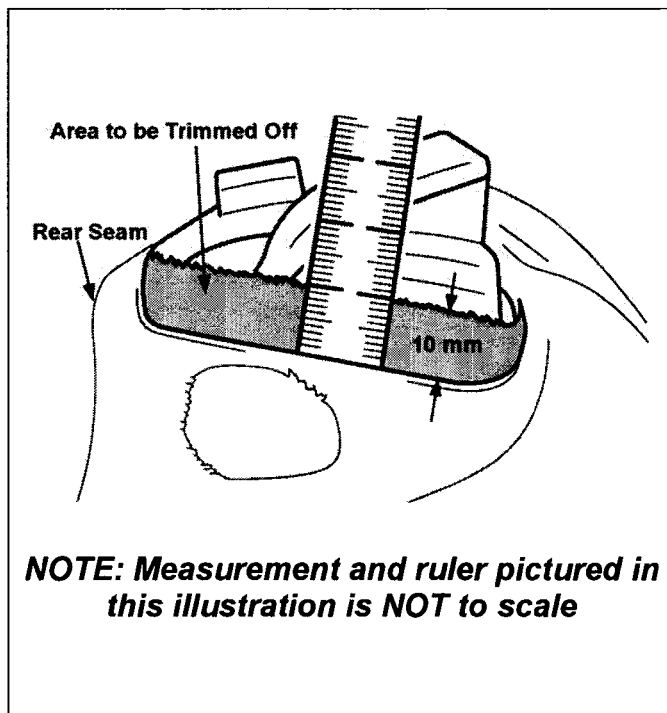
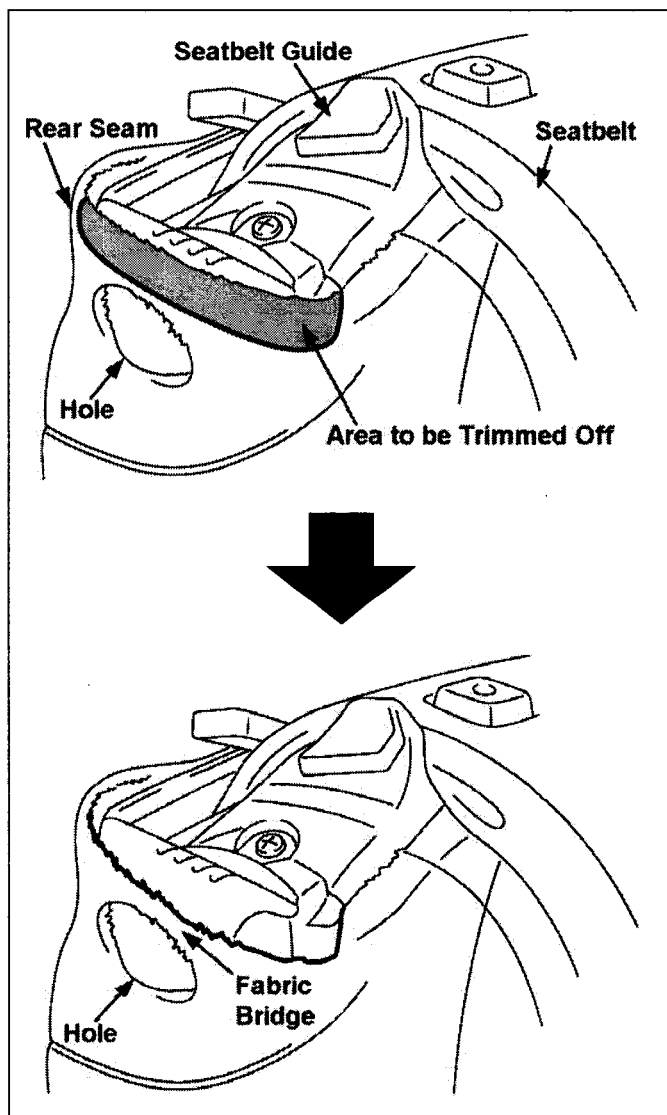
## 2. TRIM THE SEATBACK COVER

To prevent the edge of the seat material from being visible through the seatbelt slot on the new seatbelt bezel, a small portion of the seat cover must be trimmed.

(a) Measure 10 mm down from the upper edge of the seatback cover (as shown in the illustration), and draw a horizontal line from the front corner to the back edge of the seatback cover, just before the rear seam.

(c) Using a pair of scissors, **CAREFULLY** cut along the line drawn, trimming off the shaded portion of the seatback cover **ONLY**. During this process make sure to maintain a fabric bridge between the seat back cover hole and area to be trimmed off.

- DO NOT cut any portion of the rear seam located on the back edge of the seatback cover.
- DO NOT cut more than this amount.
- USE EXTREME CAUTION when cutting.
