TOYOTA CUSTOMER SERVICES

Volume: XII
Number: TC05-016
Date: 07/19/2005
 Action
 Retain
 Information

SUBJECT: SPECIAL SERVICE CAMPAIGN (SSC) – 50K
(MID-2005 MODEL YEAR TUNDRA ACCESS CAB WITH FRONT CAPTAIN'S CHAIRS
FRONT PASSENGER OCCUPANT CLASSIFICATION SYSTEM INDICATOR LIGHT LENS)

TECHNICAL INSTRUCTIONS

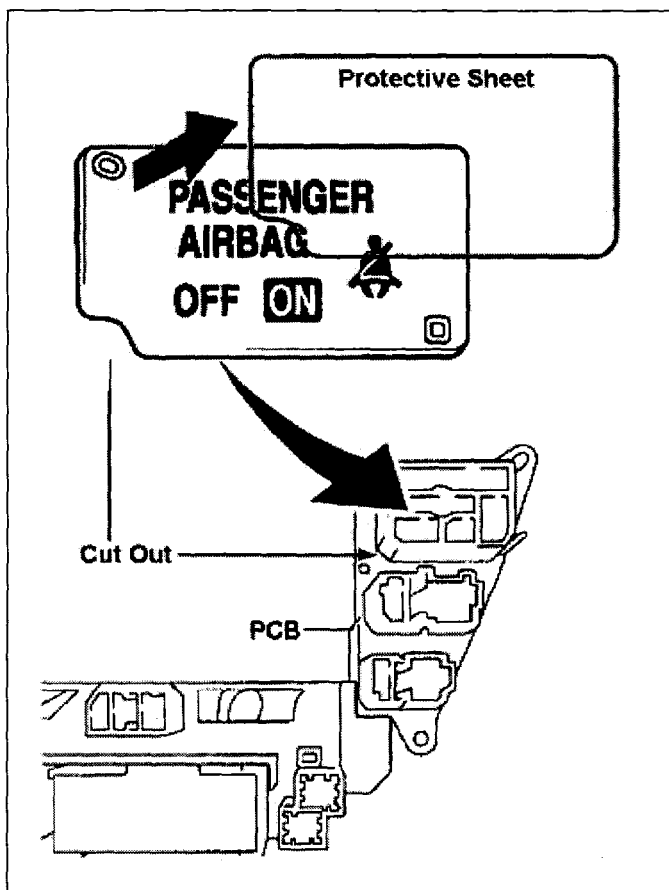
5. INSTALL THE NEW PASSENGER AIRBAG INDICATOR LENS

4. REMOVE THE OLD PASSENGER AIRBAG INDICATOR LENS

(a) Remove the protective sheet from the new indicator lens.

(b) Install the new indicator lens, making sure the cut out on the PCB and the indicator lens match up.

The protective sheet covering the new indicator lens, may make the lens appear to have scratches on it when it does not.
