SUBJECT: Safety Recall Notification [Recall #]

MODELS: Combination Steel/Aluminum Flatbed Trailers, Combination Steel/Aluminum Dropdeck Trailers, and Aluminum Flatbed Trailers, manufactured between January 1, 2003 and July 13, 2005 and equipped with mounted toolboxes.

DATE: July 25, 2005

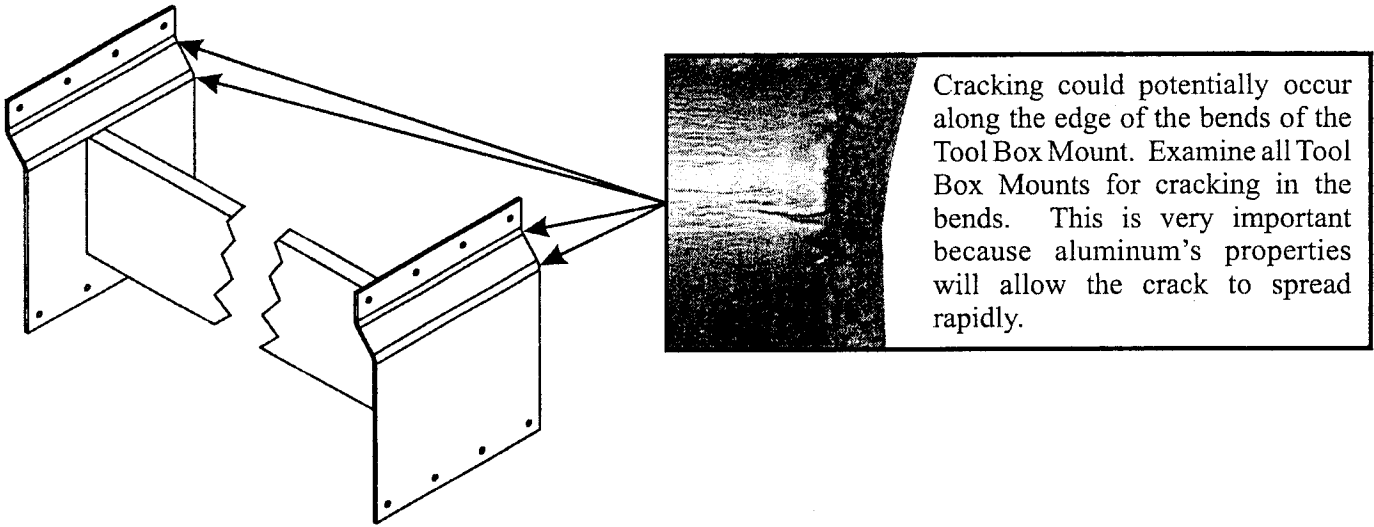
# Repair Information

Reinke Manufacturing Company, Inc. has determined that a defect which relates to motor vehicle safety exists in Reinke Combination Steel/Aluminum Flatbed Trailers, Combination Steel/Aluminum Dropdeck Trailers, and Aluminum Flatbed Trailers, manufactured between January 1, 2003 and July 13, 2005 and equipped with mounted toolboxes. Each toolbox is attached to the trailer with a mounting system that includes two aluminum brackets which may have developed fatigue cracks along the bend radius lines. The small cracks may further develop based on trailer usage and as a consequence the brackets may break causing the toolbox to separate from the trailer. If the toolbox separates from the trailer while the trailer is in motion, vehicles on the road are at risk of collision with the toolbox and its contents.

After examining Tool Box Mounts, consider one of the solutions based on your findings:

1. If there is no visible breaks or cracks:
  - Install Gussets as per instructions on the next page.
2. If there is any edge cracks extending less than 1/8" from edge:
  - Install Gussets as per instructions on the next page.
3. If there is any edge cracks extending more than 1/8" from edge or any visible cracks in the bends:
  - Grind out crack to sound metal. Clean area to be welded with a degreaser such as "Simple Green." Weld crack shut using ER 5356 Filler Metal Wire. E = MIG Wire/Filler and R = TIG Wire/Filler. Avoid undercutting or excessive build-up. Grind area to approximate original contour.
  - Install Gussets as per instructions on the next page.
