SAFETY RECALL BULLETIN

SUBJECT: COOLANT HOSE REPLACEMENT — SAFETY RECALL CAMPAIGN		No: SR-05-004	
		DATE: August, 2005	
		MODEL: 2005 Lancer Evolution	
CIRCULATE TO:	<input type="checkbox"/> GENERAL MANAGER	<input checked="" type="checkbox"/> PARTS MANAGER	<input checked="" type="checkbox"/> TECHNICIAN
<input checked="" type="checkbox"/> SERVICE ADVISOR	<input checked="" type="checkbox"/> SERVICE MANAGER	<input checked="" type="checkbox"/> WARRANTY PROCESSOR	<input type="checkbox"/> SALES MANAGER

2005 Lancer Evolution Water Feed Hose

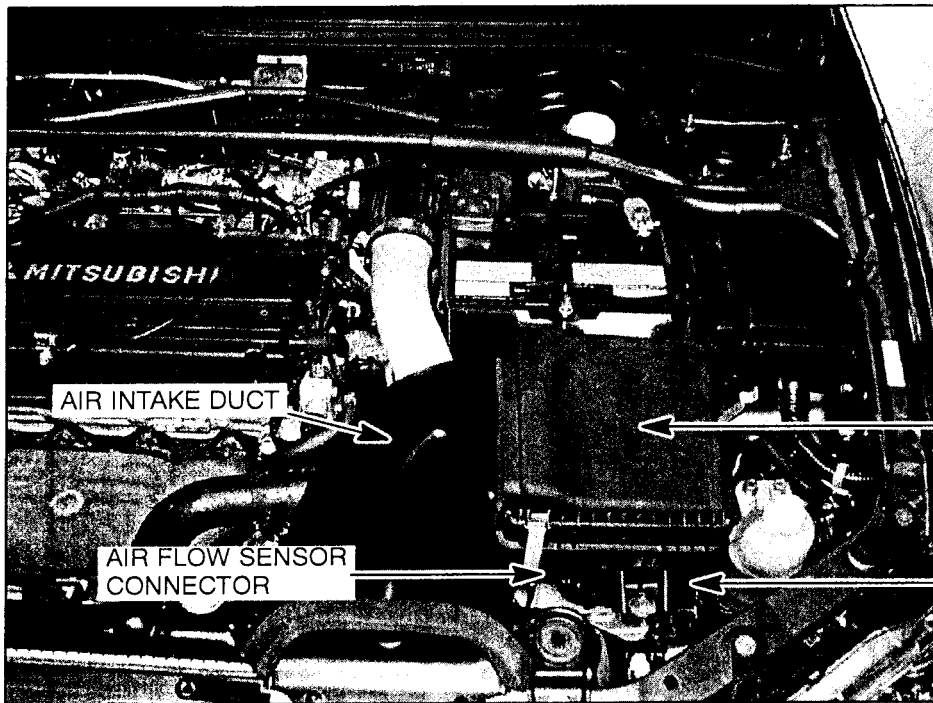
AIR CLEANER ASSEMBLY

AIR FLOW SENSOR CLAMP

3. Remove the air intake duct and the air cleaner assembly.
4. Remove the air flow sensor connector and its clamp.

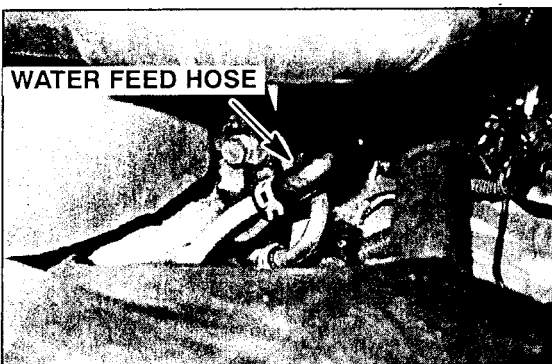
The turbocharger water feed hose on affected vehicles was incorrectly manufactured, and as a result may allow coolant leakage. Since the hose is located near the exhaust manifold, if a leak occurs during vehicle operation when the manifold is hot, coolant may ignite and cause a vehicle fire. Dealers must replace the turbocharger water feed hose as described in this bulletin.

7. Replace the turbocharger water feed hose.
