# Technical Service Bulletin

Model TUCSON(JM)

Number 5-58-P03-JM

REPLACEMENT OF PARKING BRAKE LEVER ASSEMBLY(RECALL)

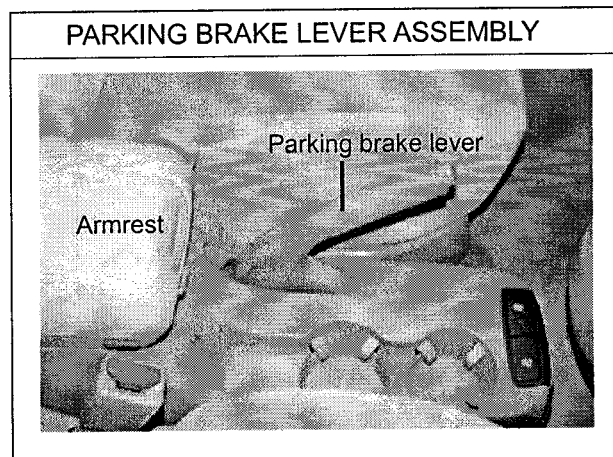
Certain TUCSON(JM) vehicles were produced with the pawl of a parking brake lever assembly that was incorrectly manufactured.

Improperly manufactured parking brake lever pawl may cause the parking brake lever not to engage when applying the lever.

Correct the above condition by replacing the parking brake lever assembly with a new one in accordance with the service procedure below.
