GM SERVICE AND PARTS OPERATIONS
DCS1453
URGENT DISTRIBUTE IMMEDIATELY

Subject: 05068 Product Safety Recall
Front Wheel Speed Sensor Corrosion

Models: 1999-2002 Chevrolet Silverado
2000-2002 Chevrolet Tahoe, Suburban
2002 Chevrolet Avalanche
1999-2002 GMC Sierra
2000-2002 GMC Yukon, Yukon XL
Located in the Severe Corrosion Areas Listed

SUBJECT: FRONT WHEEL SPEED SENSOR CORROSION

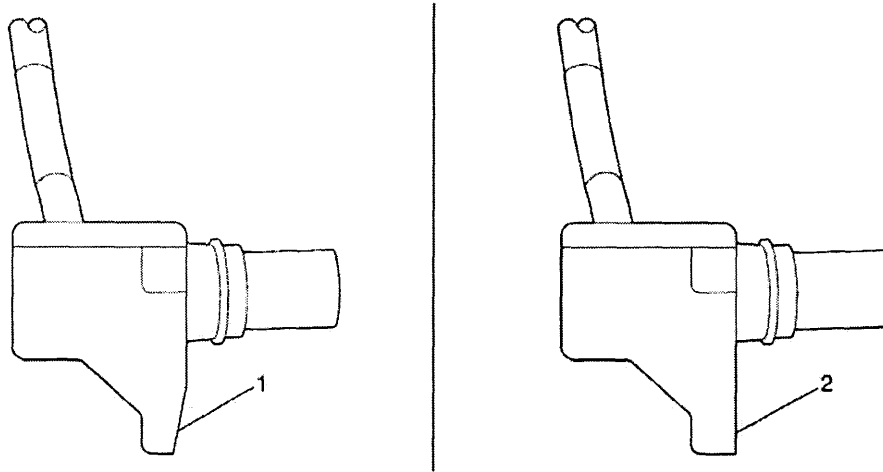
1563355

Important: The mounting surface on the sensor must be flat in the next step in order to be mounted correctly on the bearing hub assembly. If the mounting surface on the sensor is warped or bent, the sensor must be replaced.

11. Inspect to see if the mounting surface on the sensor is flat. Check the mounting surface on the sensor head for flatness by placing it on the edge of a metal machinist's scale or other suitable straight edge to measure the flatness. Check the sensor for flatness in multiple positions/directions (minimum 3).
- If the sensor mounting surface is NOT flat (1), the sensor must be replaced. Proceed to the next step and replace the sensor.
 - If the sensor mounting surface IS flat (2), the sensor IS to be reused. Proceed to Step 16.

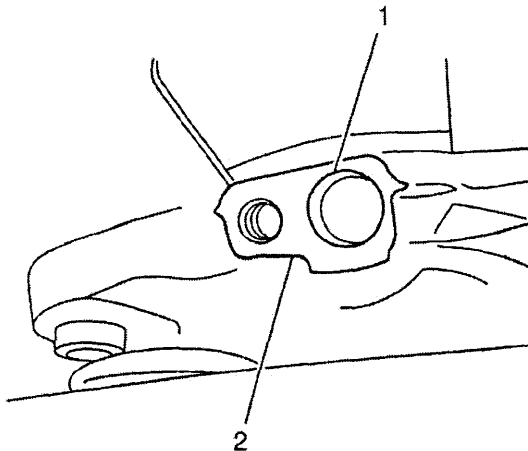
1563354

Important: All rust and corrosion must be removed from the wheel speed sensor mounting surfaces on the bearing hub in the next step.

16. Temporarily plug the wheel speed sensor hole (1) in the bearing hub to prevent debris from entering it when you clean it.

17. Using a wire brush, sandpaper, emery cloth, scotch brite, or equivalent, thoroughly clean the wheel speed sensor mounting surface (2) on the bearing hub to remove any rust or corrosion.
18. Using compressed air, remove all debris from the bearing hub surface.
19. Using a clean shop towel, clean the sensor and the O-ring.

20. Apply (spray) two thin coats of the specified rust penetrating lubricant (corrosion inhibitor) listed in this bulletin, to the complete sensor mounting surface on the bearing hub. Allow to dry for 3-5 minutes between coats.
21. When the corrosion inhibitor is dry to the touch (about 10 minutes), apply a light coating of the specified grease to the complete sensor mounting surface on the bearing hub and to the sensor and O-ring.
22. Remove the temporary plug from the hole in the bearing hub.
23. Install the wheel speed sensor in the bearing hub and install the bolt. Ensure that the sensor is seated flat against the hub.
