GM SERVICE AND PARTS OPERATIONS
DCS1516
URGENT DISTRIBUTE IMMEDIATELY

Subject: 05068A Product Safety Recall
 Front Wheel Speed Sensor Corrosion

File In Section: Product Recalls
Bulletin No.: 05068A
Date: February 2006

SUBJECT: FRONT WHEEL SPEED SENSOR CORROSION

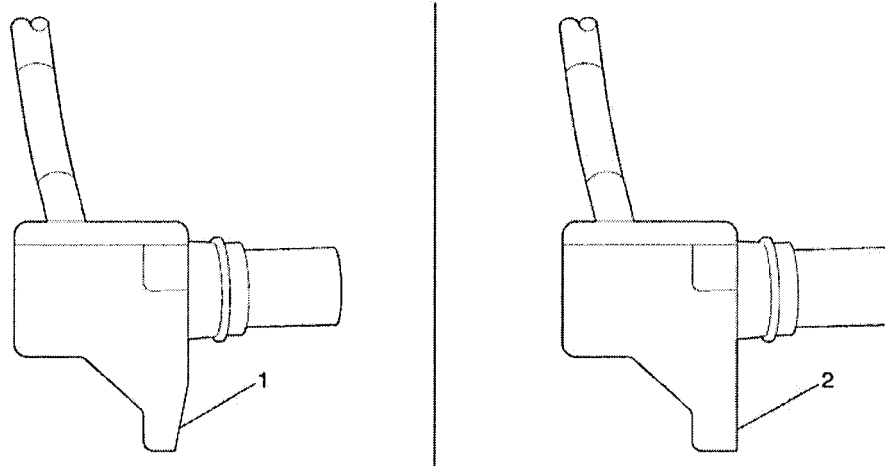
1563355

Important: The mounting surface on the sensor must be flat in the next step in order to be mounted correctly on the bearing hub assembly. If the mounting surface on the sensor is warped or bent, the sensor must be replaced.

11. Inspect to see if the mounting surface on the sensor is flat. Check the mounting surface on the sensor head for flatness by placing it on the edge of a metal machinist's scale or other suitable straight edge to measure the flatness. Check the sensor for flatness in multiple positions/directions (minimum 3).
- o If the sensor mounting surface is NOT flat (1), the sensor must be replaced. Proceed to the next step and replace the sensor.
 - o If the sensor mounting surface IS flat (2), the sensor IS to be reused. Proceed to Step 16.

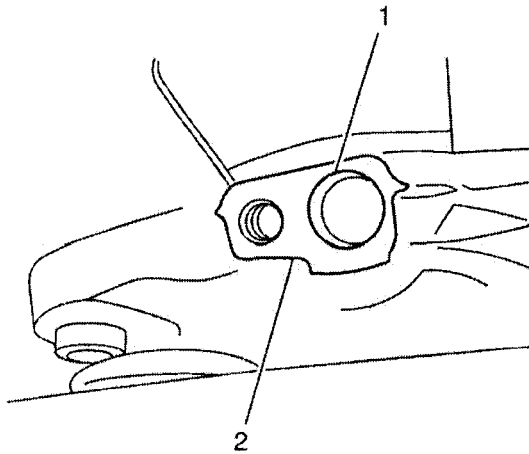
1563354

Important: All rust and corrosion must be removed from the wheel speed sensor mounting surfaces on the bearing hub in the next step.

16. Temporarily plug the wheel speed sensor hole (1) in the bearing hub to prevent debris from entering it when you clean it.

17. Using a wire brush, sandpaper, emery cloth, scotch brite, or equivalent, thoroughly clean the wheel speed sensor mounting surface (2) on the bearing hub to remove any rust or corrosion.
18. Using compressed air, remove all debris from the bearing hub surface.
19. Using a clean shop towel, clean the sensor and the O-ring.

20. Apply (spray) two thin coats of the specified rust penetrating lubricant (corrosion inhibitor) listed in this bulletin, to the complete sensor mounting surface on the bearing hub. Allow to dry for 3-5 minutes between coats.
21. When the corrosion inhibitor is dry to the touch (about 10 minutes), apply a light coating of the specified grease to the complete sensor mounting surface on the bearing hub and to the sensor and O-ring.
22. Remove the temporary plug from the hole in the bearing hub.
23. Install the wheel speed sensor in the bearing hub and install the bolt. Ensure that the sensor is seated flat against the hub.
