Michael A. Berardi  
Director  
Service Engineering Operations  
Ford Customer Service Division

January 28, 2008

**SUBJECT:** **Safety Recall 05S28 - Supplement #14:** 1992-2004 Multiple Vehicle Lines - Speed Control System Modification

**Safety Recall 05S28 - Supplement #14**  
1992-2004 Multiple Vehicle Lines  
Speed Control System Modification

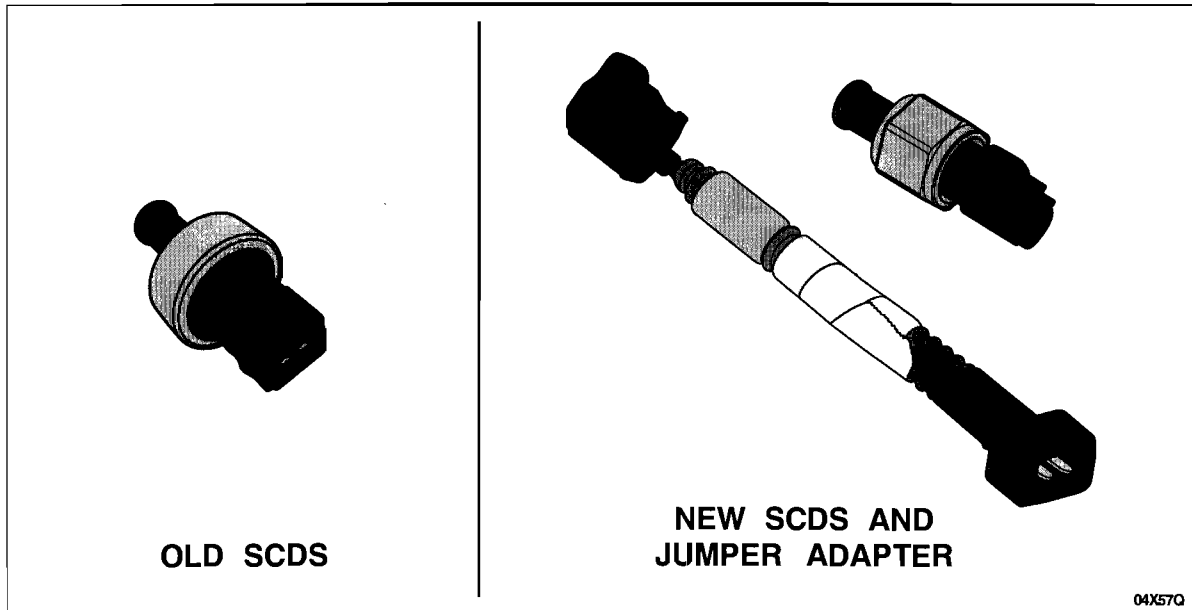
FIGURE 1

The Speed Control Deactivation Switch (SCDS) involved in Recall 05S28 and the revised SCDS is illustrated below. See Figure 1.

Note that the revised SCDS has a different electrical connector. A jumper adapter (which is included in the parts kit) is required when replacing the old SCDS with the revised SCDS.

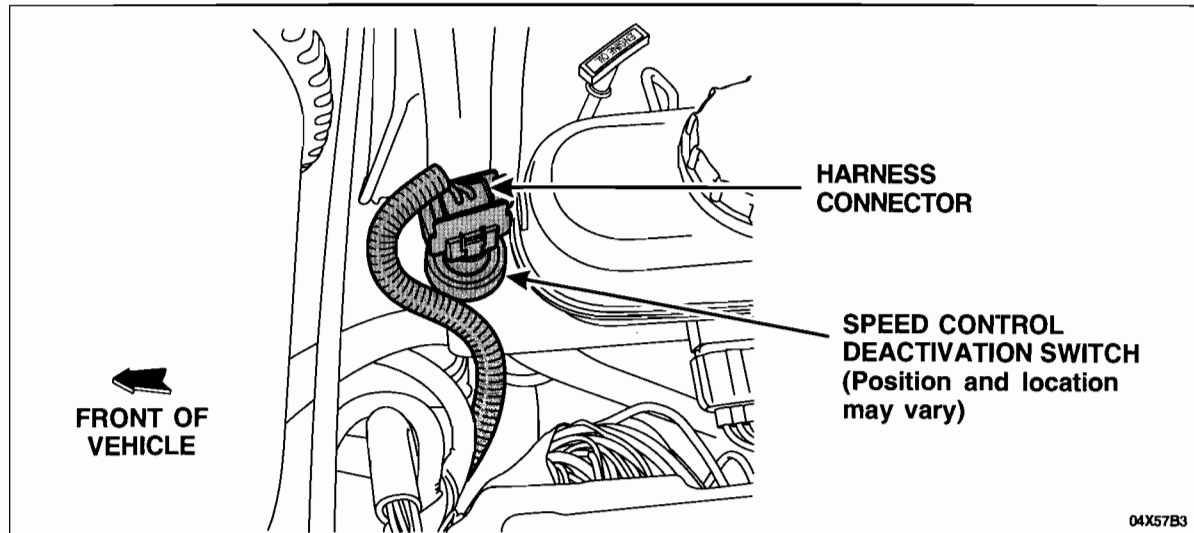
FIGURE 2

Disconnect the SCDS and inspect the harness connector (see Figure 2) for the presence of brake fluid. Refer to the Vehicle Application And Repair Chart on page 5 to identify the correct repair procedure.

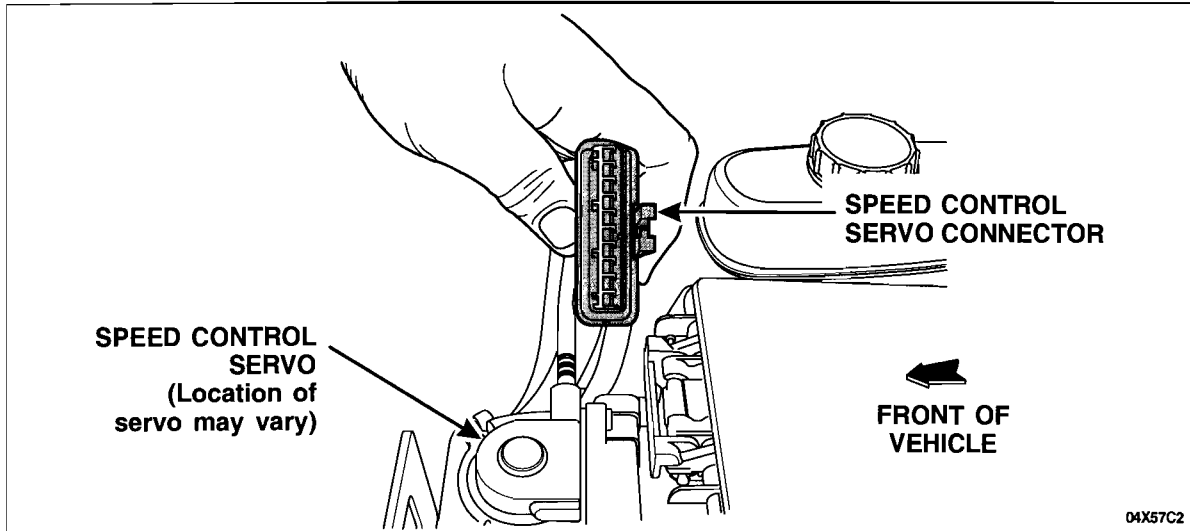
**FIGURE 5**

6. Disconnect the speed control servo and inspect the vehicle harness connector for heat damage. See Figure 5.
  - If no heat damage is found at the speed control servo connector (even if there is presence of brake fluid in the connector), proceed to next step.
  - If the speed control servo connector is heat damaged, call the Special Service Support Center for further instructions.
