August 28, 2006

**SUBJECT:** Safety Recall 05S28 - Supplement #9  
 Certain 1994-1996 Model Year Bronco, 1994-2002 F-150 through F-550, 1997-2002 Expedition, 1998-2002 Navigator, 2002 Blackwood, 1994-1996 E-150/250/350, 1996-2002 E-450, 2000-2002 Excursion, and 1998 Explorer and Mountaineer vehicles equipped with Speed Control – Speed Control System Modification

The underhood Speed Control Deactivation Switch (SCDS) may overheat, smoke, or burn, which could result in an underhood fire. The potential for a fire exists regardless of whether speed control is being used or the engine is running.

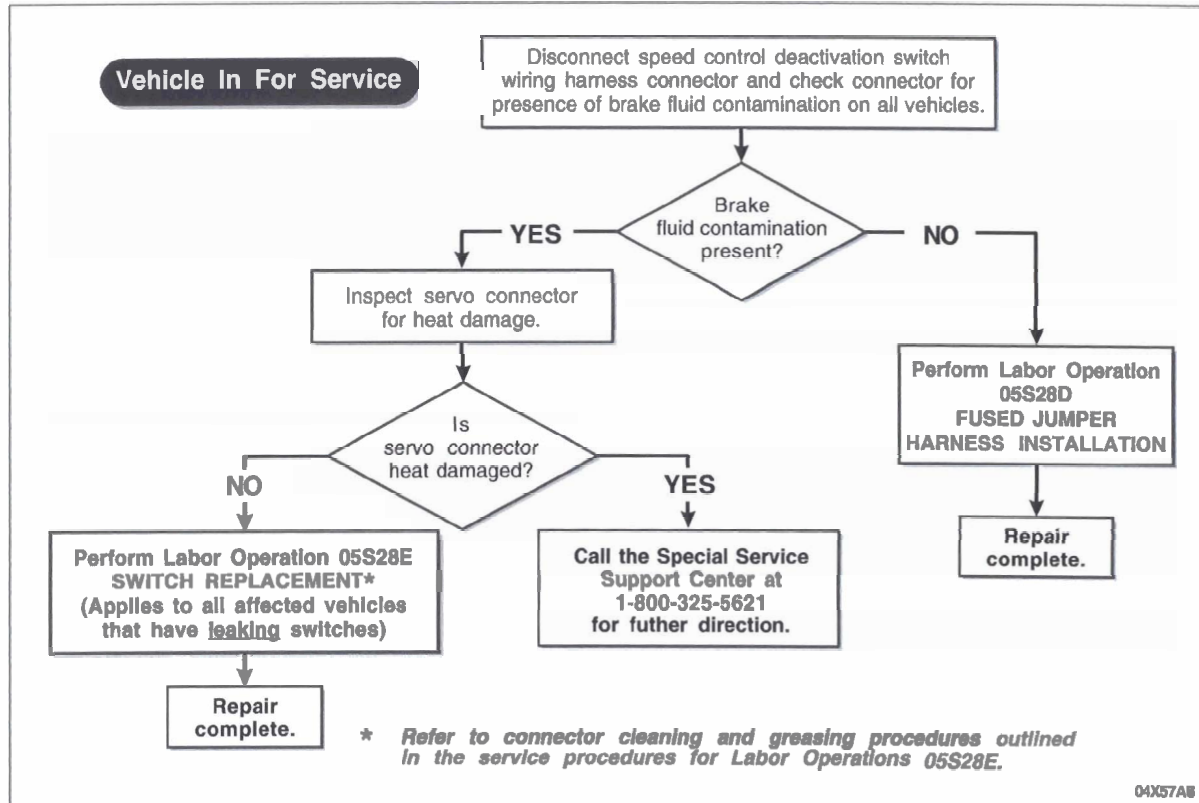
FIGURE 1

This program involves inspecting the speed control deactivation switch connector for presence of brake fluid and then determining which repair to perform. A flow chart has also been developed to help direct you to the proper repair. See Figure 1.

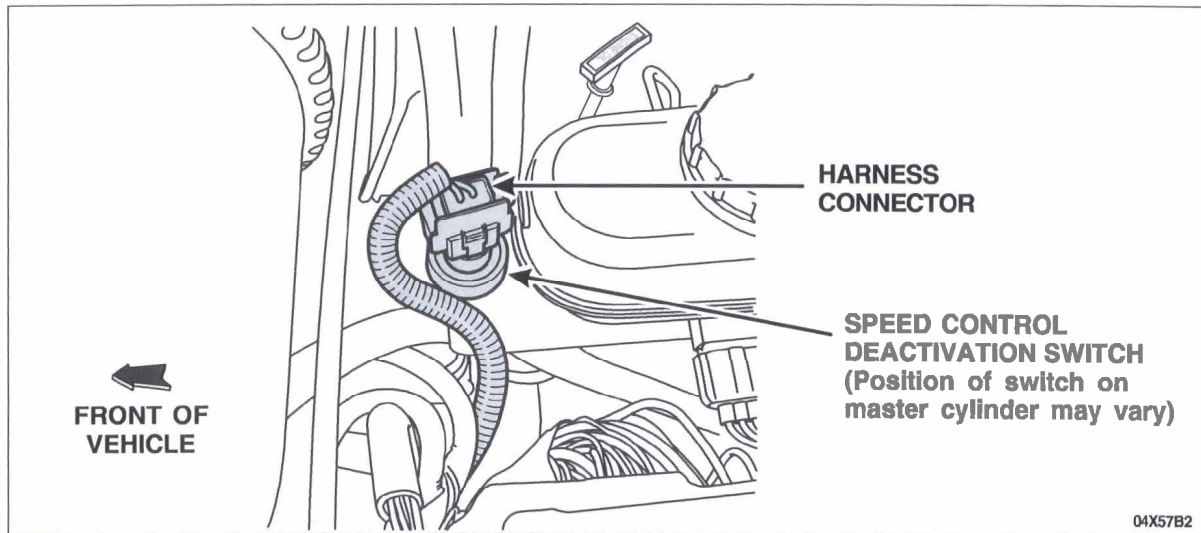
FIGURE 2

2. Disconnect the speed control deactivation switch located on the brake master cylinder and inspect the harness connector for the presence of brake fluid. See Figure 2.
  - If no brake fluid is present:
    - install the fused jumper harness (Labor Operation D).
  - If brake fluid is present, DISCONNECT THE SPEED CONTROL SERVO AND INSPECT THE VEHICLE HARNESS CONNECTOR FOR HEAT DAMAGE. See Figure 3.
    - If no heat damage is found at the speed control servo connector (even if there is presence of brake fluid in the connector), proceed to Labor Operation E.
    - If the speed control servo connector is heat damaged, call the Special Service Support Center at 1-800-325-5621 for further instructions.
