SUBJECT: Safety Recall 05S28-S7
Certain 1994-1996 Model Year Bronco, 1994-2002 F-150/250 (Under 8500 GVW), 1997-2002 Expedition, 1998-2002 Navigator, and 2002 Blackwood Vehicles Equipped With Speed Control
Speed Control System Modification

Safety Recall 05S28-S7

**CERTAIN 1994-1996 MODEL YEAR BRONCO,
1994-2002 F-150/250 (UNDER 8500 GVW), 1997-2002 EXPEDITION,
1998-2002 NAVIGATOR AND 2002 BLACKWOOD VEHICLES EQUIPPED
WITH SPEED CONTROL — SPEED CONTROL SYSTEM MODIFICATION**

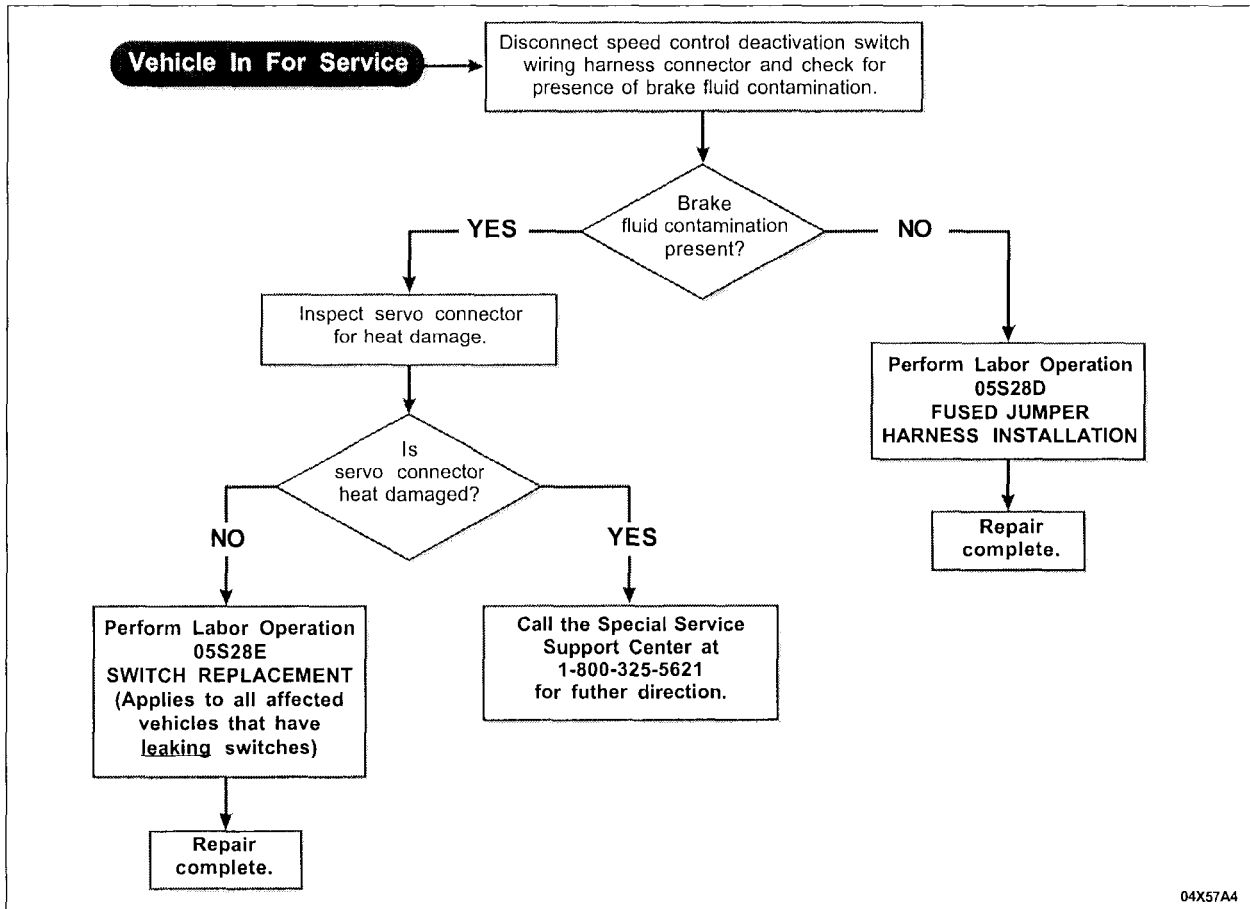
FIGURE 1

This program involves performing an inspection procedure to determine which repairs to the speed control system must be performed; either installation of a fused jumper harness or replacement of the speed control deactivation switch. A flow chart has been developed to direct you to the proper service actions. See Figure 1.

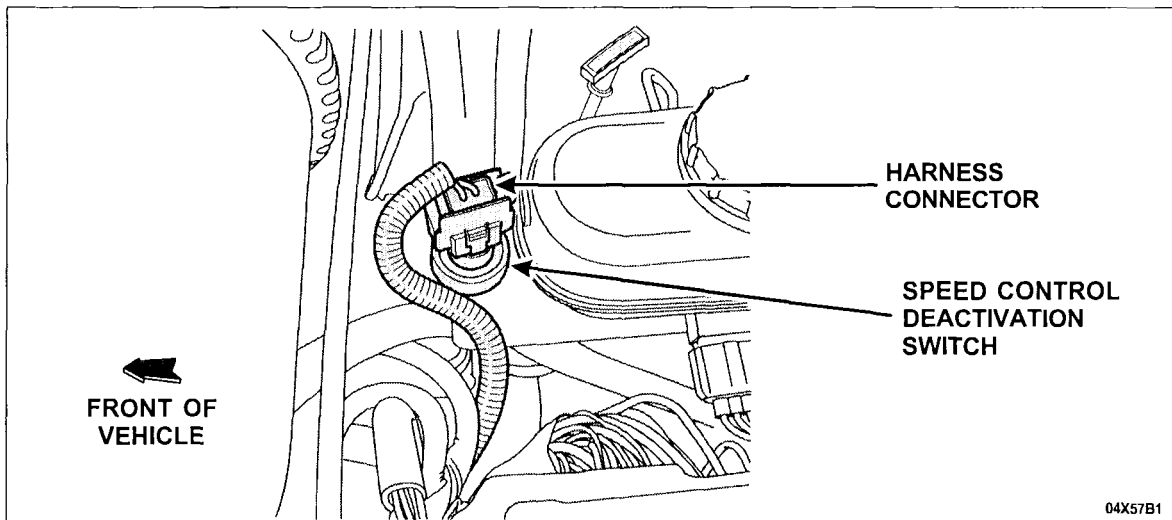
FIGURE 2

1. Disconnect the speed control deactivation switch located on the brake master cylinder and inspect the harness connector for the presence of brake fluid. See Figure 2.
 - If no brake fluid is present:
 - install the fused jumper harness (Labor Operation D).
 - If brake fluid is present, disconnect the speed control servo and inspect the vehicle harness connector for heat damage. See Figure 3.
 - If no heat damage is found at the speed control servo connector (even if there is presence of brake fluid in the connector), proceed to Labor Operation E.
 - If the speed control servo connector is heat damaged, call the Special Service Support Center at 1-800-325-5621 for further instructions.
