RE: Recall Number 05V-395 Defect Information Report (additional information)  
(Hyundai Campaign 073)

# HYUNDAI Technical Service Bulletin

Group CAMPAIGN	
		Number 05-01-010	
Subject <b>OCCUPANT CLASSIFICATION SYSTEM (OCS) SMART BUFFER FEATURE REMOVAL REPROGRAMMING - CAMPAIGN 073</b>		Date OCTOBER, 2005	
		Model 2004-2005 ELANTRA	
<b>CIRCULATE TO:</b>	<input type="checkbox"/> GENERAL MANAGER	<input checked="" type="checkbox"/> PARTS MANAGER	<input checked="" type="checkbox"/> TECHNICIAN
<input checked="" type="checkbox"/> SERVICE ADVISOR	<input checked="" type="checkbox"/> SERVICE MANAGER	<input checked="" type="checkbox"/> WARRANTY MGR	<input type="checkbox"/> SALES MANAGER

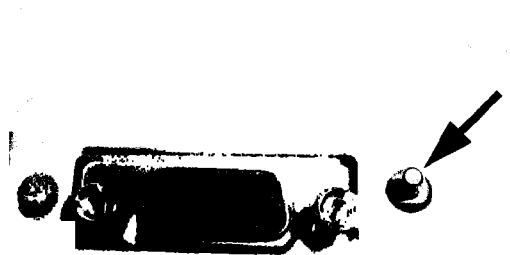
8. Press and release the black button on the back of the box to start the reprogramming.
