Subject: Product Safety Recall 15023, re-inspection of certain vehicles previously inspected under recall 15021

MODIFICATION INSTRUCTION

MI No. 248-2611 Edition 2	Date May 2006	9-5
Distr. US, CA, JP, TW		9-3 (9400)

Check/replacement of ignition discharge module

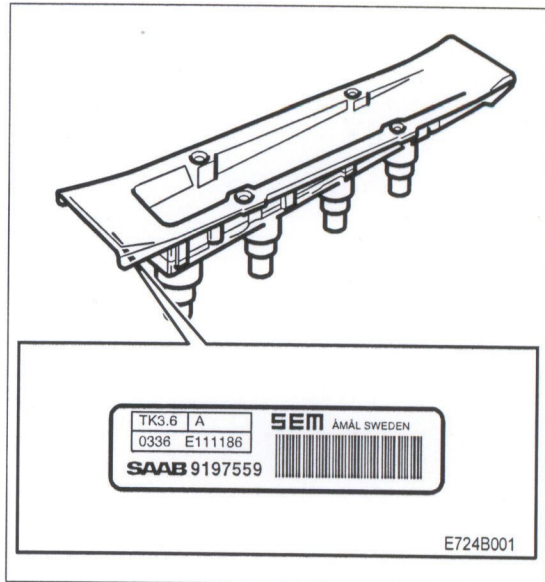
- 2 Check the serial number of the ignition discharge module.
 - B205/235:** Is the serial number E001000 or higher?
 - B308:** Is the serial number F001000 or higher?

- Yes:** The ignition discharge module must not be replaced.
 - NO:** The ignition discharge must be replaced.
- 3 Fit the ignition discharge module as described in WIS.

- If the old ignition discharge module is to be refitted, lubricate it with Krytox.
 - New ignition discharge modules come pre-lubricated with Krytox and do not require additional lubrication.
