Subject: Product Safety Recall 15021 - Inspection/replacement of IDM

Models: 2000-2002 Saab 9-3 and 9-5 (4 cylinder models)
2001 Saab 9-5 (6 cylinder models)

<h1>Product Safety Recall</h1>	Campaign ID:	15021
		Date:	17 Feb 2006
		Issue No:	1

Check/replacement of ignition discharge module

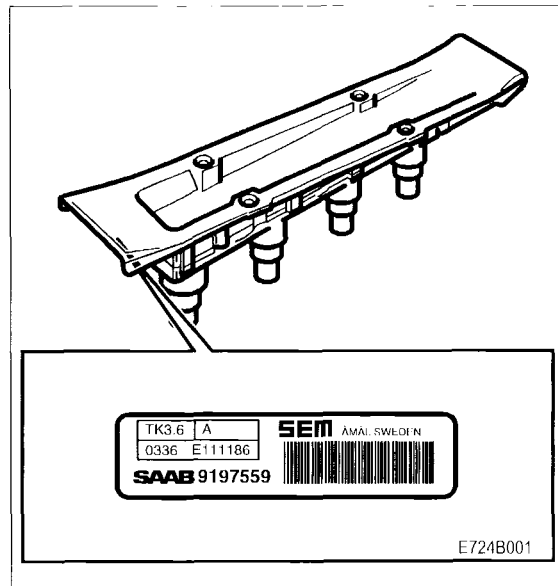
- 1 Remove the ignition discharge module as described in WIS - Engine - Trionic T7 - Adjust/replace - Ignition discharge module. Do not carry out "Extended ignition discharge module diagnose"
- 2 Check the serial number of the ignition discharge module. If the ignition discharge module is from the serial number interval below, it must be replaced. Other ignition discharge modules are not to be replaced.

B205/235: Serial number interval D000000 - D336210 or B083821 - B096117.

B308: Serial number interval C048743 - C072404.

- 3 Fit the ignition discharge module as described in WIS.

If the old ignition discharge module is to be refitted, lubricate it with Krytox.

New ignition discharge modules come pre-lubricated with Krytox and do not require additional lubrication.
