# VEHICLE RECALL

## SC304

**Date:** 03/16/06 (Supersedes SC304 dated 02/22/06)

**Subject:** Front Axle Brake Cam Lubrication — CXN and CHN Model Chassis

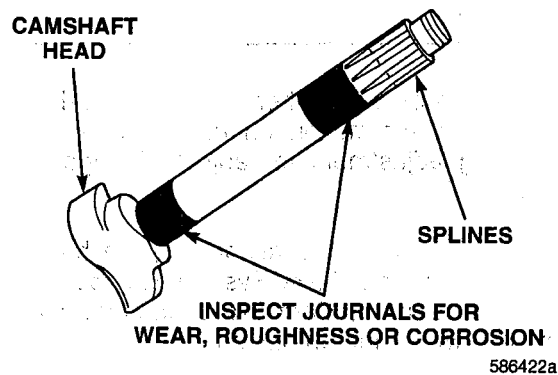
**Figure 2 — Inspect Brake Cam**

It has been determined that the front steer axle brake cams may not have been lubricated at assembly on certain CXN and CHN model chassis equipped with ArvinMeritor™ 15" x 4" and 16.5" x 5" brakes. Lack of lubrication can result in dragging brakes due to the cam journals corroding and not allowing the brakes to fully release. Approximately 2,582 CXN and CHN model chassis manufactured February 2004 through June 2005 are involved in this campaign. A list of affected chassis has been sent to all applicable dealers.

The front steer axle brake cams on all affected chassis must be removed and inspected. Inspect the area of the cam journals for wear, roughness or corrosion.

Damaged brake cams and associated brake components must be replaced per the following criteria:

- If there is no wear, roughness or corrosion evident on the brake cam journals, reinstall the cams, but replace the cam bushings and seals and brake shoe retaining hardware with new components.
- If the brake cam journals are worn, rough or corroded, replace the cam, cam bushings, seals and brake shoe retaining hardware.
