TO: All Weekend Warrior Dealers
RE: Safety Recall Notice, NHTSA ID. No. 05V444000

WEEKEND WARRIOR	
SHIT 01 OF 01	DRAWN BY: farrinuo
DATE: 4/14/08	
MARKER LIGHT ADDITION.DWG	
MARKER LIGHT ADDITION

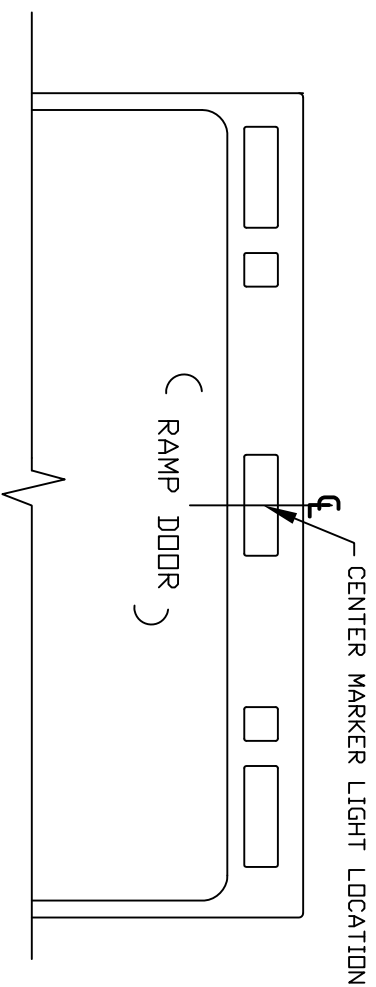
REAR MARKER LIGHT
(ALL MODELS)

Weekend Warrior Trailers, Incorporated has decided that certain recreational trailers fail to conform to the lighting requirements of Federal Motor Vehicle Safety Standard No. 108, "Lamps, Reflective Devices, and associated Equipment." Specifically, certain trailers were manufactured without all required lighting equipment. Without this lighting, and particularly, during night driving conditions or while the trailer is parked, other vehicles may not see a trailer, thereby, increasing the risk of a crash.

NOTE: THE 'REAR IDENTIFICATION LIGHT' MUST BE CENTERED ON THE REAR EYEBROW SECTION OF THE TRAILER ON A HORIZONTAL PLANE AND IN ALIGNMENT WITH THE OUTBOARD IDENTIFICATION LIGHTS. CONNECT POWER TO THE MARKER LIGHT ASSEMBLY BY SPLICING INTO THE EXISTING MARKER LIGHT CIRCUIT WIRE HARNESS.
