File In Section: Product Recalls
Bulletin No.: 05086
Date: October 2005

PRODUCT SAFETY RECALL

SUBJECT: POWER STEERING HOSE FRACTURE

**MODELS: 2006 BUICK RAINIER
2006 CADILLAC ESCALADE
2005 CHEVROLET CORVETTE, SILVERADO
2006 CHEVROLET CORVETTE, EXPRESS, SILVERADO, TAHOE,
TRAILBLAZER, TRAILBLAZER EXT
2005 GMC SIERRA
2006 GMC ENVOY, ENVOY XL, SAVANA, SIERRA, YUKON
2006 HUMMER H2**

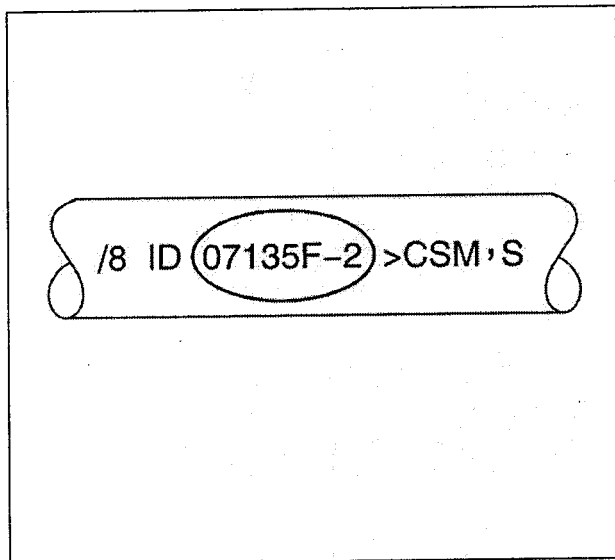
1704027

1. Inspect and record the power steering pressure line for the date code as shown above. The date code is printed on the hose and is repeated approximately every 6 inches (150 mm). Depending on the vehicle configuration, there may be one or two hoses to inspect. Vehicles equipped with the hydro-boost system will have two hoses while others will only have one hose. Removal of conduit may be necessary in order to inspect the date code.

- If the date code is one of the codes listed above, the hose(s) must be replaced. Proceed to the Hose Replacement Procedure.
- If the date code is not one of the codes listed above, then replace the conduit if applicable and no further action is required.

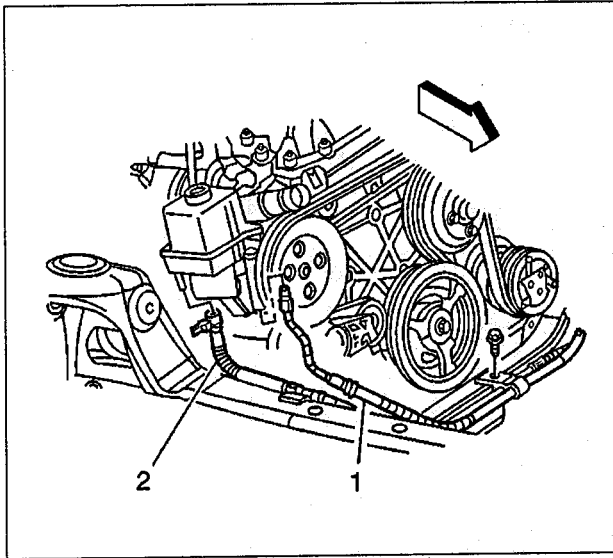
687439

Rainier/TrailBlazer/TrailBlazer EXT/Envoy/Envoy XL with 4.2L Engine Power Steering Pressure Hose (1). This pressure line has two hose sections and both must be inspected. Vehicle may need to be lifted to inspect both.

Vehicle	Hose	SI Document #
Rainier/TrailBlazer/TrailBlazer EXT/Envoy/Envoy XL	Power Steering Pressure Hose	847857 (follow instructions through the removal procedure to remove the power steering hose assembly. Replace the pressure hose in the assembly on the bench. Use due care when opening and closing the line position brackets to avoid damaging them. Proceed with installation instructions.

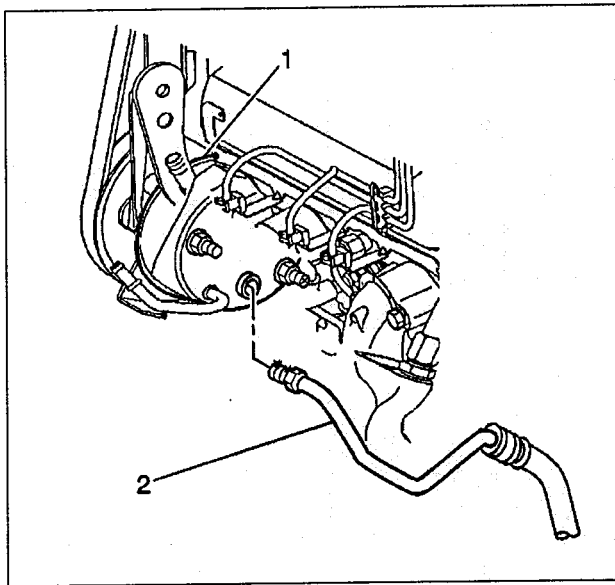
309298

Express/Savana Steering Pump to Hydro-Boost Pressure Line (2)

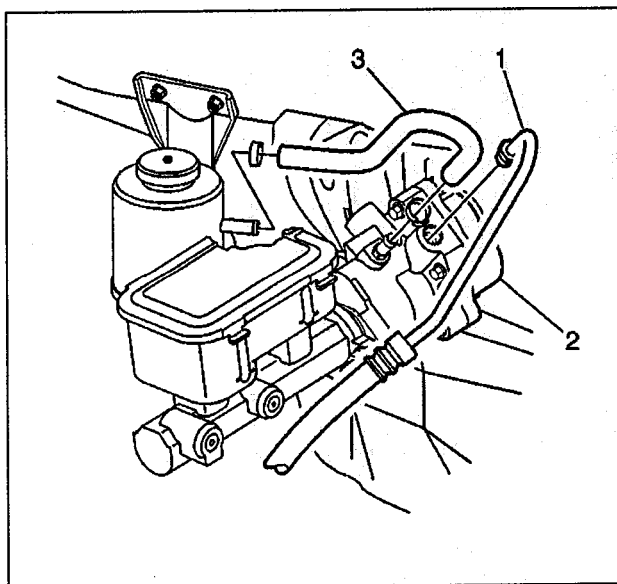
407982

Express/Savana Hydro-Boost to Steering Gear Pressure Line (1).

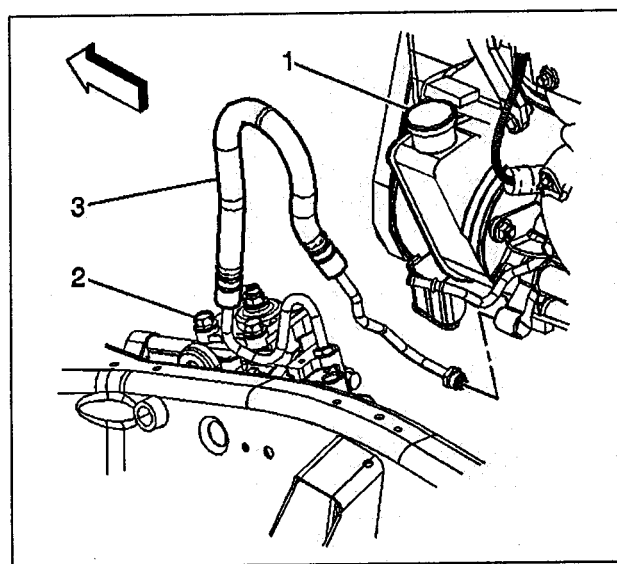
748675

Silverado/Tahoe/Sierra/Yukon/Escalade Non Hydro-Boost Pressure Line (3).

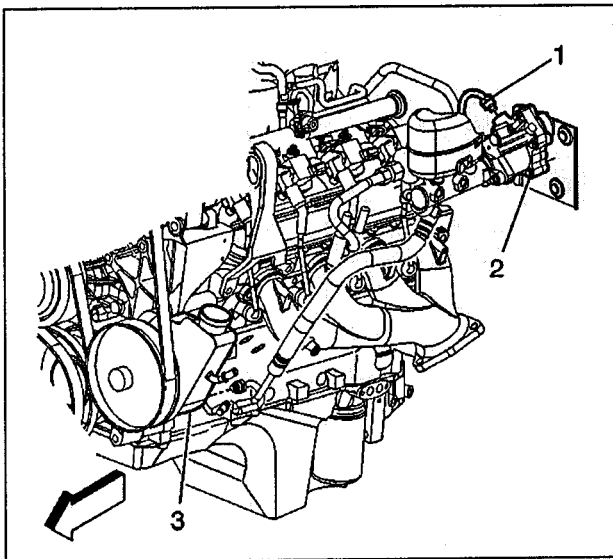
650858

Silverado/Tahoe/Sierra/Yukon/Escalade Power Steering Pump to Hydro-Boost Pressure Line (1).

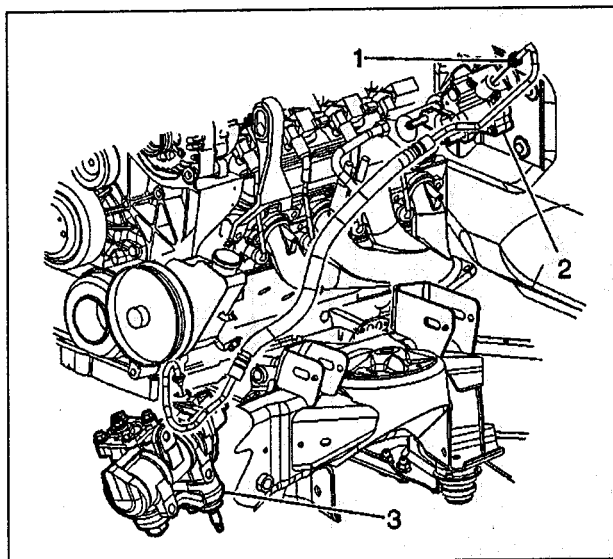
650863

Silverado/Tahoe/Sierra/Yukon/Escalade Hydro-Boost to Steering Gear Pressure Line (1).

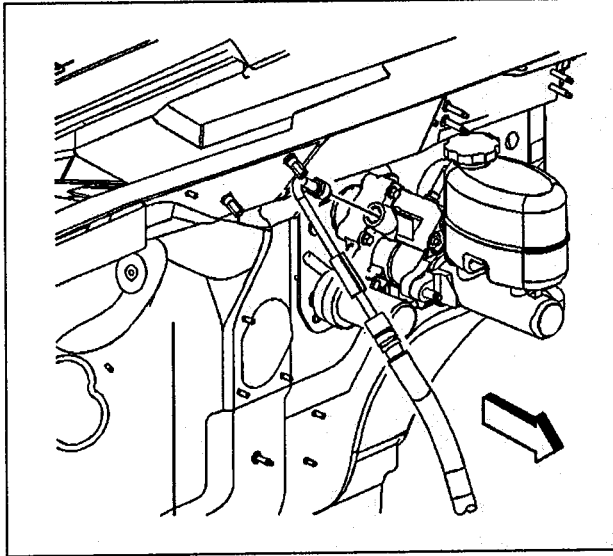
795542

Hummer H2 Power Steering Pump to Hydro-Boost Pressure Line.

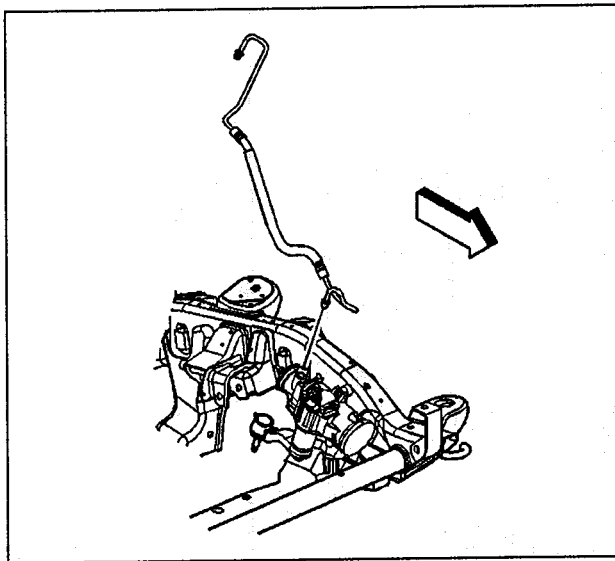
793265

Hummer H2 Hydro-Boost to Steering Gear Pressure Line.

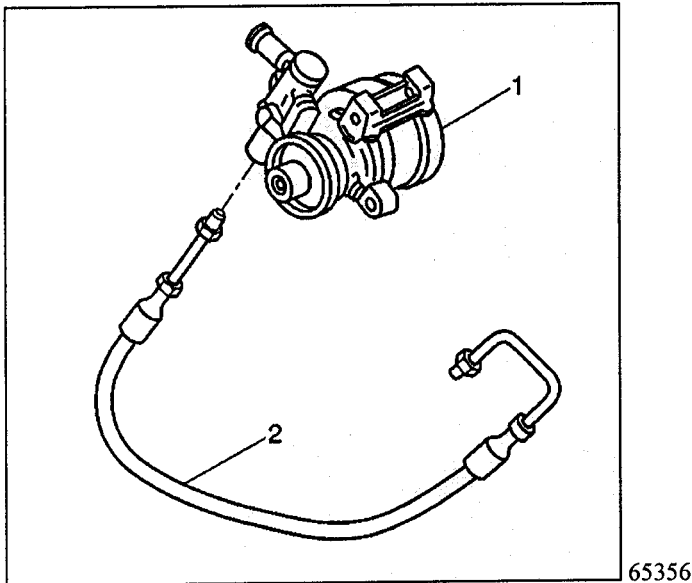
65356

Corvette Power Steering Pressure Hose (2). The vehicle will need to be lifted on a hoist for inspection. Removal of the power steering cooler bolts will give increased access to the pressure hose.
