Reference: NHTSA Identification Number 05V-460

DEFECT INFORMATION REPORT FOR DAIMLERCHRYSLER RECALL E14

Safety Recall E14

Transmission Cup Plug Bracket

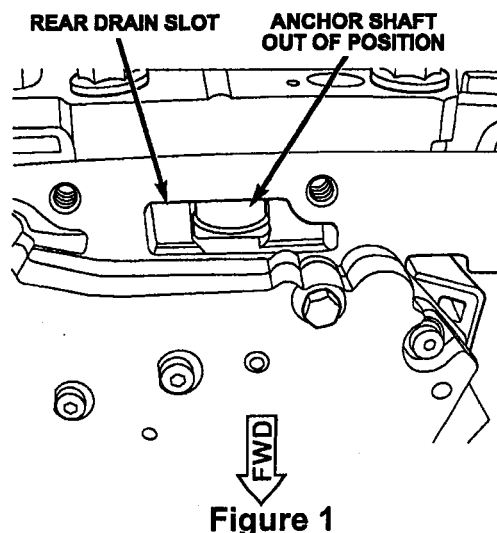
Figure 1

10. Look into the rear drain slot (Figure 1).

- If you do not see the anchor shaft, continue with Section C – Cup Plug Bracket Installation.
- If the anchor shaft is visible, it has slid rearward out of position, continue with Step 11.

11. Insert a screwdriver into the rear drain slot and gently pry the anchor shaft back into the case. Use a pair of needle nose pliers and gently grip the shaft and guide it into the case if needed.

- If the anchor shaft is flush with the edge of the hole, continue with Section C – Cup Plug Bracket Installation.
 - If the anchor shaft springs back out (not flush with the edge of the hole), continue with Step (12).

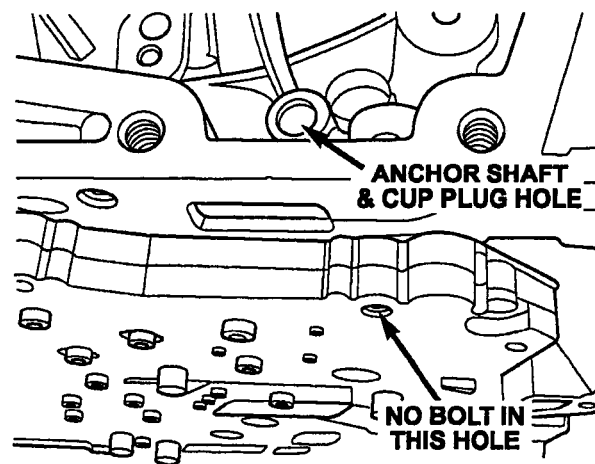
Figure 3

REAR VIEW (ADAPTOR/EXTENSION REMOVED FOR VIEWING PURPOSES)

22. Hand-start the valve body bolts **EXCEPT** the bolt for the bolt hole shown in Figure 3. This bolt will be installed later in Section C.
23. Tighten the valve body bolts to 105 in-lbs (12 N·m).
24. Install the transmission oil filter and tighten the transmission oil filter bolts to 40 in-lbs (5 N·m).
25. Rotate the shifter shaft counter clockwise to the L1 position and install and adjust the shifter linkage.

16. Hand-start the valve body bolts **EXCEPT** the one bolt for the bolt hole as shown in Figure 3. This bolt will be installed later in Section C.
17. Tighten the valve body bolts to 105 in-lbs (12 N·m).
18. Install the transmission oil filter and tighten the transmission oil filter bolts to 40 in-lbs (5 N·m).
19. Rotate the shifter shaft counter clockwise to the L1 position and install and adjust the shifter linkage.
20. Attach the transmission solenoid/pressure switch and range sensor electrical connectors.
21. Continue with Section C – Cup Plug Retention Bracket Installation.

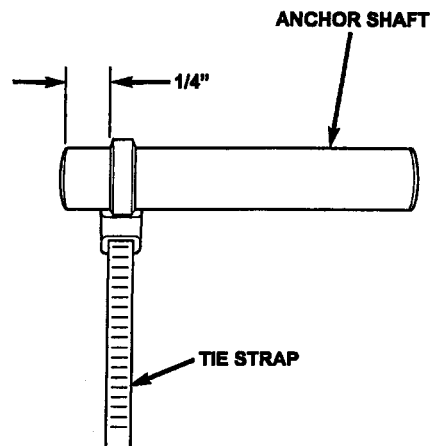
Figure 4

B. If the anchor shaft has come out of the hole and is visible in the drain hole: Use a magnet to extract it. Secure a tie wrap (P/N 04641780) to the anchor shaft about 1/4" from one end as shown in Figure 4.

C. If you cannot see the anchor shaft: Obtain a new anchor shaft (P/N 04431999) and secure a tie wrap (P/N 04641780) to the anchor shaft about 1/4" from one end as shown in Figure 4.
