Reference: NHTSA Identification Number 05V-462

Safety Recall E17 Out-of-Park Alarm System

2003 – 2004 (DR) Dodge Ram Pickup Truck

2005 (DH) Dodge Ram Pickup Truck

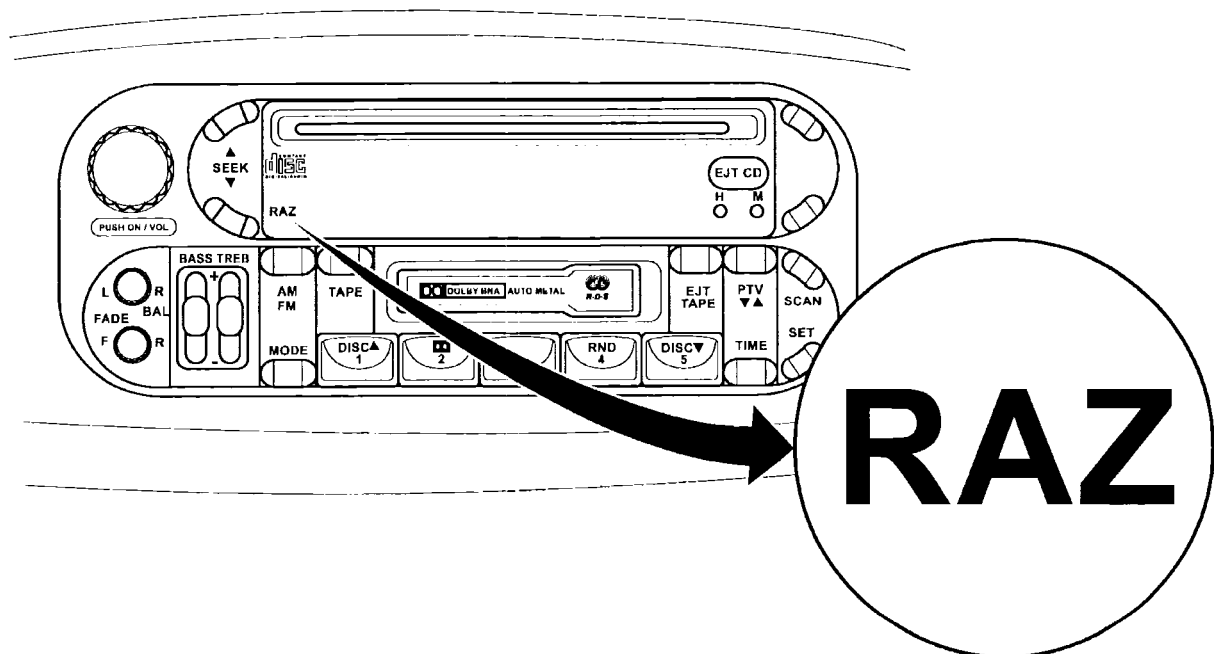
Figure 1 – 2003 Model Year Shown

11. Disconnect the DRBIII from TechCONNECT and the external power supply.
12. Inspect the radio face plate. The radio sales code is printed on the face of the radio (Figure 1). If the vehicle is equipped with an “RAZ” radio, it must be removed from the instrument panel and completely disconnected to eliminate the possibility of any electronic communication between the radio and the instrument cluster during the flash procedure.
13. **Vehicles equipped with a “RAZ” radio:** remove the ABS module fuse (#35) from the Power Distribution Center (PDC) (Refer to the bottom of the PDC cover for fuse location). This will prevent any communication between the ABS module and the instrument cluster during the flash procedure.

CAUTION: The flash process will fail if you are attempting to flash a “RAZ” radio equipped vehicle without disconnecting the radio and removing the ABS module fuse as outlined in Steps 12 and 13.
