DEFECT INVESTIGATION

**Re: Defect Information Report – supplemental information  
(FL-460), NHTSA no. 05V-467,  
Meritor spindle on Meritor and AAC rear axle housings**

**Section 573.6 Defect Information Report**  
**FL-460, Meritor spindle on Meritor and AAC rear axle housings;**  
**NHTSA no. 05V-467**  
**Supplement No.: 03**

## Subject: ArvinMeritor Rear Axle Spindles

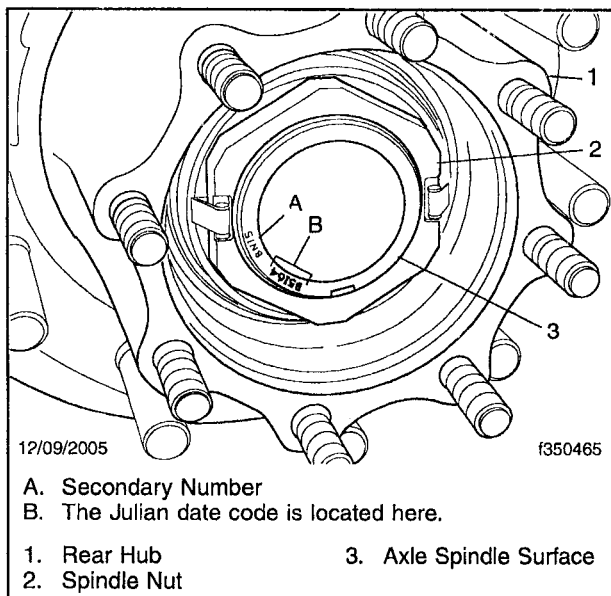
**Fig. 3, Julian Date Code and Secondary Number Locations**

The Julian date code consists of an alpha designator followed by four digits (e.g., *B1234*). If the date code is *B5129*, or *B5130*, replace the axle housing. Go to "Replacing the Axle Housing."

If the Julian date code on the spindle is *B5131*, check the secondary number next to the date code. If that number starts with an "S," replace the axle housing. If the secondary number starts with a "B," or any letter but "S," the axle spindle is all right.

9. Repeat the procedure, checking all the remaining rear-axle spindles on the vehicle. If any are found to have the affected Julian date codes, replace the axle housing. Go to "Replacing the Axle Housing."
10. If the axle housing does not need replacement, install the axle driveshafts, using new gaskets. Install the tapered dowels, if applicable.
