HYUNDAI Technical Service Bulletin

Group	CAMPAIGN	
		Number	05-01-010	
Subject	OCCUPANT CLASSIFICATION SYSTEM (OCS) SMART BUFFER FEATURE REMOVAL REPROGRAMMING - CAMPAIGN 073		Date	OCTOBER, 2005
			Model	2004-2005 ELANTRA
CIRCULATE TO:	<input type="checkbox"/> GENERAL MANAGER	<input checked="" type="checkbox"/> PARTS MANAGER	<input checked="" type="checkbox"/> TECHNICIAN	
<input checked="" type="checkbox"/> SERVICE ADVISOR	<input checked="" type="checkbox"/> SERVICE MANAGER	<input checked="" type="checkbox"/> WARRANTY MGR	<input type="checkbox"/> SALES MANAGER

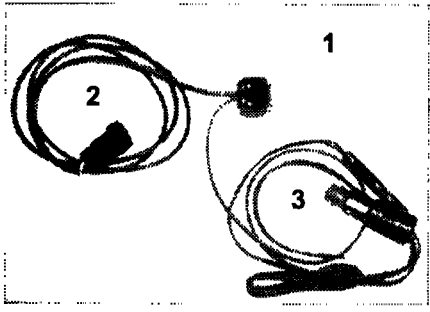
PART NAME	PART NUMBER	CONTENTS	PHOTO
OCS Reprogramming Tool	00305-CMP00-73	1. Reprogramming Box 2. OCS Cable 3. Power Adapter
