Land Rover North America, Inc.

SERVICE BULLETIN

Bulletin: SRE05-13
 Section: Recall
 Date: 02 November 2005
 Model: Range Rover Sport (LS)

Subject: Recall B021 – Quarantine Notification for Affected Vehicles

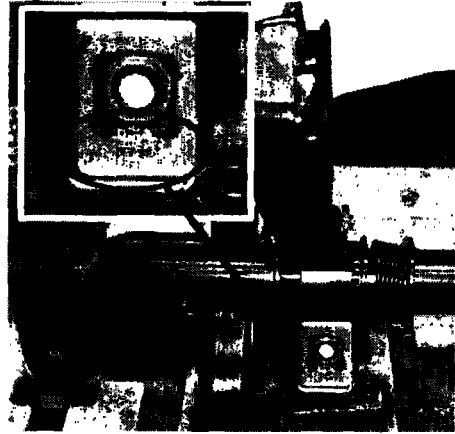
Figure 2

1. Open left hand rear door.
2. Identify the left hand rear second row seat belt buckle. (Circled in Figure 1)
3. Fold the seat cushion forward.
4. Inspect the serial number stamped on the buckle. (Figure 2)
5. Determine if the serial number is either "05 02 02" or "05 03 02."
6. If the serial number is any other SERIES than 05 02 02 or 05 03 02, no further action is required.

Vehicles manufactured within the above range may contain seatbelt buckle assemblies where the steel anchor straps were made with material that does not conform to the required material strength properties. This was captured through routine testing and a plant hold was issued. A small number of vehicles were not contained within the Land Rover controlled locations.
