SI B24 06 05
Automatic Transmission

November 2005
Technical Service

Safety Recall Campaign 05V-504: Parking Lock Guide Plate

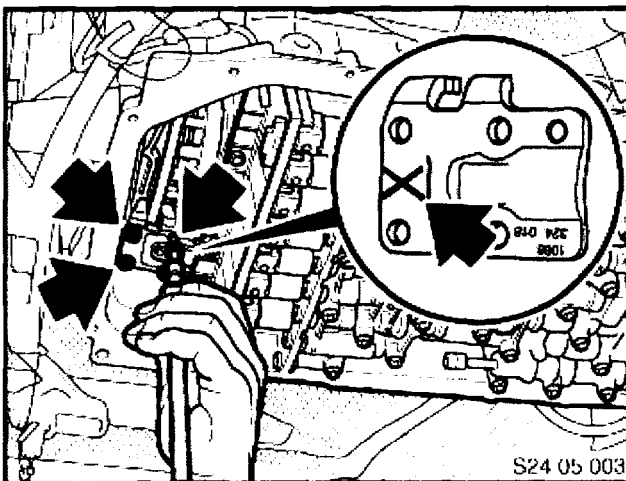
Some of the ZF 6HP26 automatic transmissions installed in the affected vehicles have been assembled using non-hardened parking lock pawl guide plates. A non-hardened guide plate can cause a misalignment of the lock pawl to the park wheel, resulting in a partial engagement of the transmission parking lock.

7. Remove the parking pawl guide plate (illustration shows guide plate removed from the transmission).

8. Install the new guide plate (PN 24 53 1 219 287) and tighten four guide plate bolts to 10 Nm.

Important:
The replacement guide plate is recognized by the mark "X" on its side.
9. The removed (defective) guide plate has to be returned to BMN NA Warranty Parts Return Center, together with a copy of the warranty claim.
