Re: 49 CFR Part 573; Recall of Mercedes-Benz SLK (170) Tail Lamps

Re: Recall Campaign 2006080005 – Update - Replace Tail Lamps, Model 170 Model Year 1998 – 2000

Campaign No. 2006080005, November 2006

SUBJECT: **MODEL 170, MODEL YEAR 1998-2000**
REPLACE TAIL LAMPS

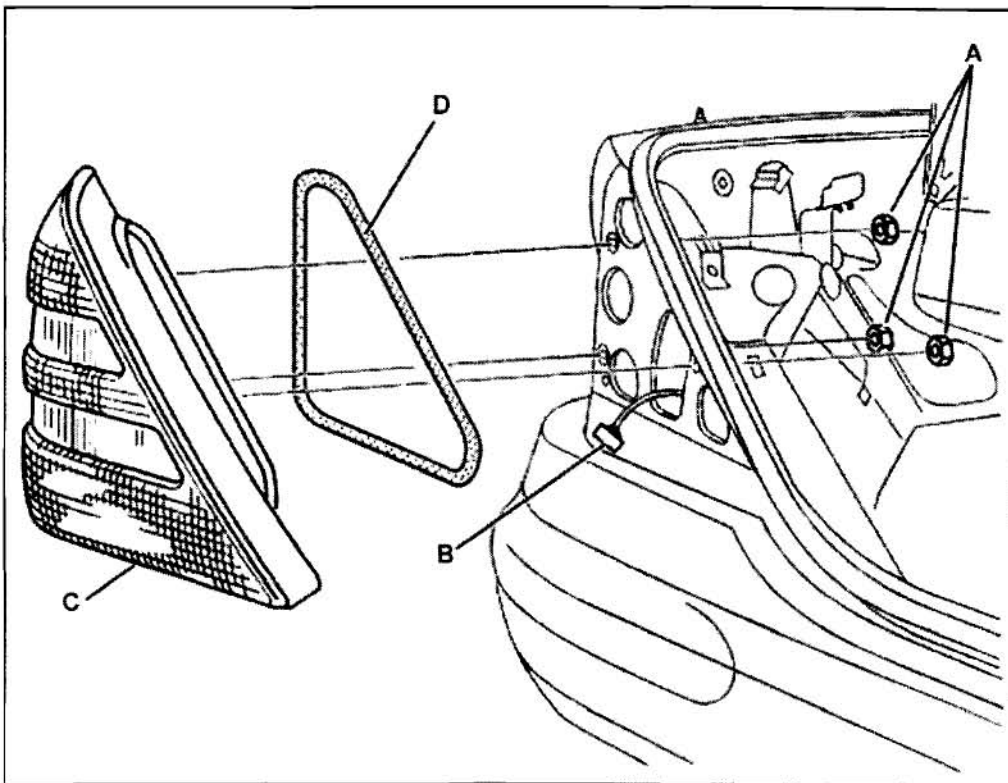
Figure 1

This Recall Campaign has been initiated because DCAG has determined that due to the heat generated by the brake lamps of the affected vehicles (see VIN range on the following page) the base of the lamp socket can be subject to thermal deformation over time. This deformation can cause movement in the socket-to-bulb connection, which may lead to a loosening of the electrical contacts in the sockets and a failure of the bulb to illuminate. This can cause a failure of either brake light (the center brake light is not affected). A failure of the brake lamp bulbs to illuminate could lead to a rear end vehicle crash. Dealer will replace all rear lamp modules in affected vehicles with new rear lamp modules redesigned with a more heat resistant material, different bulbs, and enhanced lamp holder mountings. Dealer will also place a label in the vehicle operator's manual indicating new bulb part number assignment.

1. Open trunk lid.
2. Remove first-aid kit on left side; remove flap in wheelhouse paneling and CD changer (if applicable) on right side.
3. Remove nuts (A, Figure 1).
4. Disconnect electrical connector (B).
5. Replace tail lamps (C) on both sides of vehicle.

Ensure to install and position seal (D) correctly when installing new tail lamp.

6. Reassemble in reverse order.
