Re: 49 CFR Part 573; Recall of Mercedes-Benz SLK (170) Tail Lamps

Re: Recall Campaign 2006080005 - Replace Tail Lamps, Model 170 Model Year 1998 - 2000

Campaign No. 2006080005, September 2006

TO: ALL MERCEDES-BENZ CENTERS
SUBJECT: **MODEL 170, MODEL YEAR 1998-2000
REPLACE TAIL LAMPS**

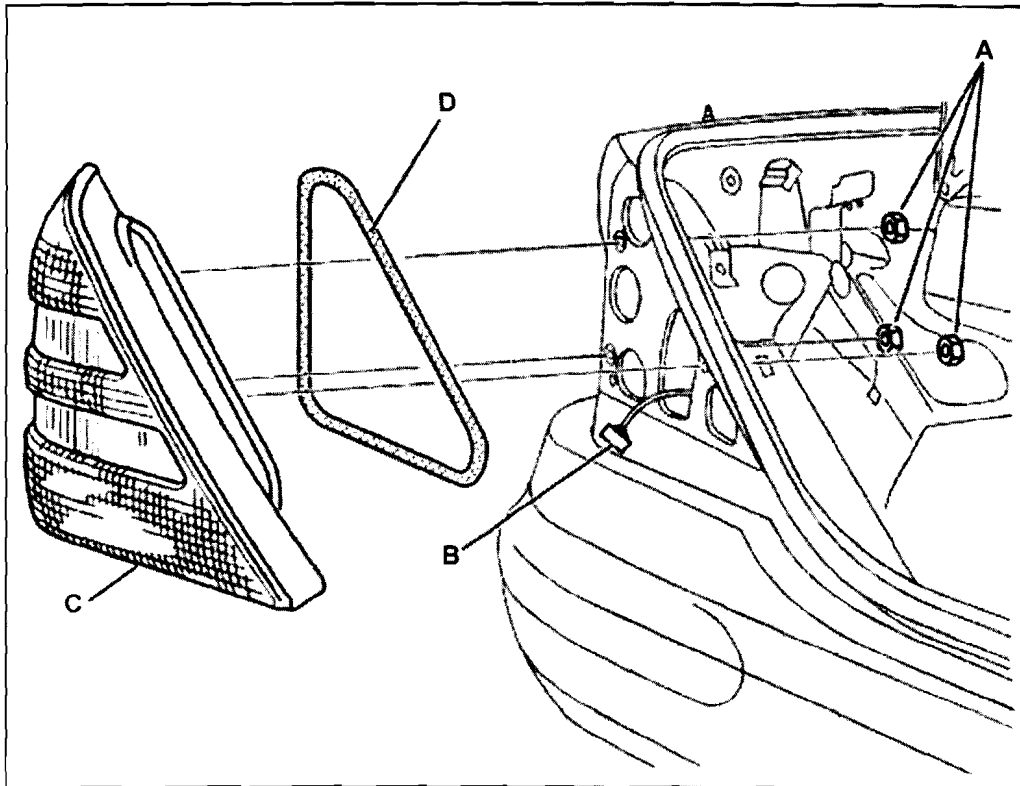
Figure 1

1. Open trunk lid.
2. Remove first-aid kit on left side; remove flap in wheelhouse paneling and CD changer (if applicable) on right side.
3. Remove nuts (A, Figure 1).
4. Disconnect electrical connector (B).
5. Replace tail lamps (C) on both sides of vehicle.

Ensure to install and position seal (D) correctly when installing new tail lamp.

6. Reassemble in reverse order.
