**Re: 49 CFR Part 573; Recall of Mercedes-Benz SLK (170) Tail Lamps**

Re: Recall Campaign **2006080005 Update and Customer Notification** - Replace Tail Lamps, Model 170 Model Year 1998 - 2004

Campaign No. 2006080005, February 2007

SUBJECT: **MODEL 170, MODEL YEAR 1998-2004**  
**REPLACE TAIL LAMPS**

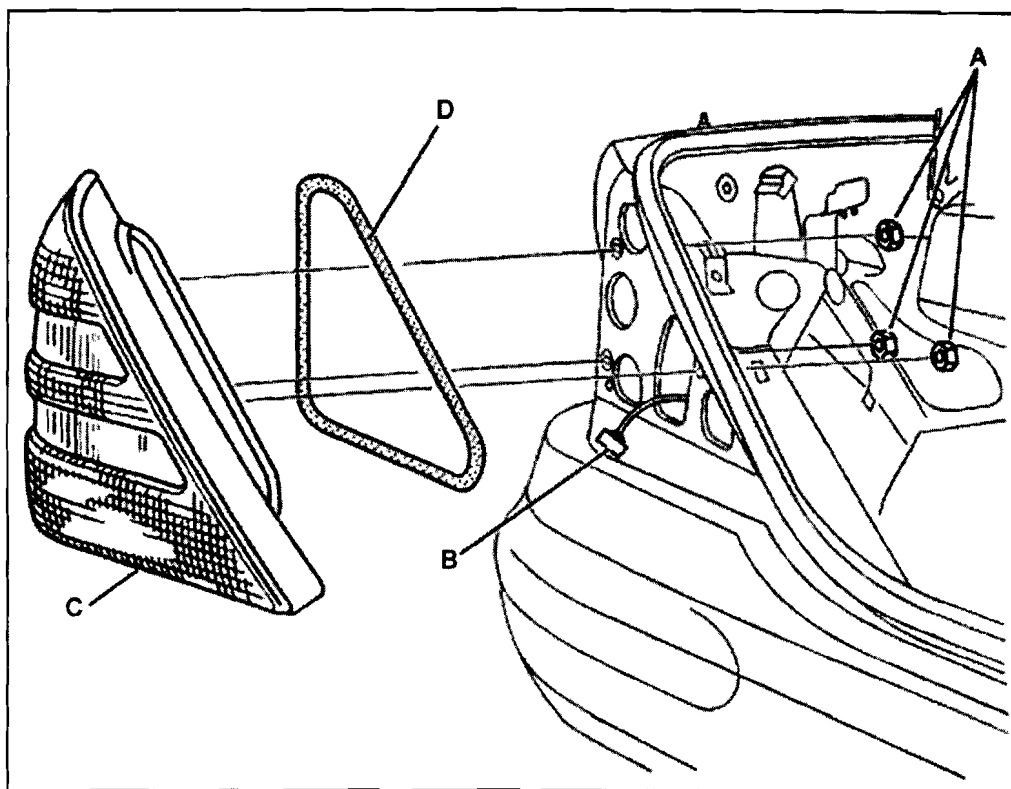
Figure 1

This Recall Campaign has been initiated because DCAG has determined that due to the heat generated by the brake lamps of the affected vehicles (see VIN range on the following page) the base of the lamp socket can be subject to thermal deformation over time. This deformation can cause movement in the socket-to-bulb connection, which may lead to a loosening of the electrical contacts in the sockets and a failure of the bulb to illuminate. This can cause a failure of either brake light (the center brake light is not affected). A failure of the brake lamp bulbs to illuminate could lead to a rear end vehicle crash. Dealer will replace all rear lamp modules in affected vehicles with new rear lamp modules redesigned with a more heat resistant material, different bulbs, and enhanced lamp holder mountings. Dealer will also place a label in the vehicle operator's manual indicating new bulb part number assignment.

1. Open trunk lid.
2. Remove first-aid kit on left side; remove flap in wheelhouse paneling and CD changer (if applicable) on right side.
3. Remove nuts (A, Figure 1).
4. Disconnect electrical connector (B).
5. Replace tail lamps (C) on both sides of vehicle.

Ensure to install and position seal (D) correctly when installing new tail lamp.
