Honda Motor Co., LTD is announcing a safety recall campaign for a limited number of 2006 TLs.

Safety Recall: Right Front Impact Sensor Is Loose

Applies To: **2006 Accord 2-Door** – From VIN 1HGCM8...6A000936 thru 1HGCM8...6A001775 **November 4, 2005**
2006 Accord 4-Door – From VIN 1HGCM6...6A003065 thru 1HGCM6...6A003941

Safety Recall: Left Front Impact Sensor Is Loose

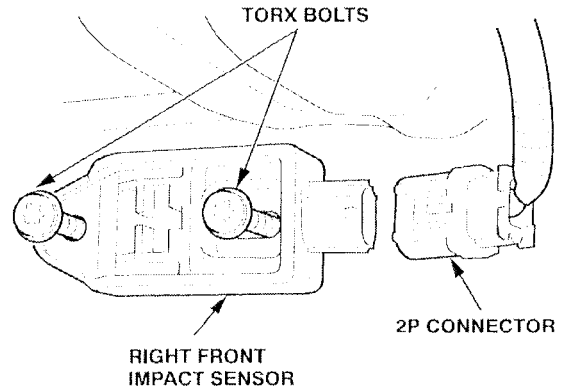
The bolts on the right (passenger's side) front impact sensor were not properly torqued. If the bolts loosen or fall out, the sensor may fail to properly detect a crash, possibly resulting in delayed or non-deployment of the passenger's airbag.

On some 2006 TLs, the bolts on the right (passenger's side) front impact sensor were not properly torqued. If the bolts loosen or fall out, the sensor may fail to properly detect a crash, possibly resulting in delayed or non-deployment of the passenger's airbag.

1. To keep the front airbags from deploying, turn the ignition switch off, remove the key, and wait at least 3 minutes.
2. Remove the front bumper. Refer to page 20-124 of the 2004-06 TL Service Manual.
3. Disconnect the 2P connector from the right (passenger's side) front impact sensor.

4. Using a Torx T30 bit, loosen the sensor's two Torx bolts to see if they are cross-threaded.
5. Hold the sensor tight against its bracket while you torque the Torx bolts to 9.8 N·m (7.2 lb-ft).
6. Reconnect the sensor's 2P connector.
7. Reinstall the front bumper.
8. Turn the ignition switch to ON (II), and watch the SRS indicator.
 - If the indicator comes on for about 6 seconds and then goes off, go to step 9.
 - If the indicator comes on but doesn't go off, troubleshoot the SRS for other possible problems, then go to step 9.

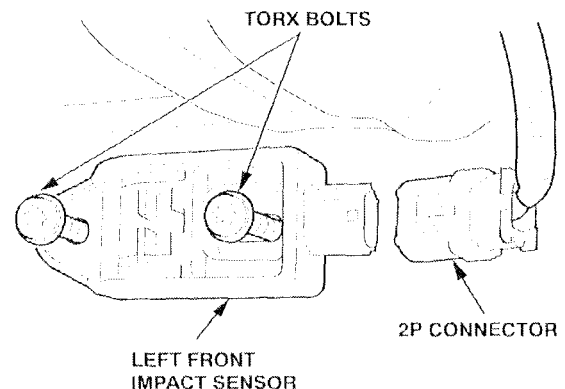
The bolts on the left (driver's side) front impact sensor were not properly torqued. If the bolts loosen or fall out, the sensor may fail to properly detect a crash, possibly resulting in delayed or non-deployment of the driver's airbag.

On some 2006 Accords, the bolts on the left (driver's side) front impact sensor were not properly torqued. If the bolts loosen or fall out, the sensor may fail to properly detect a crash, possibly resulting in delayed or non-deployment of the driver's airbag.

1. To keep the front airbags from deploying, turn the ignition switch off, remove the key, and wait at least 3 minutes.
2. Remove the front bumper:
 - 2-Door: Refer to page 20-184 of the 2003–06 Accord Service Manual.
 - 4-Door: Refer to page 20-185 of the service manual.
3. Disconnect the 2P connector from the left (driver's side) front impact sensor.

4. Using a Torx T30 bit, loosen the sensor's two Torx bolts to see if they are cross-threaded.
5. Hold the sensor tight against its bracket while you torque the Torx bolts to 9.8 N·m (7.2 lb-ft).
6. Reconnect the sensor's 2P connector.
