Ref: 05V-512

Subject: 2004-2006 Maxima Lumbar Seat Safety Recall Campaign Update #1

INTERIM REPAIR INSTRUCTIONS MAXIMA DRIVER'S SEAT HARNESS ROUTING

Revised 11/14/05

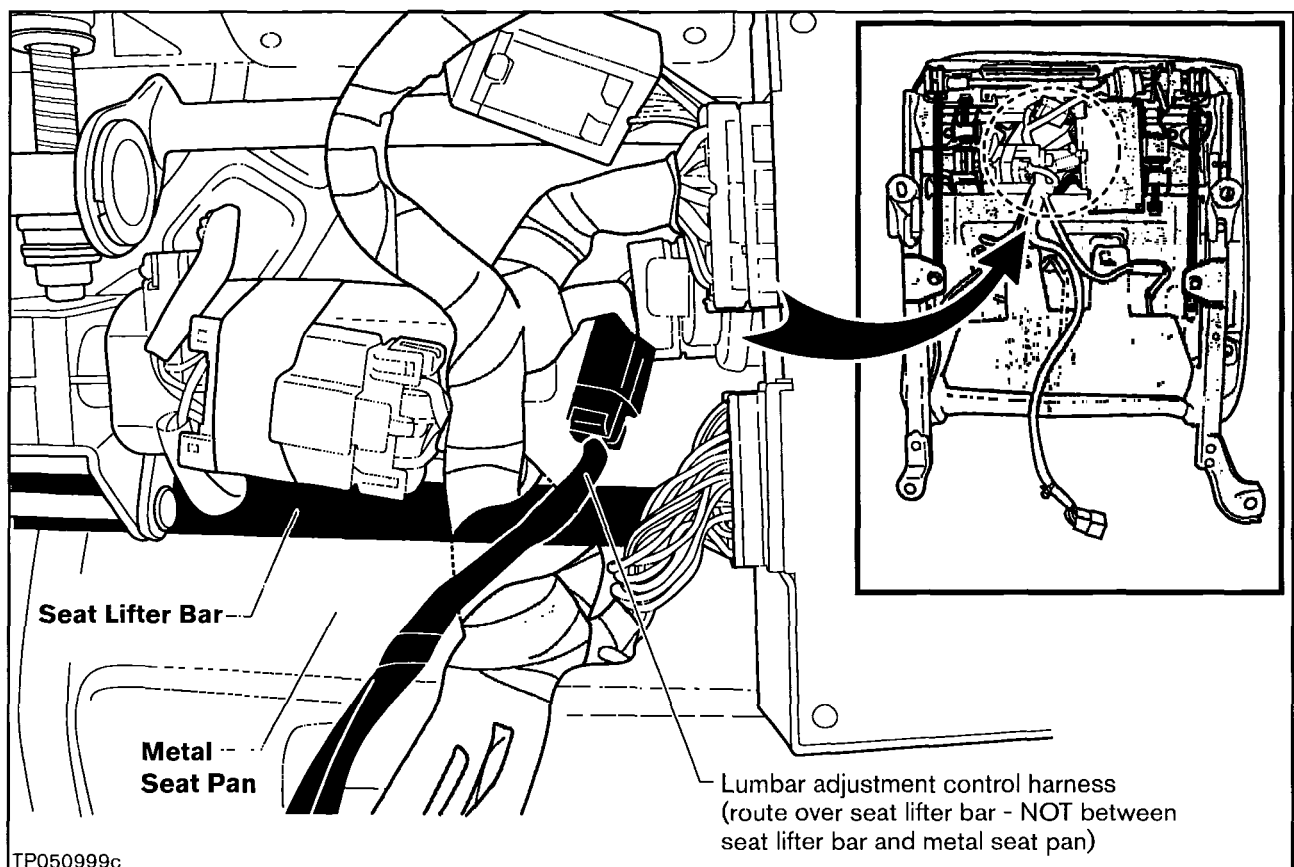
Figure 11

CAUTION: Do NOT route the lumbar adjustment control harness between the seat lifter bar and the metal seat pan.

- The lumbar adjustment control harness is reconnected and routed as shown in Figure 11.
