Subject: 2004-2006 Maxima Lumbar Seat Safety Recall Campaign Update #2

VOLUNTARY RECALL CAMPAIGN DRIVER'S SEAT HARNESS ROUTING

CAMPAIGN I.D. # / NHTSA #: PB011 / 05V-512

APPLIED VEHICLE: 2004-06 Maxima (A34) – with power lumbar driver seat

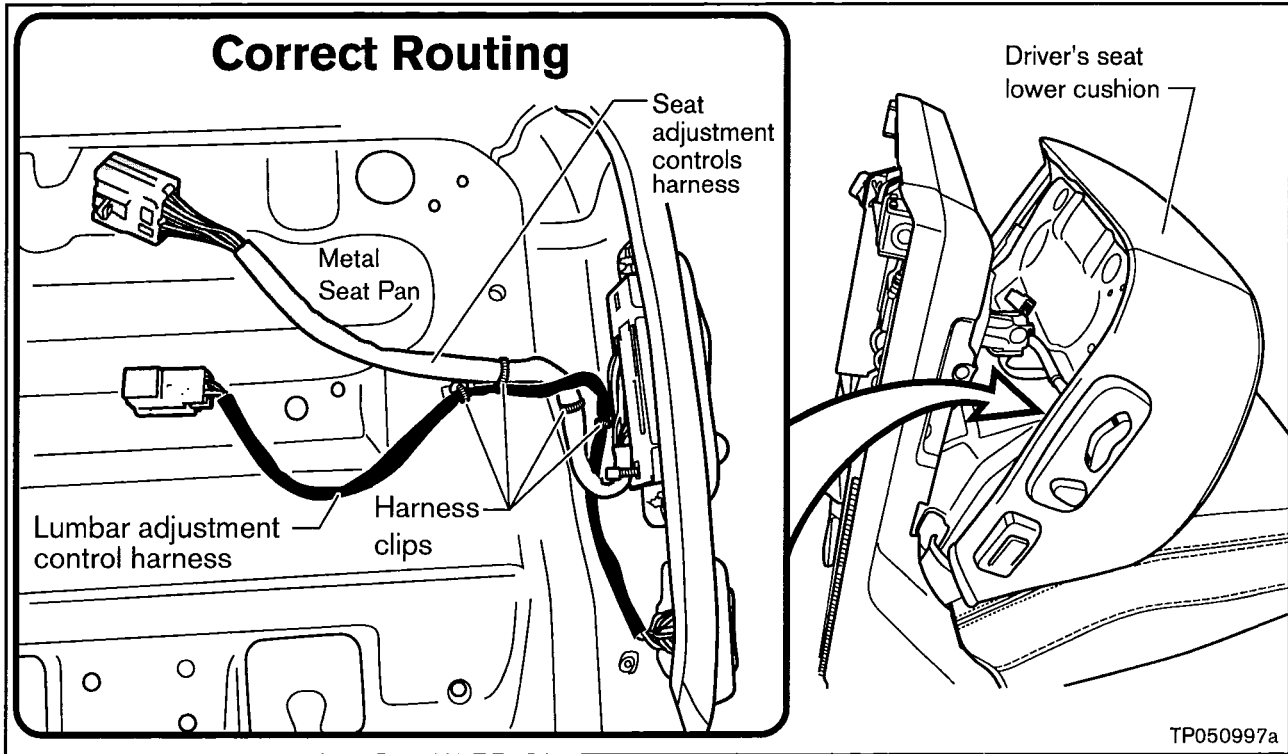
Figure 10

NOTE: The harnesses may or may not be routed as shown in Figure 10, but go ahead and unclip the harnesses whichever way they are routed.

- Unclip the seat adjustment controls harness and lumbar adjustment control harness from the metal seat pan.

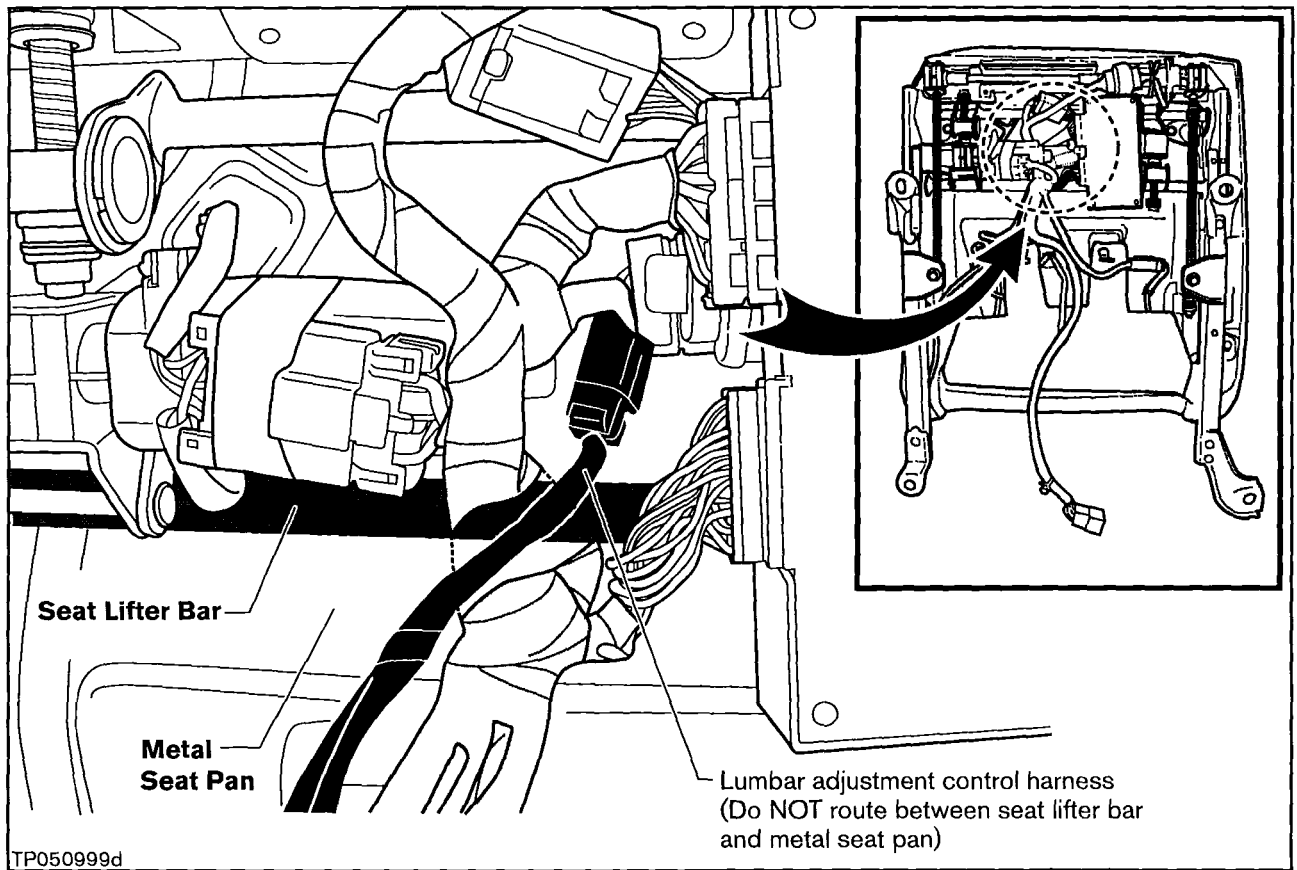
Figure 14

CAUTION: Do NOT route the lumbar adjustment control harness between the seat lifter bar and the metal seat pan.

- The lumbar adjustment control harness is reconnected and routed as shown in Figure 14.
