Subject: 2004-2006 Maxima Lumbar Seat Safety Recall Campaign Update #3

NTB05-116a

## VOLUNTARY RECALL CAMPAIGN DRIVER'S SEAT HARNESS ROUTING

**CAMPAIGN I.D. # / NHTSA #:** PB011 / 05V-512

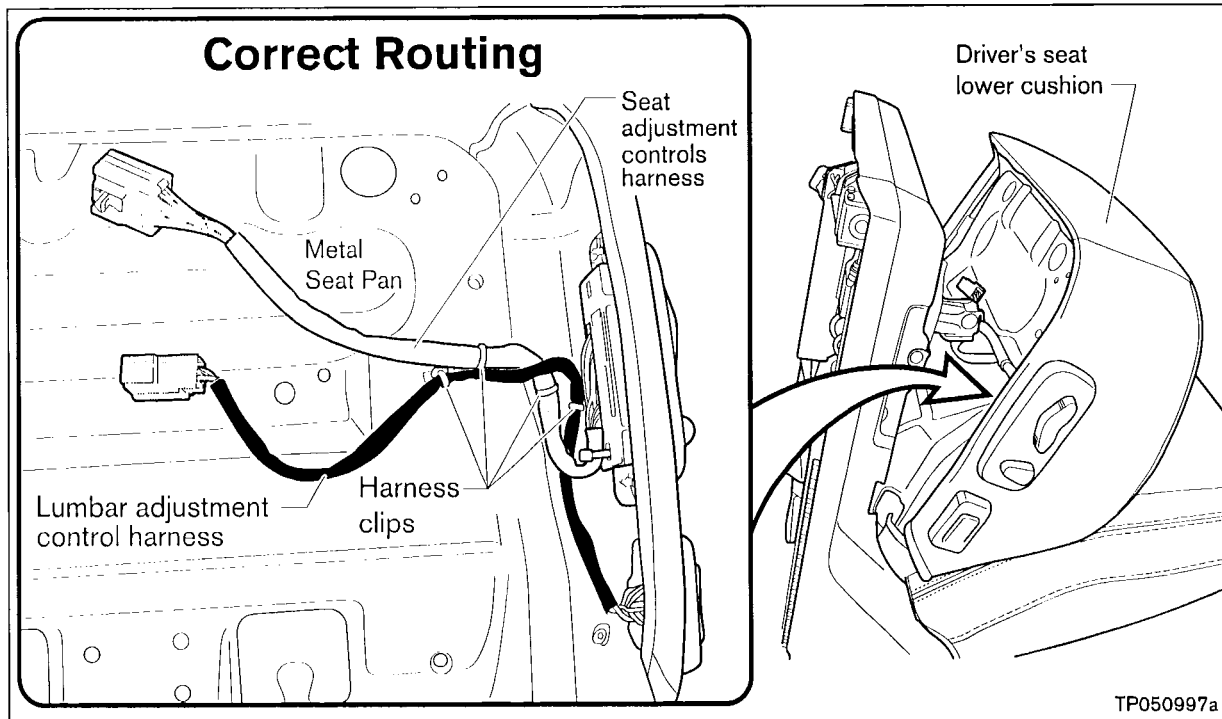
Figure 10

**NOTE:** The harnesses may or may not be routed as shown in Figure 10, but go ahead and unclip the harnesses whichever way they are routed.

6. Unclip the seat adjustment controls harness and lumbar adjustment control harness from the metal seat pan.

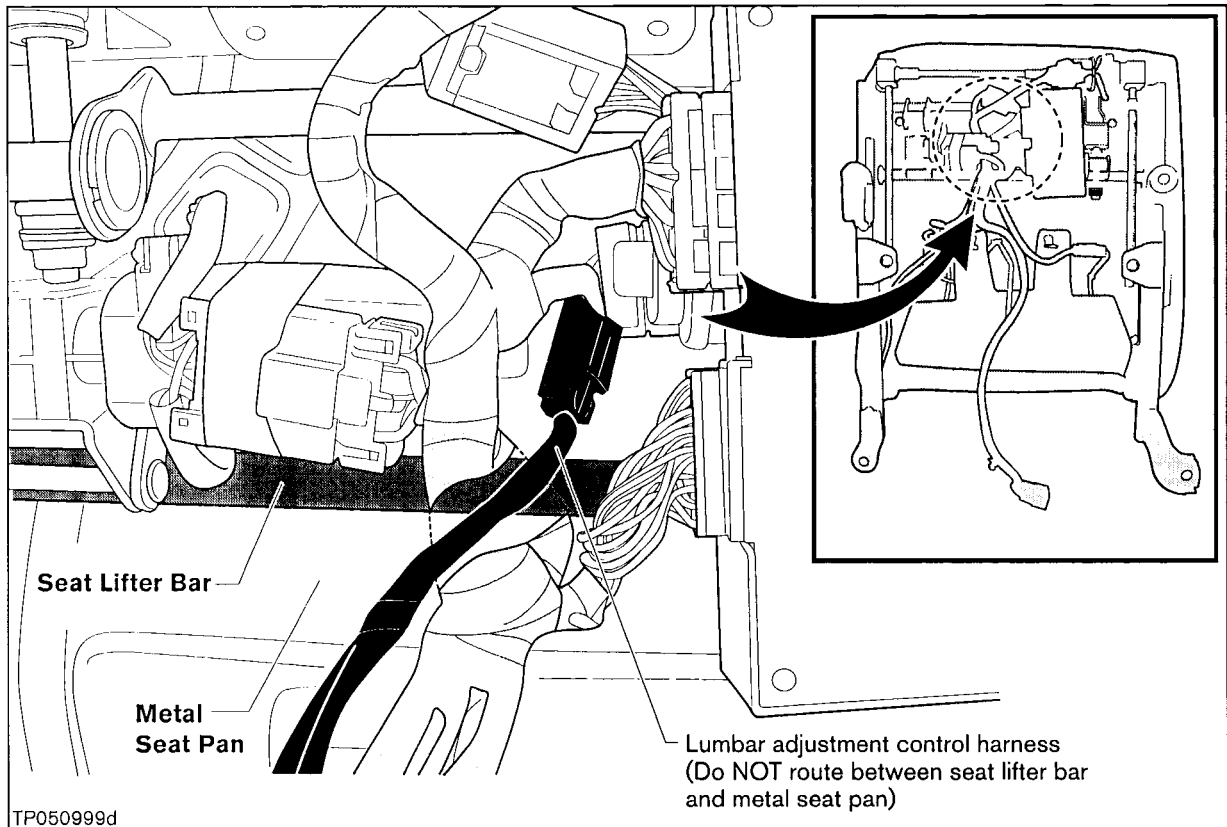
Figure 14

**CAUTION:** Do NOT route the lumbar adjustment control harness between the seat lifter bar and the metal seat pan.

- The lumbar adjustment control harness is reconnected and routed as shown in Figure 14.
