Subject: Safety Recall 05V-520
(Ford Number 05S40)

SUBJECT: **Safety Recall 05S40**
Certain 2006 Model Year Cars and Trucks
Wiper Motor Inspection

CERTAIN 2006 MODEL YEAR F-150, MARK LT, EXPEDITION, NAVIGATOR, EXPLORER, MOUNTAINEER, ESCAPE, ESCAPE HYBRID, MARINER, MARINER HYBRID, RANGER, E-SERIES AND TAURUS VEHICLES — WIPER MOTOR INSPECTION

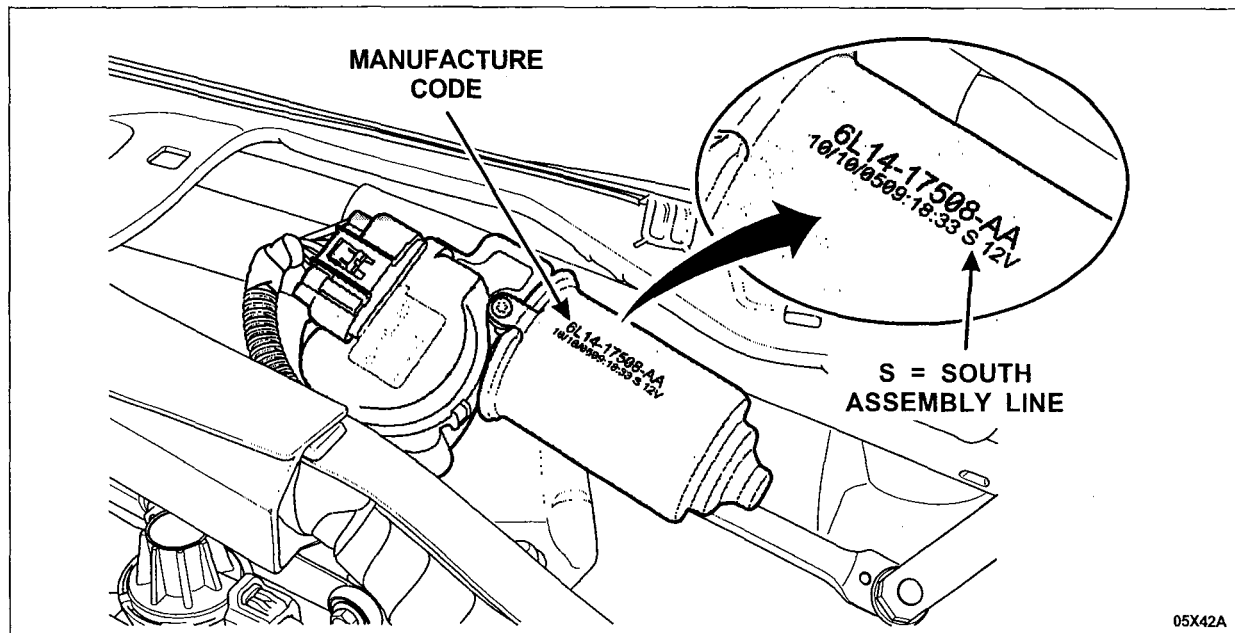
FIGURE 1

The manufacture code is laser etched onto the cylindrical wiper motor housing. The code consists of two (2) lines of numbers. One line shows the wiper motor assembly engineering part number. The other line shows the date and time of manufacture, the assembly line it was built on (N for north or S for south) then the voltage of the motor.

The wiper motor assemblies that require additional inspection for the presence of grease on the gears were built from 8-26-05 through 10-10-05 on the south assembly line. Any motor built before or after these dates, or built on the north assembly line, requires no additional inspection and the vehicle can be immediately released. See Figure 1.

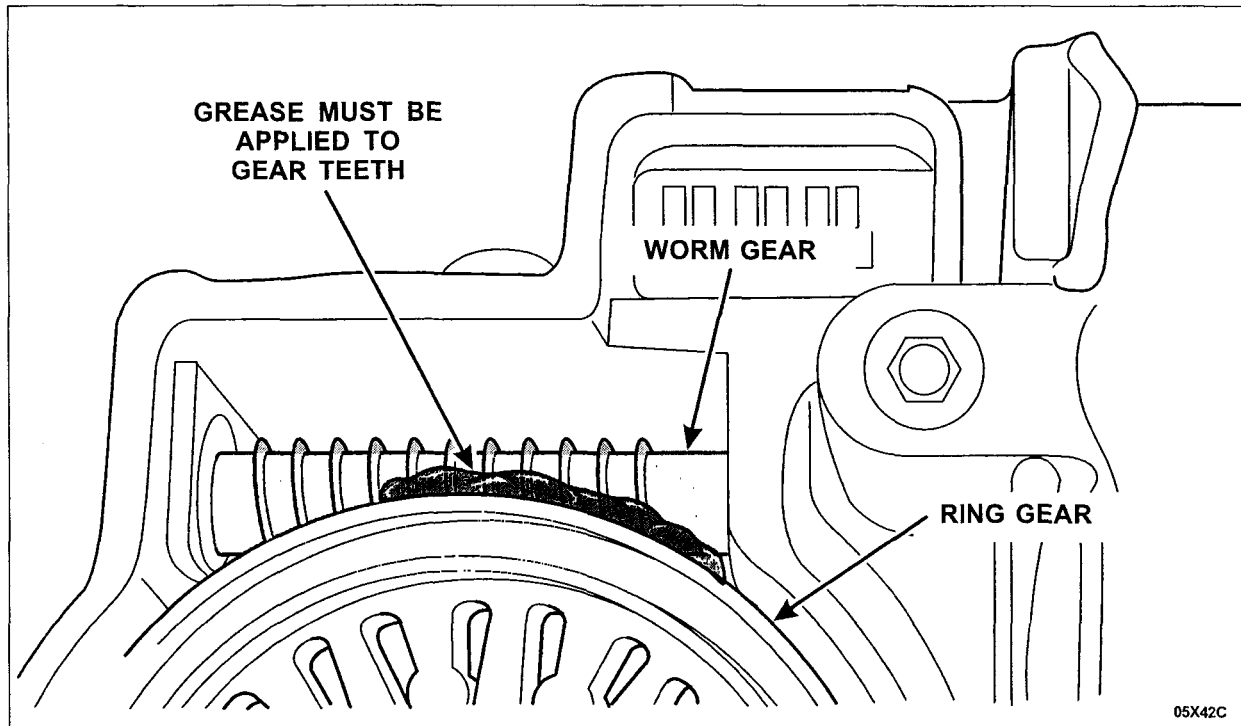
FIGURE 3

3. Inspect the worm and ring gears for presence of grease. Any amount of grease is acceptable as long as there is *some* grease present on the worm and ring gears.
 - If grease is present, no further service is required. Refer to Gear Cover Installation for specific cover installation procedures.
 - If no grease is present, apply a bead of grease, part number QFP, approximately 2-3 mm (1/8 in) wide and 20 mm (3/4 in) long, to the worm and ring gear mating area, beginning where the worm gear exits the motor. See Figure 3. The first tube will be shipped to dealers free of charge. **DO NOT USE ANY OTHER GREASE.** Then, refer to Gear Cover Installation for detailed gear cover installation procedures.
 - Refer to Attachment V for QFP Grease MSDS.
