**Re: Defect Information Report – supplemental information
(FL-464), NHTSA no. 05V-541, Fontaine Modification Sit Down Dual Drive
Conversion**

Section 573.6 Non-Compliance Information Report
FL-464, Fontaine SDDD Steering Pinchbolts; NHTSA no. 05V-541
Supplement No.: 02

Subject: Fontaine Modification Sit Down, Dual Drive Bolts

February 2006
 FL464B
 NHTSA #05V-541

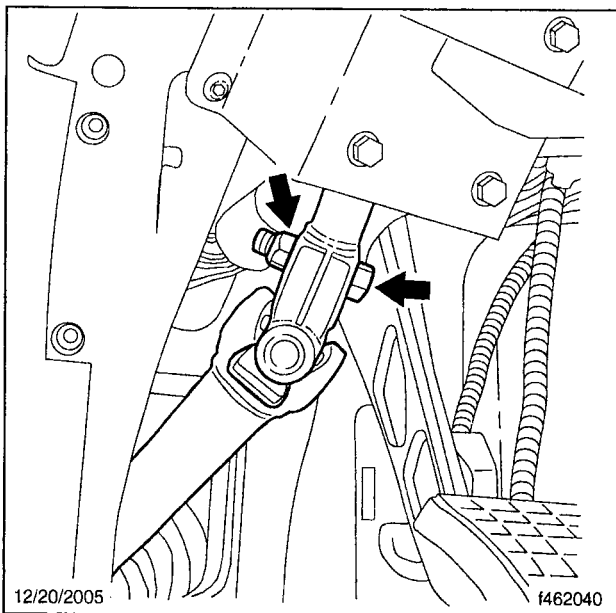
Fig. 3, Pinch Bolt on Intermediate Shaft, Left-Hand Side

The left-hand steering U-joint pinch bolt that secures the lower steering shaft to the left-hand miter box may have been improperly tightened. Incorrect hardware may have been used to install the steering cross shaft. Loss of a steering shaft pinch bolt or of a cross shaft fastener may cause a loss of steering control and possible vehicle crash without prior warning.

2. Locate the steering pinch bolt that connects the intermediate shaft to the 3-way gear box. See **Fig. 3**. Remove the steering pinch bolt and nut then discard them.

3. Install the pinch bolt and prevailing torque nut from the kit. Tighten the nut to 30 to 35 lbf-ft (40 to 45 N-m).
4. Locate the two through bolts on the steering cross-shaft U-joint, that connects the 3-way gear box on the left side, to the cross shaft. See **Fig. 4**. Remove both of the through bolts, and replace them with two 3/8-inch x 2.25-inch bolts and 3/8-inch stover nuts from the kit. Tighten the nuts to 30 to 35 lbf-ft (40 to 45 N-m).
5. Install the left-hand steering column covers.
Tilt Column: Using the three screws, attach the lower and center steering column covers to the steering column. Using three screws, attach the upper and lower clamshell covers to the steering column.
Fixed Column: Attach the lower and upper clamshell covers to the steering column.
6. Proceed to the steps for the right-hand steering position.

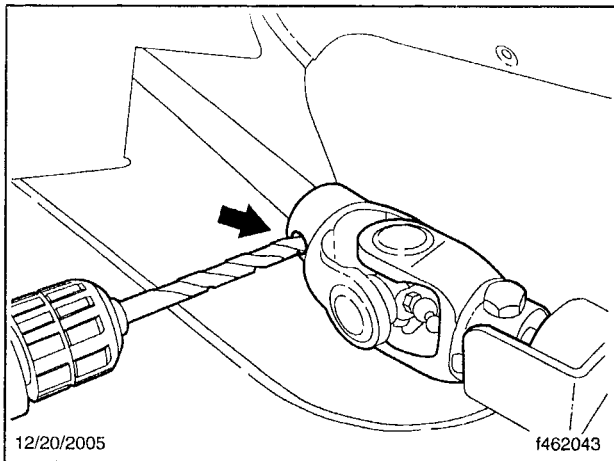
Fig. 6, Cross Shaft with One Through Bolt, Right-Hand Side

- 3.1 If one through bolt is observed:

Remove the through bolt and replace it with a 3/8-inch x 2.25-inch bolt and 3/8-inch stover nut from the kit. Tighten the nut to 30 to 35 lbf-ft (40 to 45 N·m).

Locate the setscrew in the cross-shaft U-joint yoke (in some cases the setscrew is positioned 90 degrees from the keyway position). Remove the setscrew, then using the hole as a drill guide, carefully drill a 3/8-inch hole through the cross shaft. See **Fig. 6**.

Install the supplied 3/8-inch x 2.25-inch bolt, and 3/8-inch stover nut. Tighten the nut to 30 to 35 lbf-ft (40 to 45 N·m).

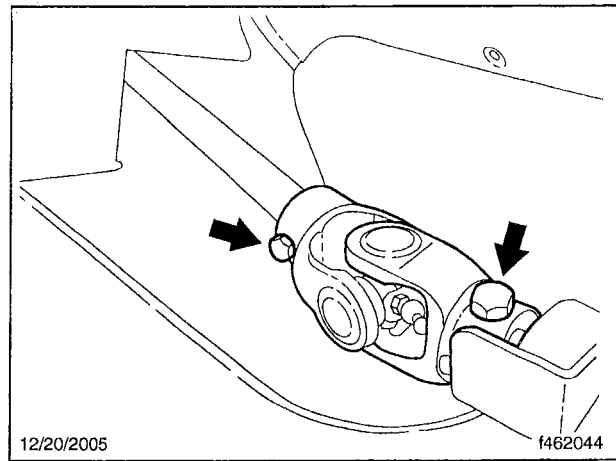
Fig. 7, Cross Shaft With Two Through Bolts, Right-Hand Side

3.2 If two through bolts are observed:

Remove the through bolts and replace them with two 3/8-inch x 2.25-inch bolts and 3/8-inch stover nuts from the kit. Tighten the nuts to 30 to 35 lbf-ft (40 to 45 N-m). See **Fig. 7**.
