**Re: Defect Information Report – supplemental information
(FL-466), NHTSA no. 05V-550, Visteon Wiper Motor on Sterling**

Section 573.6 Non-Compliance Information Report
FL-466, Visteon Wiper Motor on Sterling; NHTSA no. 05V-550
Supplement No.: 02

Subject: Visteon Windshield Wiper Motors

Windshield Wiper Motor Inspection and Replacement Procedure

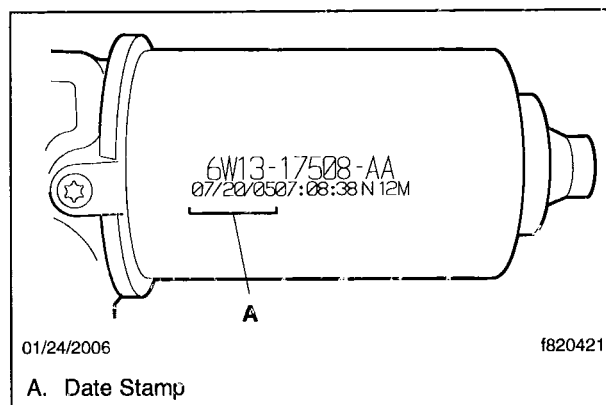
Fig. 1, Wiper Motor

1. Check the base label (Form WAR259) for a completion sticker for FL466 (Form WAR260) indicating this work has been done. The base label is usually located on the passenger-side door about 12 inches (30 cm) below the door latch. If a completion sticker is present, no further work is needed. If there is no completion sticker, go to the next step.
2. Park the vehicle on a level surface, shut down the engine, and set the parking brake. Chock the tires.
3. Open the hood.
4. Clean the wiper-motor housing and inspect the date stamp. See **Fig. 1**

NOTE: The date is written on the housing in light grey ink.

5. If the date is before September 1, 2005, or after October 14, 2005, no further work is necessary. Close the hood and go to step 16.

If the date falls between September 1, 2005, and October 14, 2005, replace the wiper motor using the following instructions.
