Re: Defect Information Report (FL-467), NHTSA 05V-551

Section 573.6 Non-Compliance Information Report
FL-467, Front Axle I-Beam; NHTSA no. 05V-551
Supplement No.: 3

Subject: AAC Front Axle I-Beams

March 2006
 FL467A
 NHTSA #05V-551

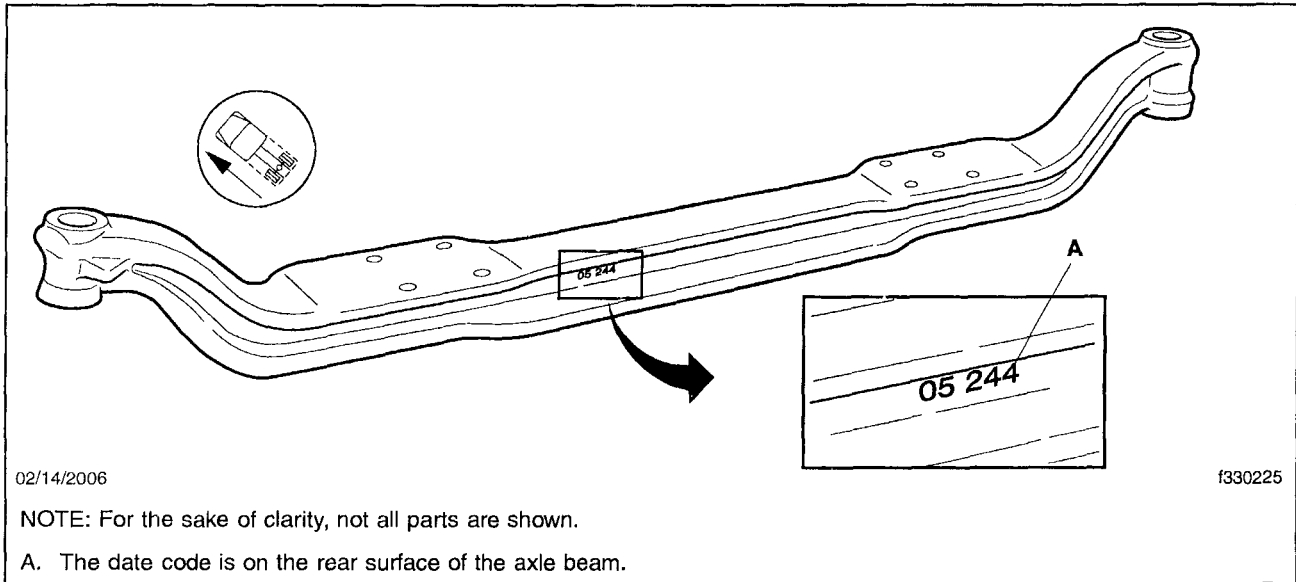
Fig. 1, Location of Date Code on Front-Axle Beam

1. Check the base label (Form WAR259) for a completion sticker for FL467 indicating this work has been done. On straight trucks and tractors, the base label is usually located on the passenger-side door about 12 inches (30 cm) below the door latch; on motorhomes, the base label is usually located on the front wall under the dash. If a sticker for FL467 is present, nothing further needs to be done. If no sticker is present, go to the next step.
2. Park the vehicle on a level surface, shut down the engine, set the parking brake, and chock the rear tires.
3. Find the date code on the rear surface of the axle I-beam web, on the driver's side and near the U-bolt pad. See **Fig. 1**. Affected axle beams are those with the date code *05 244*.

If the date code is NOT *05 244*, no further work is necessary. Clean a spot on the base label (Form WAR259). Write the recall number, FL467, on a blank red completion sticker (Form WAR260) and attach it to the base label.

If the date code IS *05 244*, go to the next step.
