Subject: Special Service Campaign (SSC) 5LC - 2006 IS 250 AWD Accelerator Pedal

TECHNICAL INSTRUCTIONS

SSC 5LC

Early 2006 IS 250 AWD Accelerator Pedal

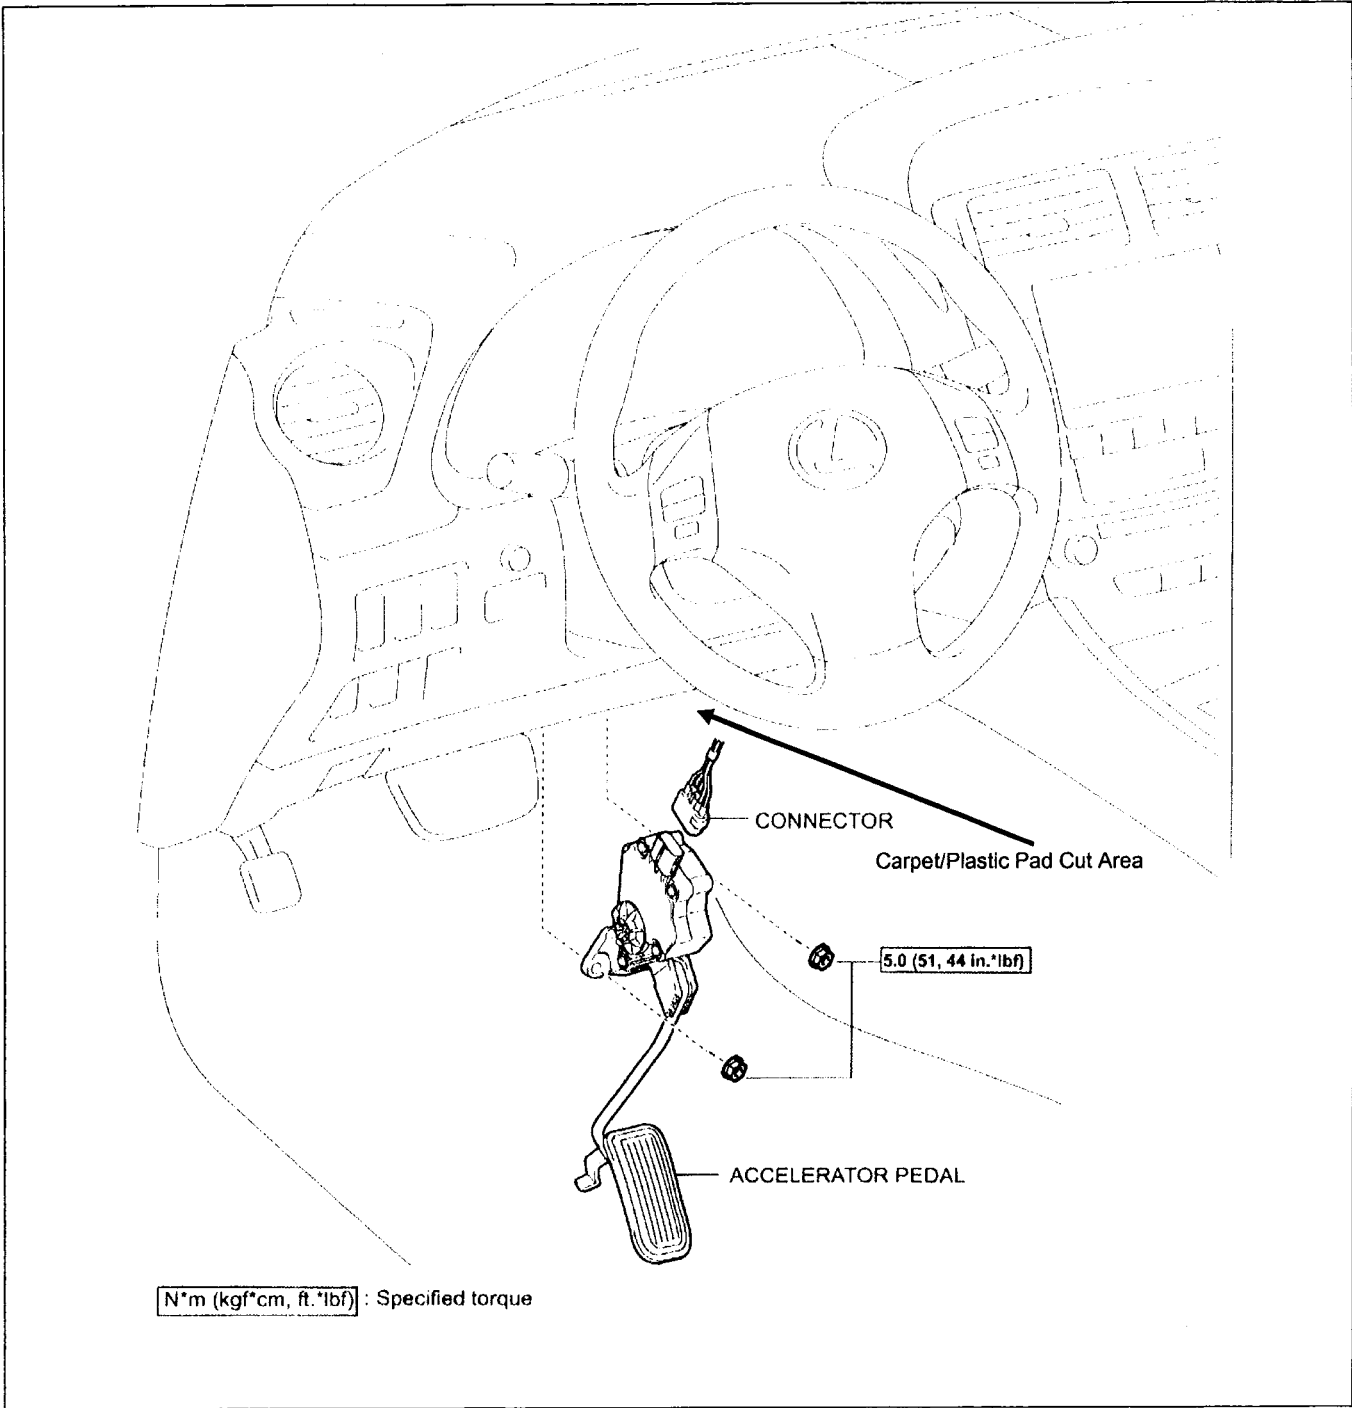
III. LOCATION OF COMPONENTS

In certain early 2006 Model Year Lexus IS 250 AWD vehicles there is a possibility that the accelerator pedal may temporarily become stuck in the partially depressed position due to inadequate clearance between the accelerator pedal linkage and a plastic pad embedded into the vehicle's carpet. This condition may interfere with the accelerator pedal returning to the idle position. In order to assure adequate clearance, dealers will be requested to replace the accelerator pedal assembly and modify the vehicle's carpet as well as plastic pad embedded into the vehicle's carpet.

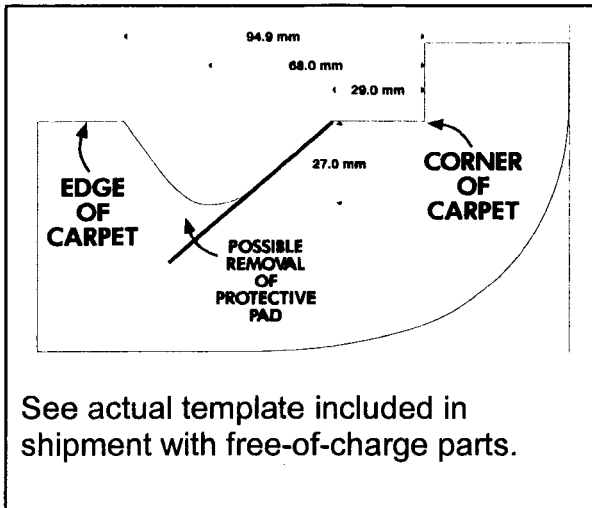
CARPET MODIFICATION PROCEDURES

- Due to variations in the placement of the plastic pad in the carpet, there may be slight variations in the area where the modification will occur.
- The Parking Brake Cable is behind this area of the carpet; please make sure that you do not damage this cable during the carpet modification.
- A Styrofoam pad is also behind the carpet. Please take care not to cut this as well.
- Based upon the production date, the plastic pad location may be slightly lower.

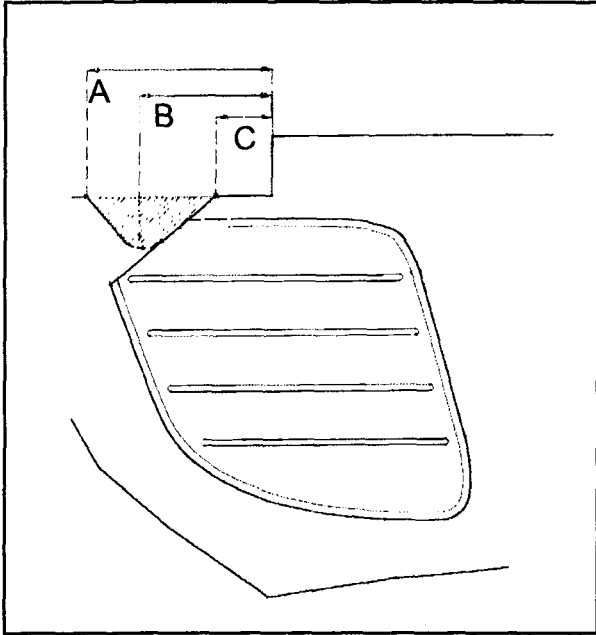
When cutting the plastic pad or the carpet, be aware of a Styrofoam pad behind the carpet. To avoid damage to the Styrofoam pad locate the two staples in the carpet behind the brake pedal and carefully pull the carpet and separate the Velcro that attaches the carpet to the Styrofoam.

The parking brake cable is located behind the carpet, do not cut the cable.

(d) Using a razor cut along the line to remove the upper inside corner of the plastic pad.

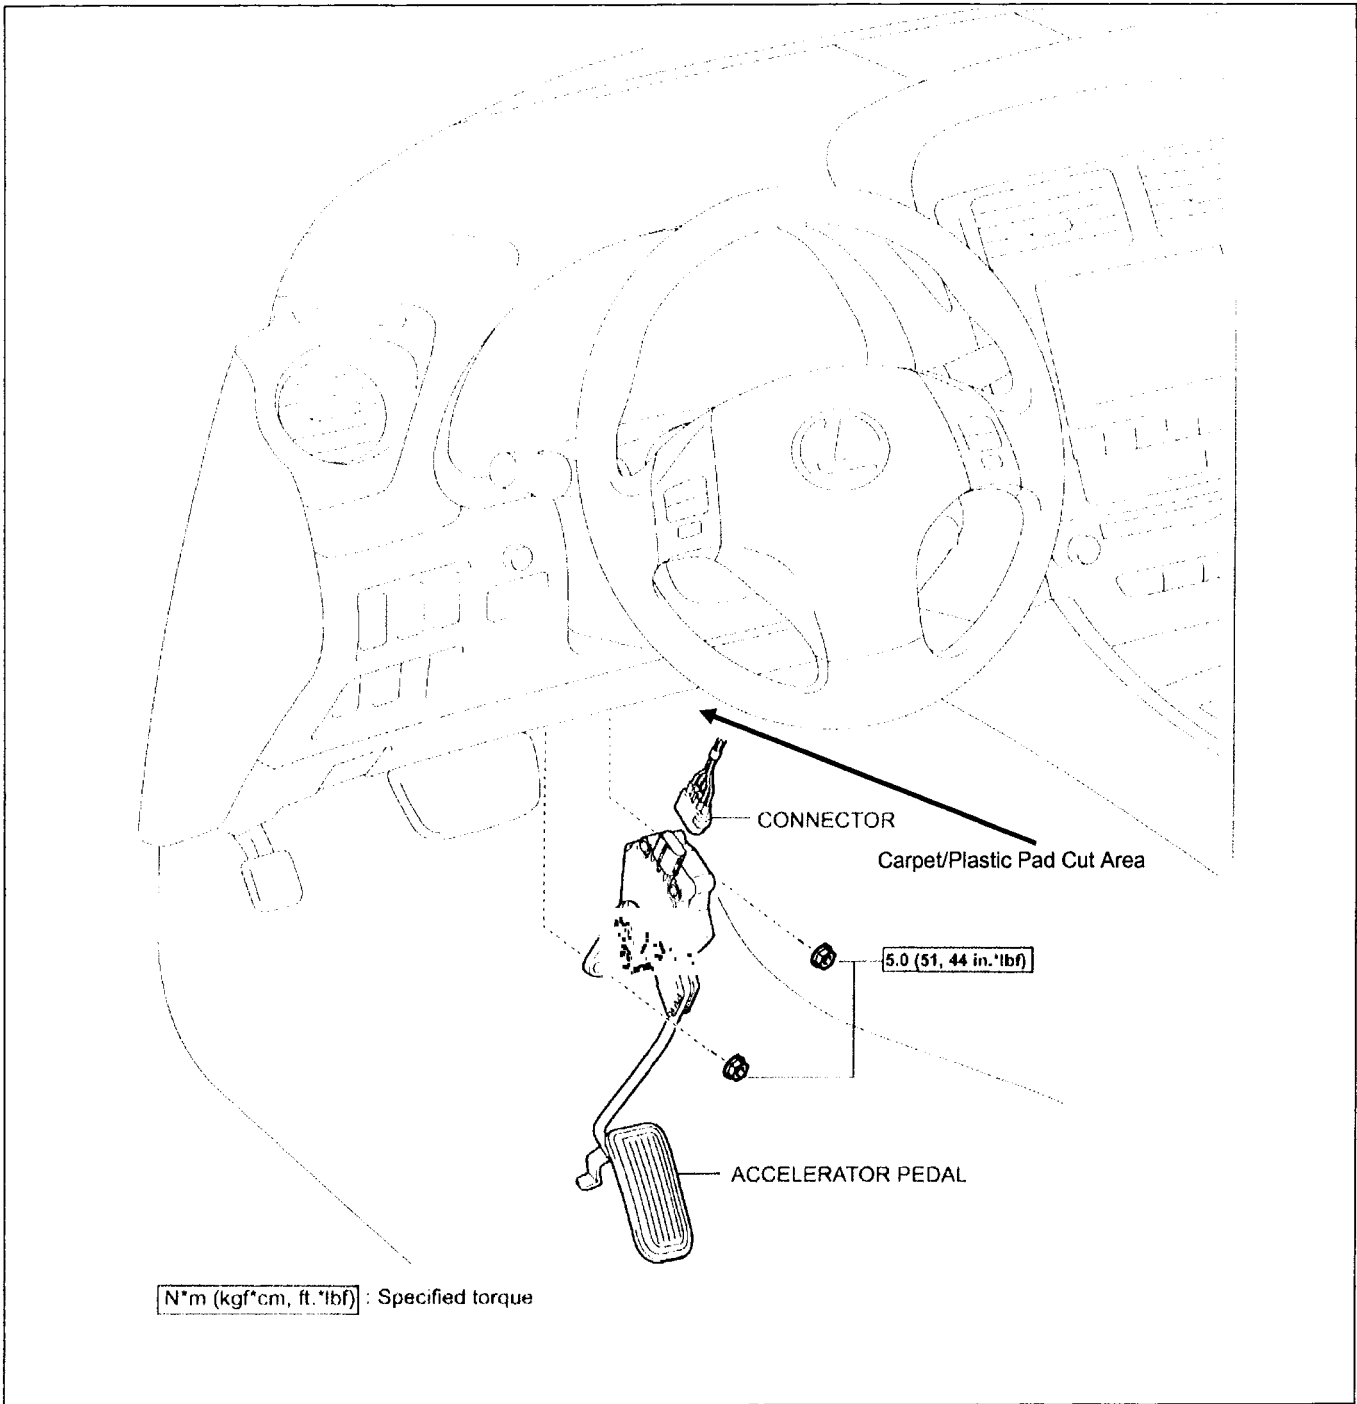
III. LOCATION OF COMPONENTS

In certain early 2006 Model Year Lexus IS 250 AWD vehicles there is a possibility that the accelerator pedal may temporarily become stuck in the partially depressed position due to inadequate clearance between the accelerator pedal linkage and a plastic pad embedded into the vehicle's carpet. This condition may interfere with the accelerator pedal returning to the idle position. In order to assure adequate clearance, dealers will be requested to replace the accelerator pedal assembly and modify the vehicle's carpet as well as plastic pad embedded into the vehicle's carpet.
