Subject: Recall Campaign No. 05V-566

4 - STROKE  
VS/VX/VZ/VL BULLETIN NO. 33  
DATE: 1/3/2006

**SAFETY RECALL CAMPAIGN**  
ALL 2005 AND CERTAIN 2006 VL800/T/Z BOULEVARD C50/T  
& VZ800 BOULEVARD M50 MOTORCYCLES  
IGNITION SWITCH INSPECTION/REPLACEMENT

**SUBJECT:** RECALL CAMPAIGN - IGNITION SWITCH INSPECTION/  
REPLACEMENT

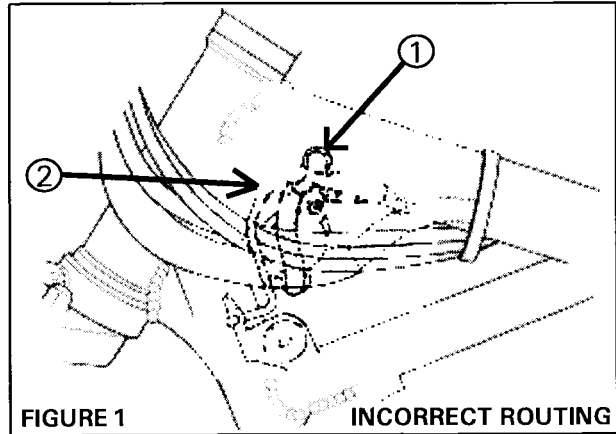
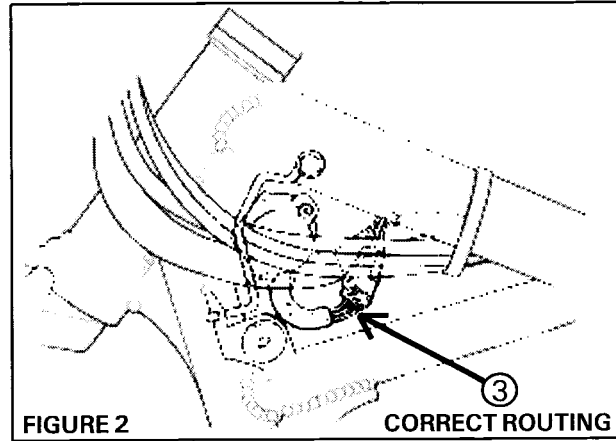
The ignition switch wiring harness may have been improperly routed at the time of production. If the wiring harness is not routed properly, it can rub against the clutch cable/throttle cable. Continued rubbing may eventually lead to a short circuit which may cause the engine to stall and/or the lights to go out. If the engine stalls the rider may be unable to restart it. This can increase the risk of a crash.

3. Remove ignition key and right side frame head cover. Remove left side frame head cover.
4. Inspect the ignition switch wiring harness ③ routing. If correct, re-install the frame head covers, fuel tank and front and rear seats. Proceed to Step 7.
5. If routing is incorrect, remove guide bolt ① and guide ② only. Inspect and re-route wires as shown in Figure 2.

If the protective covering over the ignition switch sub-harness is cut and the insulation of the lead wires is cut and/or abraded, replace the ignition switch and lock set. (Refer to VL800 Service Manual page 8-29 and VZ800 Service Manual page 9-35 for ignition switch replacement).

If the wire insulation is not cut and only the outer protective covering is damaged/cut, wrap the sub-harness with several wraps of electrical tape. In addition, if the clutch cable/throttle cable is damaged replace as necessary.

6. Re-install the cable guide, frame head covers, fuel tank and front and rear seats.
7. Turn on the ignition switch to confirm all of the electrical components are functioning properly (lights are working, engine starts and runs, etc.). Test ride the motorcycle.
8. Place an identification punch mark on the frame just after the Vehicle Identification Number per Figure 3 to confirm that the recall service has been completed. The VIN is located on the right side of the steering head pipe.
