Service Bulletin

SAFETY RECALL

2001-2002 GL1800/A Frame Weld Inspection

(This supersedes GL1800/A #17, dated September 2008)

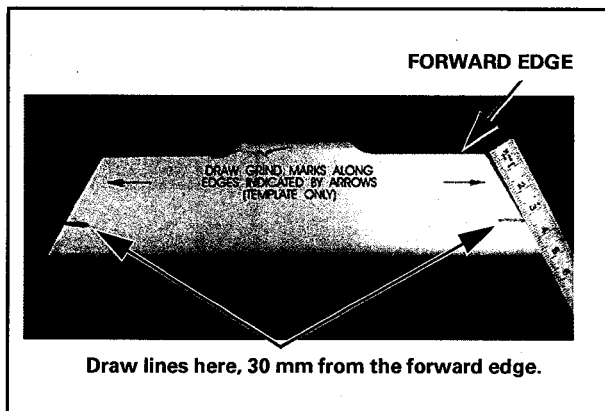
- Clean the frame crossmember with acetone.
- Draw a line on each side of the **grinding template** (S0512) 30 mm from the forward edge, stopping between the two arrows, as illustrated.

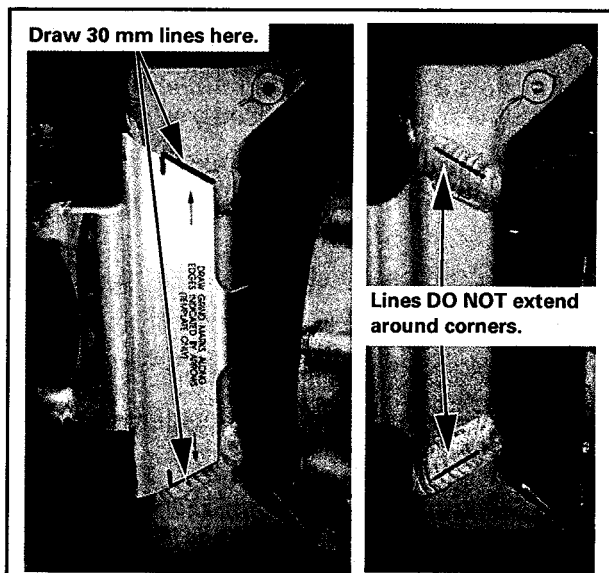
- Put this template on the frame and, using a fine-tipped felt marker (such as a Sharpie), draw a **30 mm line** on both crossmember welds. Start this line at the **forward edge** of the grinding template and stop between the two arrows as shown in the illustration. Now remove the grinding template.

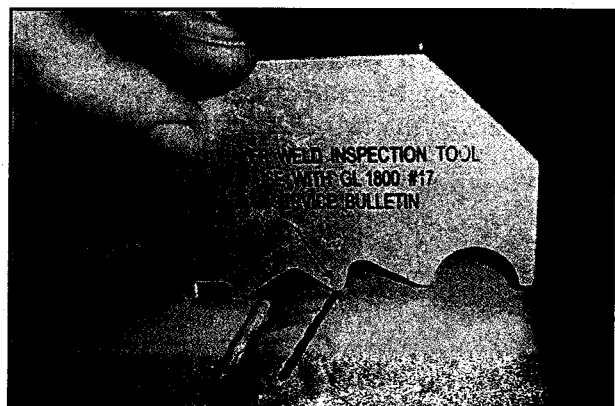
- Start with the Right weld and then inspect the Left weld.
- Place the Weld Inspection Tool on the crossmember with the INBOARD side facing the center of the crossmember. The inboard edge of the tool should contact the crossmember at all times, with the arrow-marked tip touching the marker line.

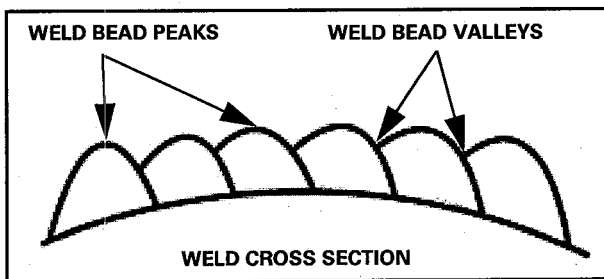
- Move the tool along the full length of the marker line, at a right angle to the line. As you move the tool along the 30 mm line, the arrow-marked tip should contact the "peaks" of the weld. The tip does not need to make contact with the "valleys" of the weld beads.

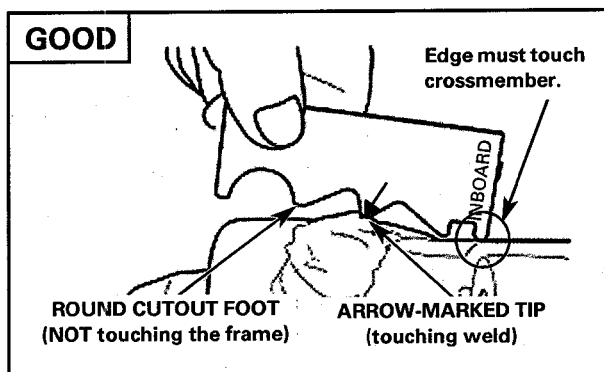
If the arrow-marked tip touches the weld bead "peaks" (top of each weld bead) along the entire length of the marker lines, the welds are GOOD (see illustration on the next page). Raise the motorcycle and reinstall all parts in the reverse order of removal. Proceed to the IDENTIFICATION section of this Service Bulletin.

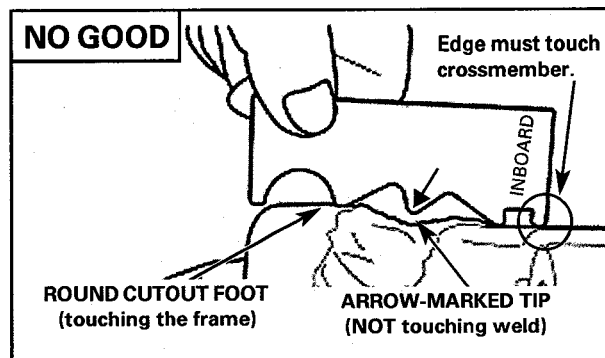
If the arrow-marked tip DOES NOT touch the weld bead peaks along the entire length of the marker line, the welds are NO GOOD (see the NO GOOD illustration).

If your inspection indicates a NO GOOD weld on either side, you must weld both sides. Proceed to the REPAIR PROCEDURE section.
