Constructors Racing Group, LLC

This report is submitted by Constructors Racing Group, LLC (CRG) pursuant to 49 CFR Part 573, to advise NHTSA that CRG will be voluntarily recalling model RB-511 and model RB-512 Roll-A-Click adjustable levers.

Generic name of the item: Motorcycle front brake lever

Model: RB-511 and RB-512, Roll-A-Click adjustable levers

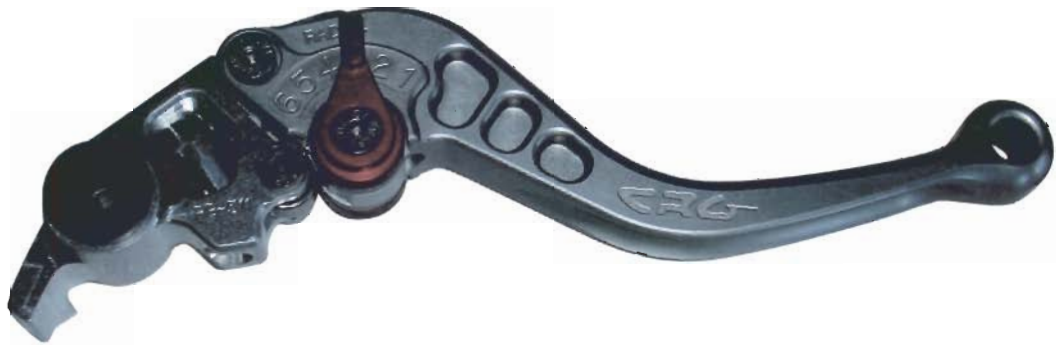
Other distinguishing information: Model RB-511 is designed for use on 2004 thru 2006 Yamaha YZF-R1 motorcycles, and 2005 thru 2006 Yamaha YZF-R6 motorcycles. Model RB-512 is designed for use on 2003 thru 2006 Ducati 749 and 999 motorcycles, and on 2004 thru 2006 Aprilla Mille R motorcycles. A picture of the brake lever is provided below for reference.

The subject equipment has a metal rocker that is attached to the end of the lever. The rocker, in turn, has a pivot bore, which interfaces with the motorcycle's master cylinder. The pivot bore contains two elements -- a reamed hole in the rocker, and a press fit composite bushing. It appears that the two bore elements may be out of line in some of the units, which can impede rotation of the master cylinder assembly. In a condition of extreme misalignment, either alone or possibly in combination with other factors such as inadequate lubrication or component wear, the brake lever could potentially become seized in the brake engaged position, thereby preventing the front brakes from disengaging.

CRG has resolved the manufacturing issue, and has changed the model numbers – which are stamped onto the rocker of each part -- to help distinguish new parts from those being recalled. RB-511 is being replaced with RB-516, and RB-512 is being replaced with RB-517. CRG is developing a recall plan and timetable, and will provide them to NHTSA promptly.
