TOYOTA
TOYOTA MOTOR NORTH AMERICA, INC.

January 25, 2006

06 V-023
(4 Pages)

Re: 2004 MY Lexus RX330 Rear Seat Belt Anchorage (FMVSS 210)
Part 573, Noncompliance Information Report

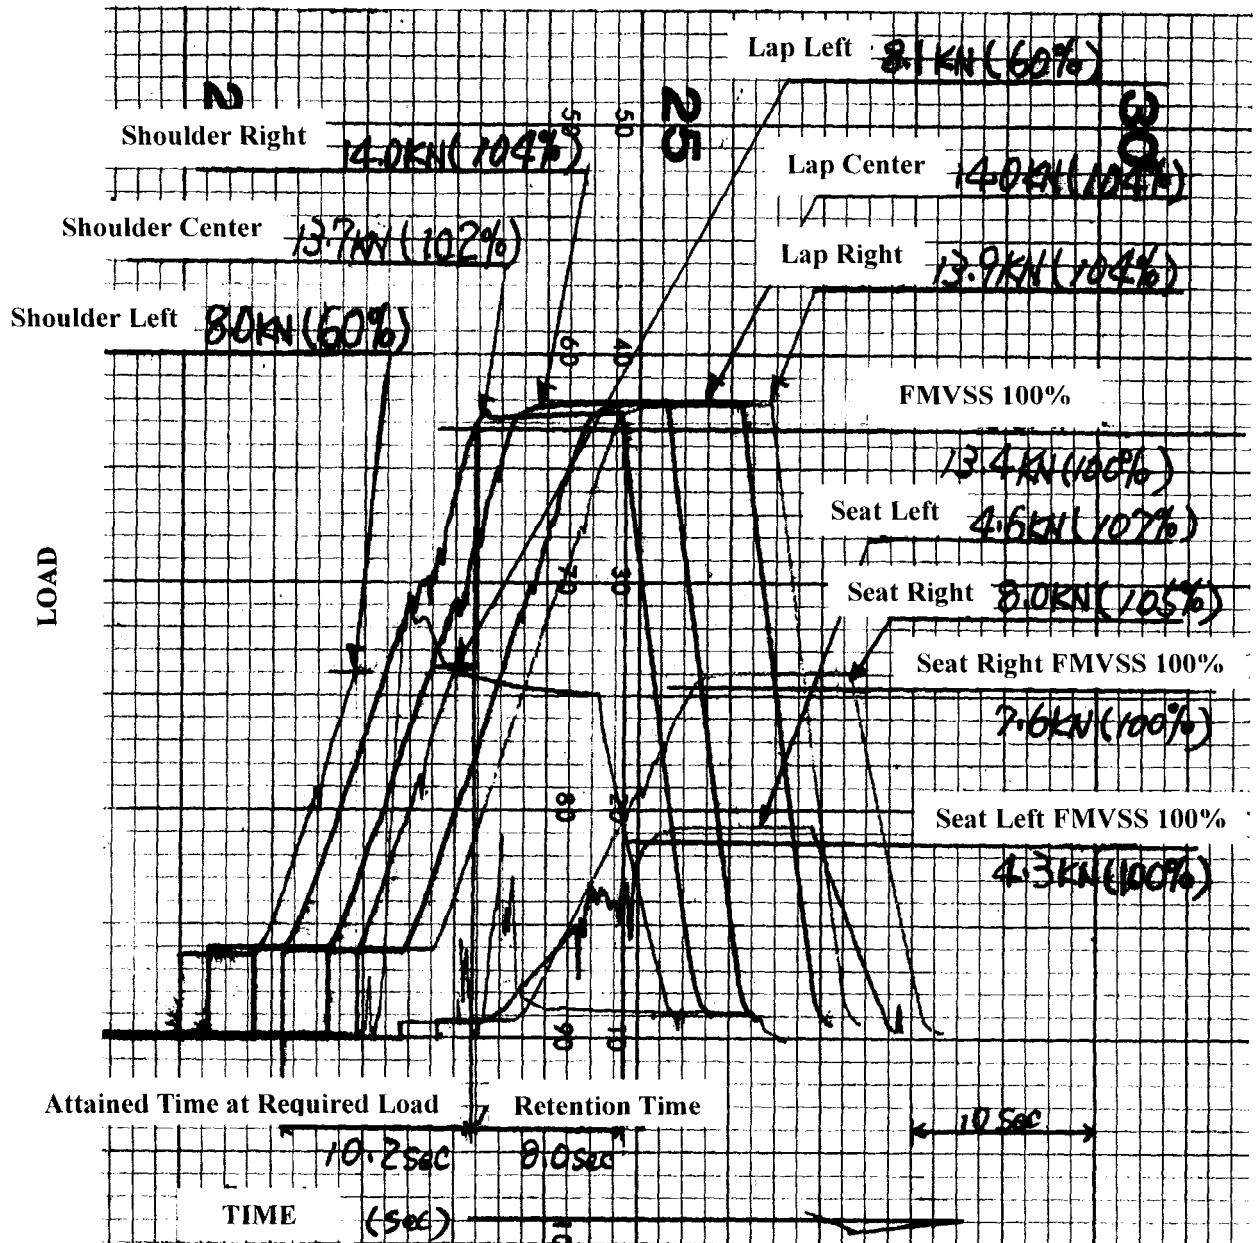
Test date: December 22, 2005

Test vehicle: RX330 (Rear seat)

Test specimen condition:

Anchor nut: Worst damage by tapping work

Anchor bolt: For RX330 made in Canada which has shorter thread length

Seat weight: Left 22.1 kg, Right 38.8 kg
