# WILSON TRAILER COMPANY

RE: Notice of Possible Defect

## REPORT TO NHTSA

1. Manufacturer's Name: Wilson Trailer Company
2. Vehicle Identification: certain 2003, 2004, 2005, and 2006 Wilson grain trailers manufactured from October 30, 2002, to May 1, 2005. Vehicles have been further identified by serial number and customer list.

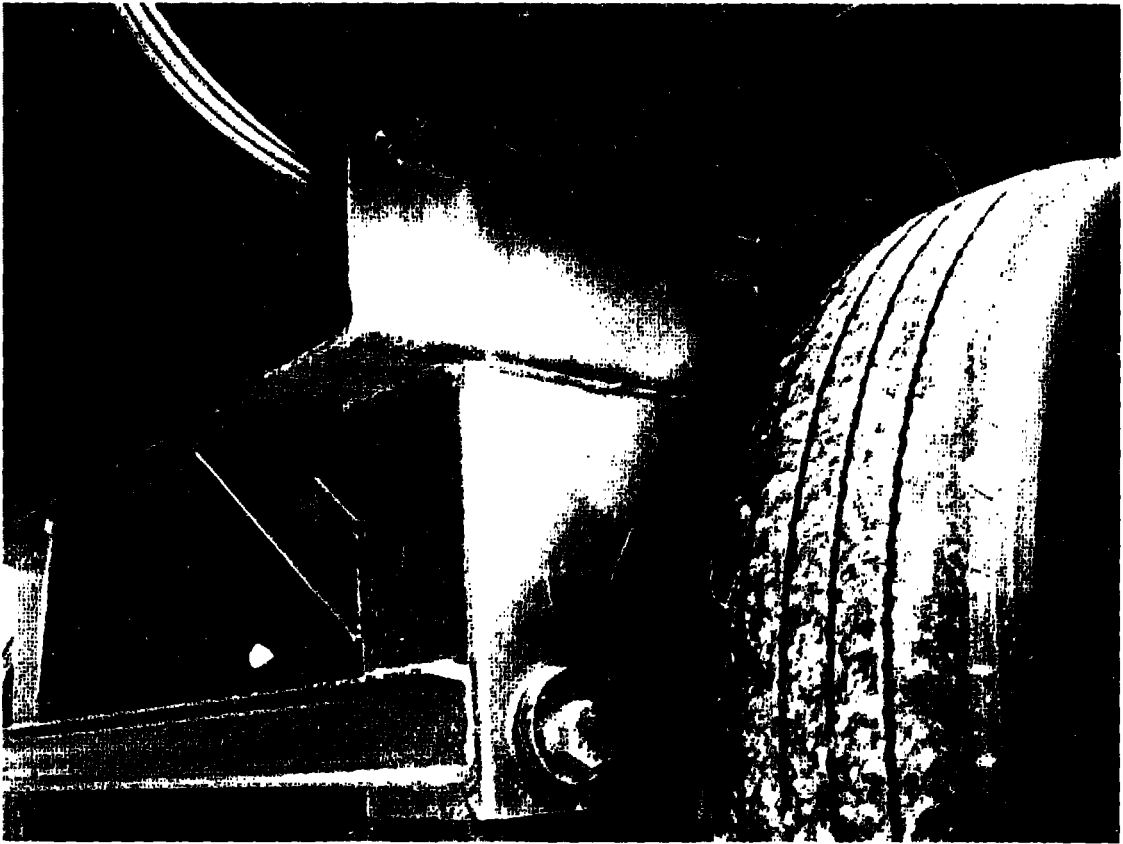
3. Total Number of Vehicles Subject to Recall: 2,177.
4. Percentage of Trailers Estimated to be Defective: Less than 1% (nine trailers).
5. Description of Defect: The defect concerns the air ride suspension hanger weldment at the attachment point between the hanger and the subframe on two-axle steel tandem configurations. Weld failure can cause the suspension and axles to detach from the trailer frame and cause personal injury to persons outside the vehicle and property damage. See enclosed photos.

6. History of Events: Nine trailers manufactured within the time period have experienced some weld cracking in the area of concern. A determination of the cause reveals that the weld at the attachment point between the hanger and subframe needs an additional support gusset to strengthen the weldment.

**Suspension Hanger without Support Gusset.**

7. Description of Remedy: To remedy the defect, one must first inspect the area of concern for any cracking in the weld and repair the weld if cracking is present. In addition, a support gusset must be installed at the area of concern. Instructions as to how to remedy the problem will be provided by the manufacturer to both the customer and the service dealer. Also, the customer and dealer will be provided a toll-free number to contact the manufacturer. The process involves inspection, remedial repair as required, and installation of the support gusset.

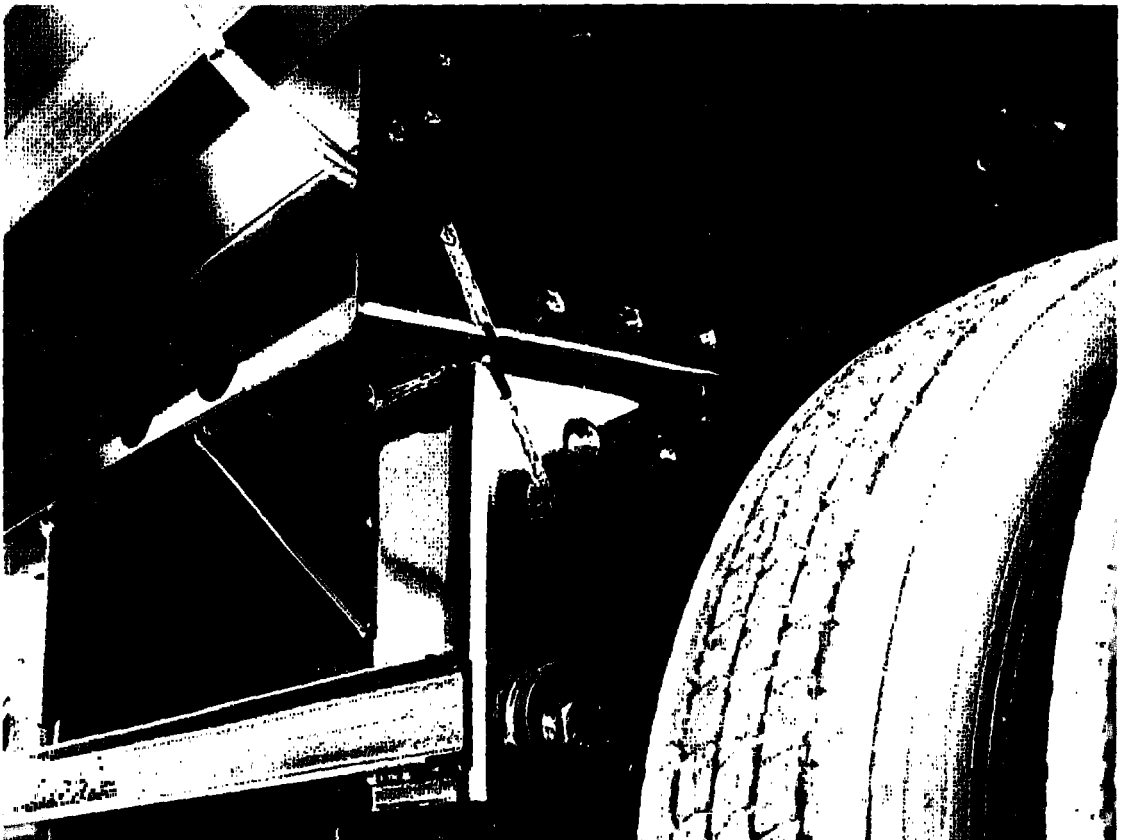
**Suspension Hanger with added Support Gusset.**
