2006 FEB -9 10 12:55
DEFECT INVESTIGATION

06V-042
(4 pages)

Re: Report Pursuant to 49 CFR 573.6
Autocar, LLC, Recall No. A-0601

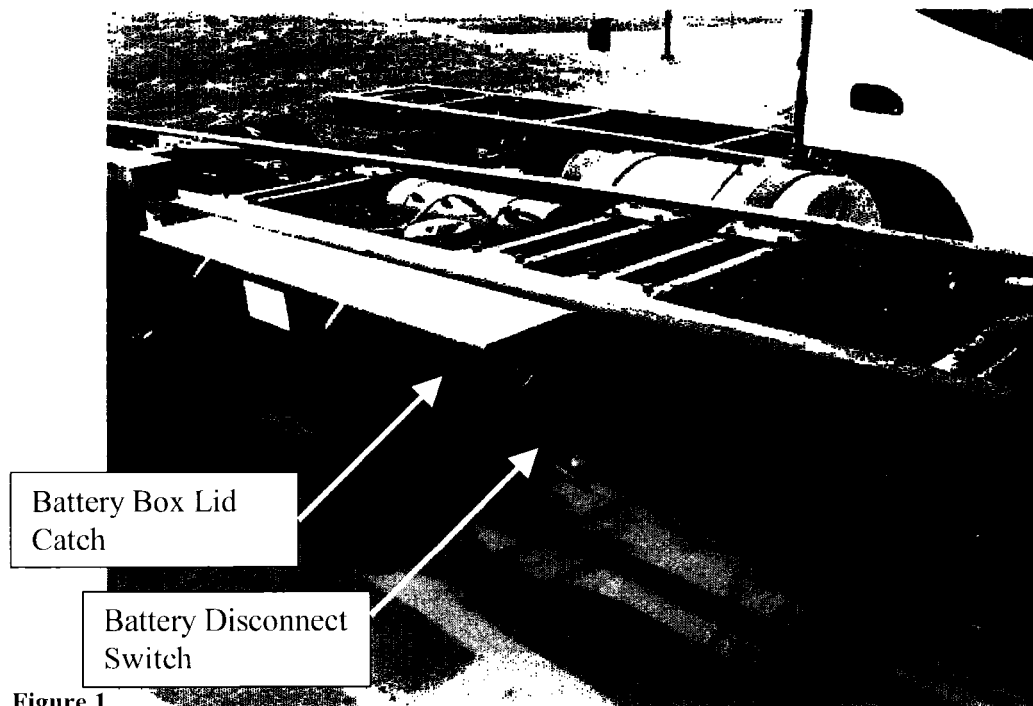
573.6(c)(5)
Exposed 12V terminals on the battery disconnect switch is in close proximity to a hinged metal latch on the battery box lid. When latching or un-latching the battery box lid, it is possible that a person wearing metal jewelry (like a watch or finger ring) might ground the metal latch through the jewelry to the exposed terminals on the battery disconnect

switch. The resulting electrical short circuit current may heat up the metal jewelry and could cause burns.

Figure 1 below shows the position of the right-hand battery box, the battery disconnect switch and the metal latch on the battery box lid.

Autocar will relocate the switch to a position further away from the metal catch and install isolating protectors over the battery disconnect switch terminals.
