## HEIL TRAILER INTERNATIONAL

Re: Heil Pull Trailer Dolly Frame Recall  
Manufacturer's Recall ID Code: EWR282

### **PART 573 Defect and Noncompliance Report**

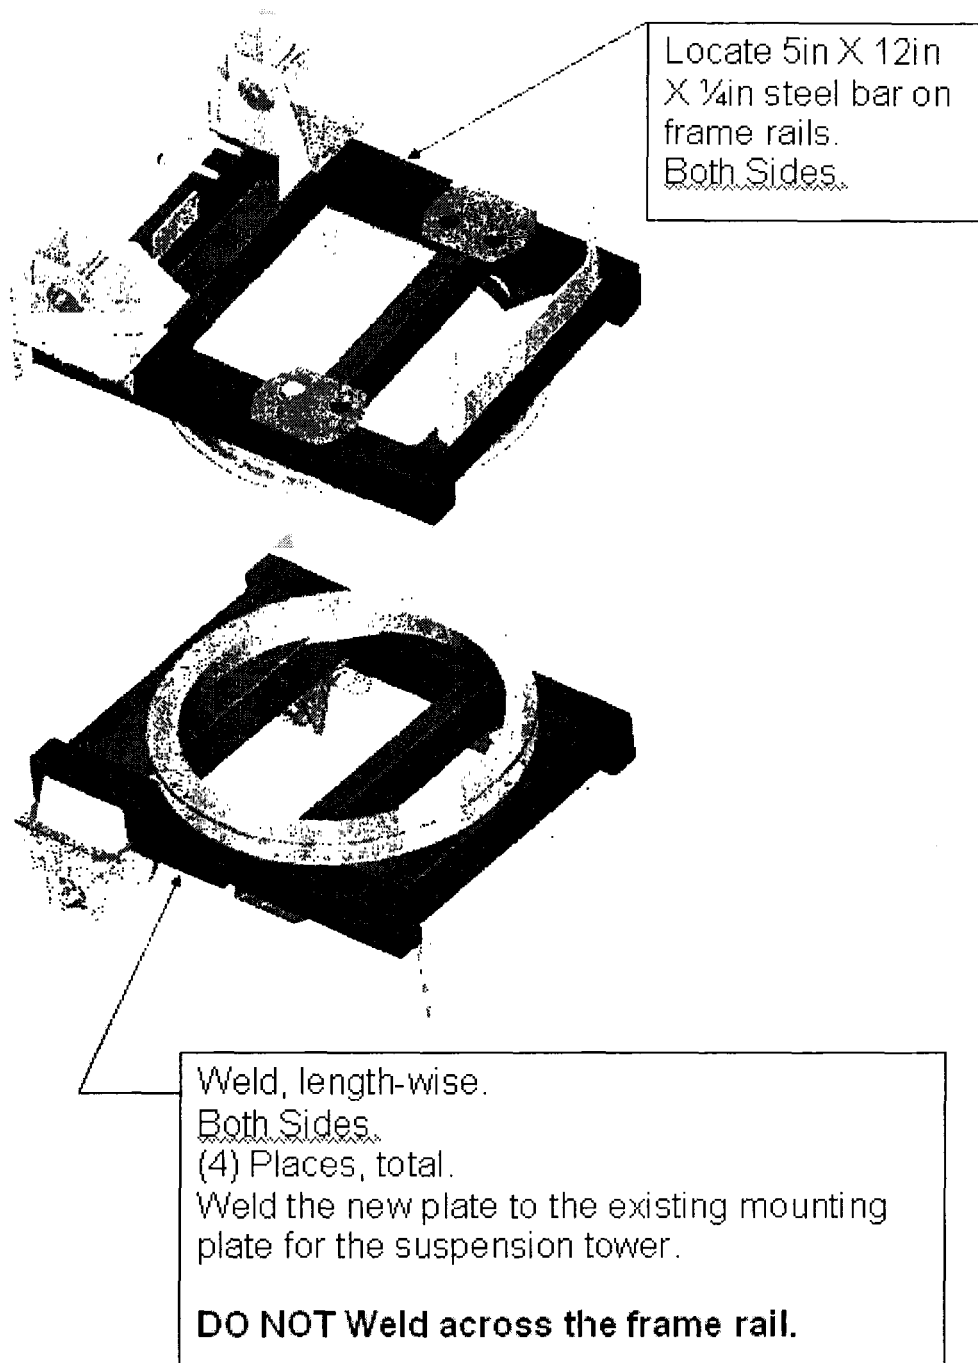
Potential frame cracking at the rear of suspension frame bracket.

Weld sequencing.

Modifications were made to the published weld procedures for the frame in question. Two distinct processes were used to communicate the revised procedure to manufacturing. (1) A weldment instruction (701-8078) was published to clarify welding procedures for the dolly frame. (See Figure 1.1.); and (2) A quality communication (2005-008) was published to clarify welding procedures for the dolly frame. (See Figure 1.2.) For the remedy condition, the tower plate welds and air bag plate welds are to stop ½" away from the edge of the frame rail. For the recall condition, the tower plate welds and air bag plate welds may continue to the edge of the frame rail.

For the remedy component/assembly, the tower plate welds and air bag plate welds are to stop 1/2" away from the edge of the frame rail.
