Re: Recall of Braun manufactured General Motors conversion vehicles

Safety Defect and Noncompliance Report Guide for Vehicles  
**PART 573 Defect and Noncompliance Report**

# Service Bulletin 32728

## for Installation of **High Pressure Fuel Line Upgrade Kit 32730K**

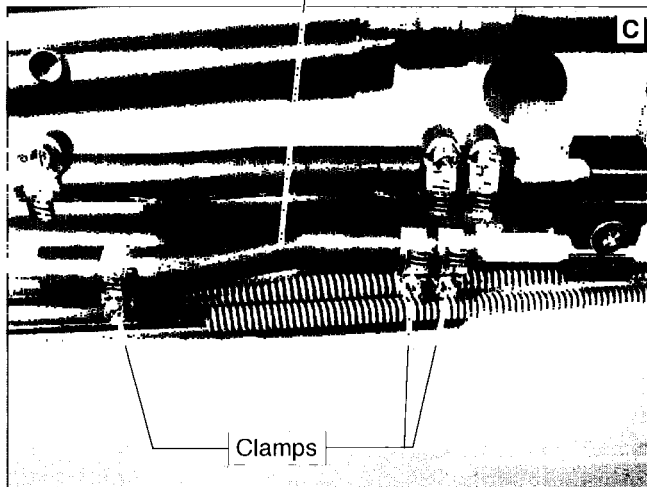
High Pressure Fuel Line Splice

**A low pressure fuel line was mistakenly used in place of a high pressure fuel line. The fuel line is located approximately beneath the driver position. (See the attached proposed Service Bulletin for illustrations of the remedy).**

**The remedy is to replace the fuel hose. The recall fuel hose is identified by light green lettering with the words, "MARTINREA GEN III E-P-CAP (R) 8.76/2.8-N 30730S0915C3." The remedy fuel hose is identified by white lettering with the words, "FUEL INJECTION HOSE (MULTI-FUEL COMPATABILITY) 3/8 INCH (9.5mm) SAE 30R9 GATES RUBBER COMPANY MADE IN USA GL103103A." (See also, the attached proposed Service Bulletin for illustrations of the remedy).**

7. Locate the deflector shield (located below driver seat area). See Photo B. Remove shield (seven Phillips self-tapping screws).
8. **Caution: Provide fuel spillage container** for this step. Some fuel will spill. Carefully remove high pressure line splice by removing three worm ring hose clamps. See Photo C. Remove and **discard** splice and three clamps.
9. Slide **new** clamps onto fuel lines (two in front and one in rear). See Photo C. Install replacement (**new**) splice (slide onto fuel lines). Splice must overlap fuel lines minimum 1-1/4" at front and minimum 3/4" at rear. Position clamps fully onto ends of splice. **Tighten clamps to 11-18 inch pounds.**
